### Site 31 – Lineham Ridge Creek II

This site consists of a creek crossing the highway along the southwest flank of Lineham Ridge. This creek channel was flagged as possibly having debris flow potential during the airphoto review.

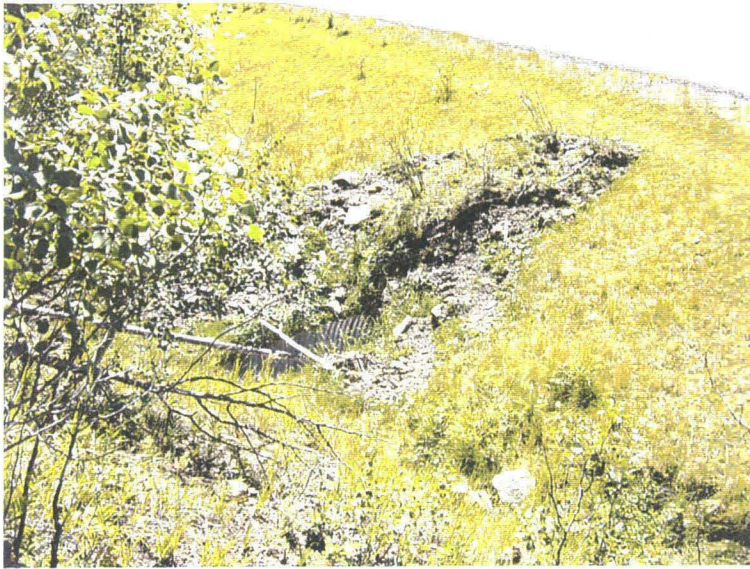
- There appeared to have been a shallow slide in the highway sideslope around the culvert inlet earlier in 2005. At the time of the inspection, the culvert inlet was clear and it appeared that the debris from the shallow slide had been cleaned out by the maintenance contractor (Photo 1). This slide is unrelated to any debris flow hazard along this creek channel.

**Photo 1** (top) – Culvert inlet adjacent to the westbound lane of the highway. There appeared to have been a shallow slide in the sideslope around the culvert inlet earlier in 2005.

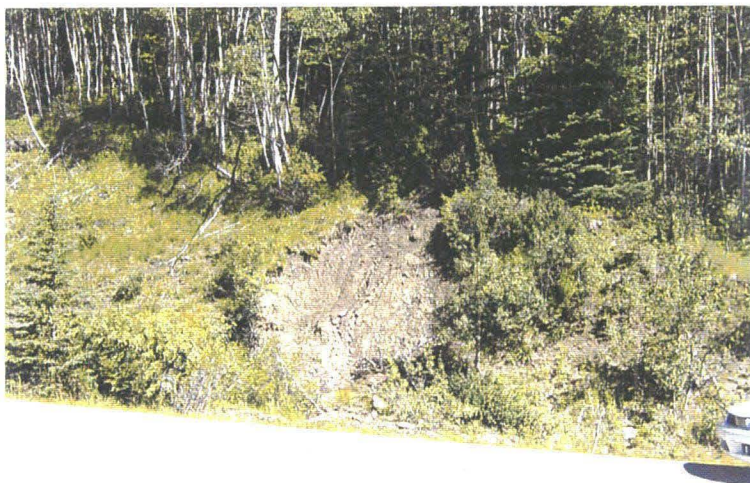
- There was a shallow slump in the cut slope above the road approximately 10 m west of the culvert inlet (Photo 2). The debris from this slump was blocking the ditch.

The heavy rainfall events in this area during June 2005 do not appear to have caused any significant erosion or debris deposition along the creek channel both above and below the highway. It is judged that the shallow slide around the culvert inlet as well as the slump along the ditch to the west of the culvert inlet were triggered by saturation of the near-surface soils in these areas during these heavy rainfall events. The shallow slide and slumping appear to have had negligible impacts on the highway.

**Photo 2** (bottom) – Shallow slump in the cut slope above the highway, approximately 10 m northwest of the culvert inlet. The debris from this slump was contained within the ditch.

It is recommended that the slump debris in the upslope ditch west of the culvert be cleared in order to restore the ditch gradient.
