Site 30 – Lantern Creek

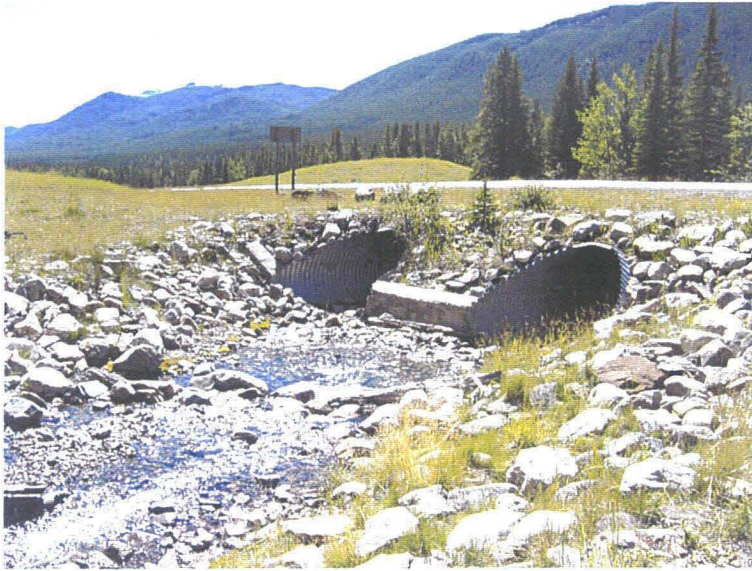
Both culverts were clear of debris at the time of the inspection in August 2005. A minor accumulation of wood debris and rocks was noted on the upstream side of one of the wood posts, however it would likely wash away under high flow conditions without any problem.

Photo 1 (top) – Culvert inlets at the Lantern Creek crossing. Both of these culverts have a series of vertical wood posts along the length of the culvert to prevent the culverts from being deformed by the weight of the overlying fill.

The culverts were clear of debris at the time of the inspection, although a few pieces of wood debris and rocks had accumulated on the upstream side of one of the wood posts near the inlet of the east culvert.

It is recommended that the maintenance contractor visually inspect the site for future debris accumulation around the culvert inlets and clean debris as necessary. The condition of the wood posts supporting the culverts should also be checked in the future.
