Site 29 – Picklejar Creek

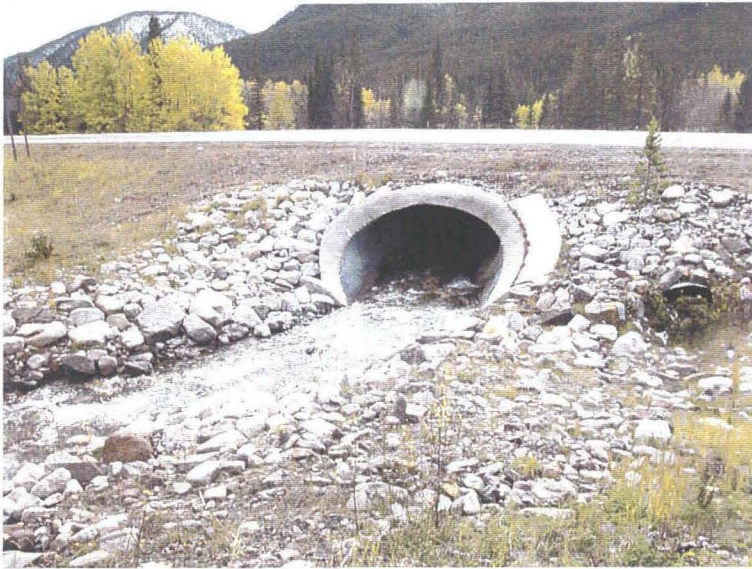
Picklejar Creek flows across the highway right-of-way via a large culvert (oval shaped, major and minor axes both greater than 2 m) with a well-armored inlet area (Photo 1). The culvert was completely clear of debris of the time of the inspection in August 2005.

Photo 1 (top) – Facing downstream towards the culvert inlet at the Picklejar Creek crossing.

It is recommended that any future debris accumulation around the inlet of the culvert be cleaned out as necessary by the maintenance contractor. The maintenance contractor may already be doing this as routine work.

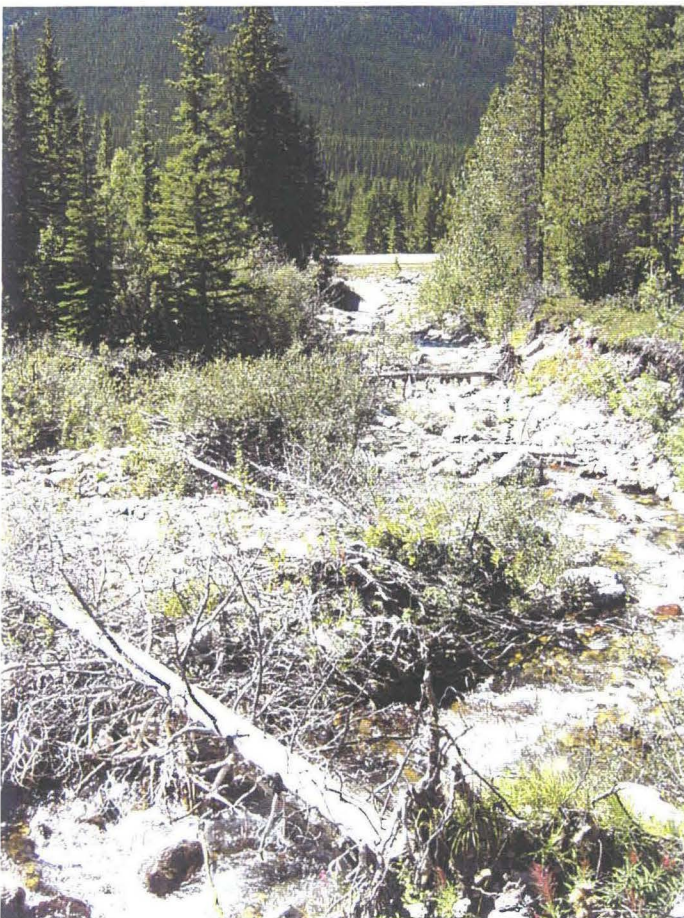
The creek channel upstream of the culvert is braided and meandering within a broader floodplain area incised approximately 2.5 to 3 m below surrounding areas and bordered by levees of rocky debris. Photo 2 shows a typical view of the channel upstream of the culvert inlet. The floodplain shows signs of frequent channel shifting under varying flow volumes. There is abundant wood, soil and rock debris along the segment of the channel extending approximately 400 to 500 m upstream of the highway. The channel gradient in this area is approximately 5°.

Photo 2 (bottom) – Typical view of the segment of the creek channel approximately 100 m upstream of the highway. The existing channel is incised approximately 2.5 to 3 m below surrounding areas and bordered by debris levees. It appears that the channel has shifted within the area bounded by the levees many times in the past under varying flow volumes. The channel gradient in this area is approximately 5°. There is abundant wood, soil and rock debris within this segment of the channel.
