Site 28 – Lipsett Ridge Rock Cut

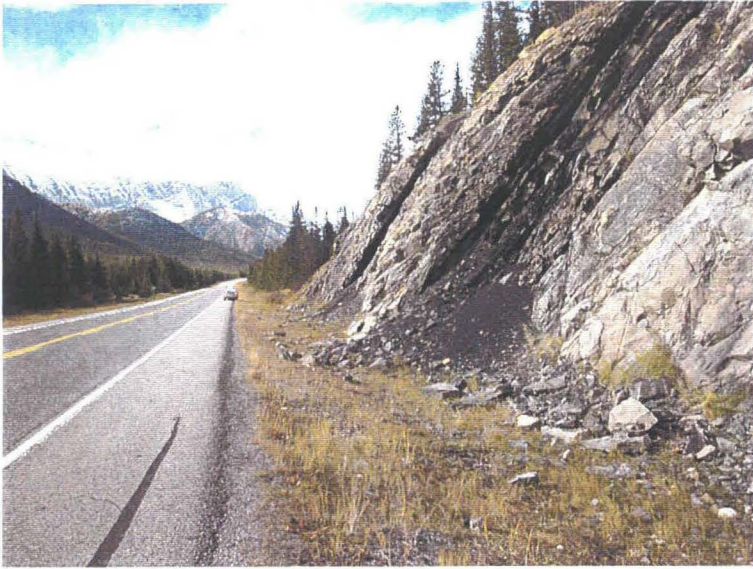
There was an accumulation of rockfall debris in the ditch at the time of the inspection in September 2005. The debris consisted of particles ranging from gravel to boulder sizes. The majority of the debris had accumulated along the toe of the cut slope, although in some locations boulder-sized particles had rolled along the debris that had accumulated below weak coal beds exposed in the cut slope and been deposited within 1.5 m of the edge of the pavement. The pavement along the northeast shoulder of the highway did not show any signs of damage from past rockfall.

Photo 1 (top) – Facing northwest across the Lipsett Ridge rock cut site. The bedrock exposed in the cut slope consists of bedded shale and coal that is steeply dipping down to the west. The rockfall debris from this cut slope ranges from gravel to boulder sizes. The rockfall debris typically accumulates at the toe of the cut slope, however there were a few locations where boulder-sized particles had rolled to within 1.5 m of the edge of the pavement.

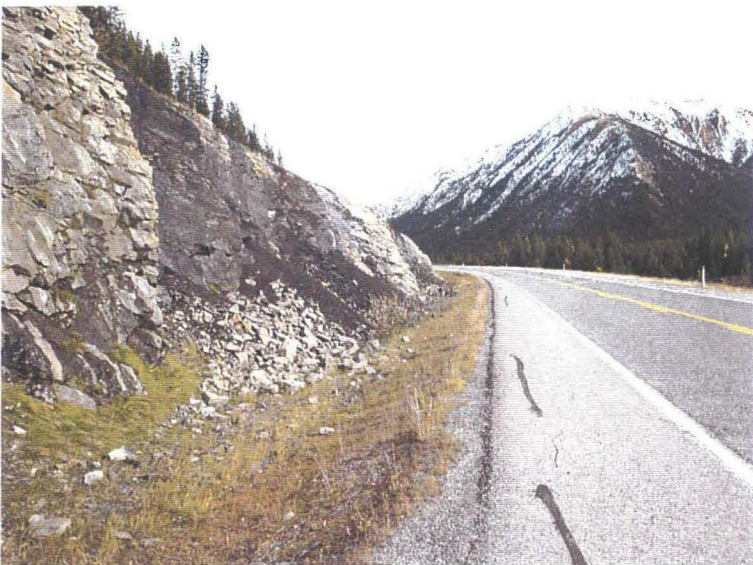
Photo 2 (bottom) – Facing southeast across the Lipsett Ridge rock cut site. The amount of rockfall debris observed in the ditch was relatively minor, however the ditch should be cleaned in order to restore its full capacity and reduce the hazard of rockfall debris rolling onto the pavement.

The Consequence Factor of 1 is contingent on the ditch being cleaned as required to maintain its capacity to hold rockfall debris. It is recommended that cleaning of the rockfall debris from the ditch be treated as an ongoing maintenance issue.
