January 19, 2022

CON0022161 Southern Region GRMP
Call-Out Report – S068 Background Data Review

Please find enclosed a Section D report relating to the S068 site, located on Forestry Trunk Road 25001 (FTR 25001), formerly called Highway 940, south of the Highwood House rest stop junction.

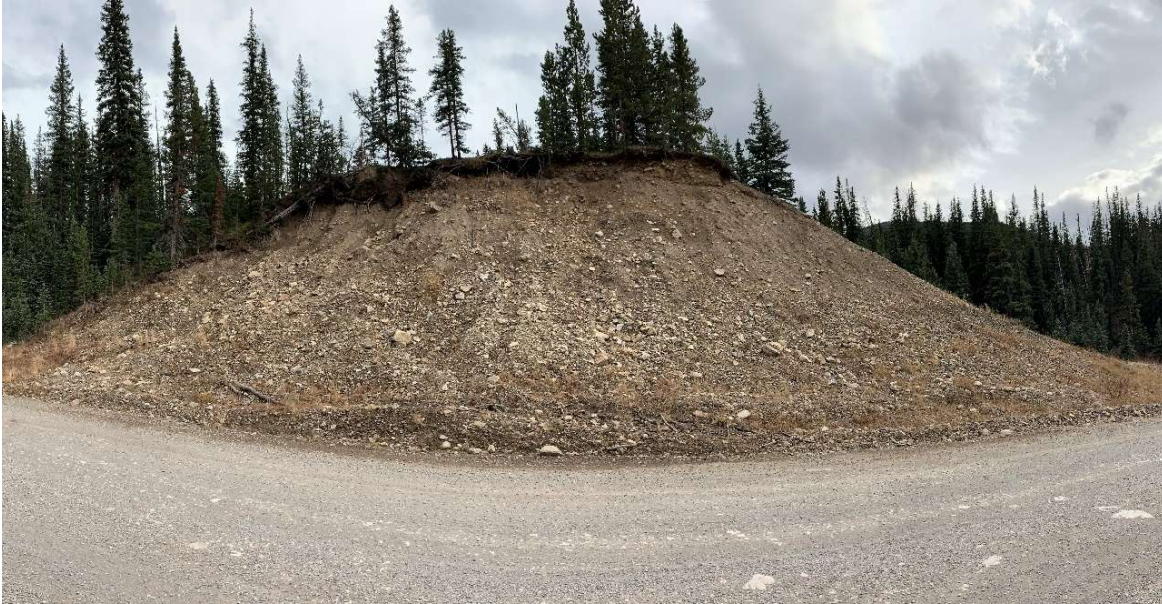
Site No.	2021 Observations (Changes since 2008)
S068-1 (25001:02 C1 7.489)	<p>S068-1 consists of an unvegetated back slope on the west side of the highway. The back slope was estimated to be at least 8 m high. There is no ditch at this site. A creek is located downslope of the highway.</p> <p>The back slope was excavated into glacial till/rocky soil. Erosion rills were noted across the back slope due to surface runoff erosion and weathering. There is an accumulation of granular material at the toe of the slope which forms a small vertical step due to road grading. Erosion at the crest of the slope has created overhanging vegetation mats and there is a risk of trees falling onto the highway.</p> <p>S068-1 was damaged due to the 2013 flooding but appears to have been repaired to approximately the original road geometry. In general, there were no significant changes noted in 2021 when compared to observations reported in the AMEC 2008 geohazard review for the Highway 940 corridor.</p>

Photo I-1 S068-1: Back slope upslope of the highway. Photo was taken facing north on October 22, 2021.

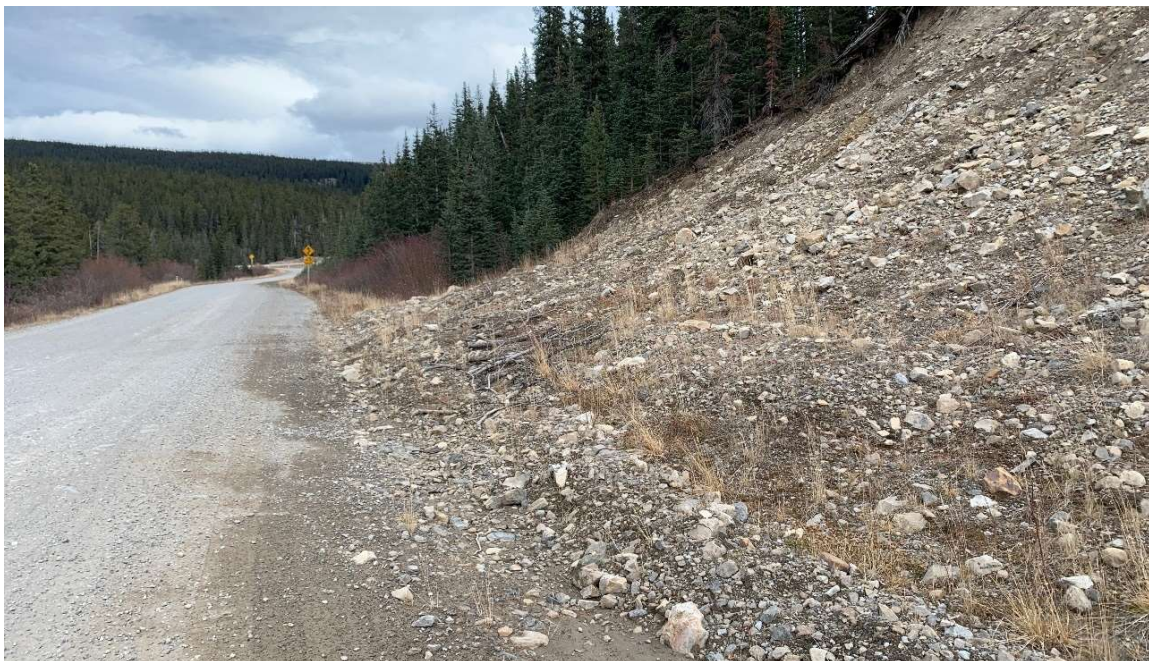
Photo I-2 S068-1: Accumulation of gravel at the back slope toe due to surface erosion and weathering. Photo was taken facing east on October 22, 2021.

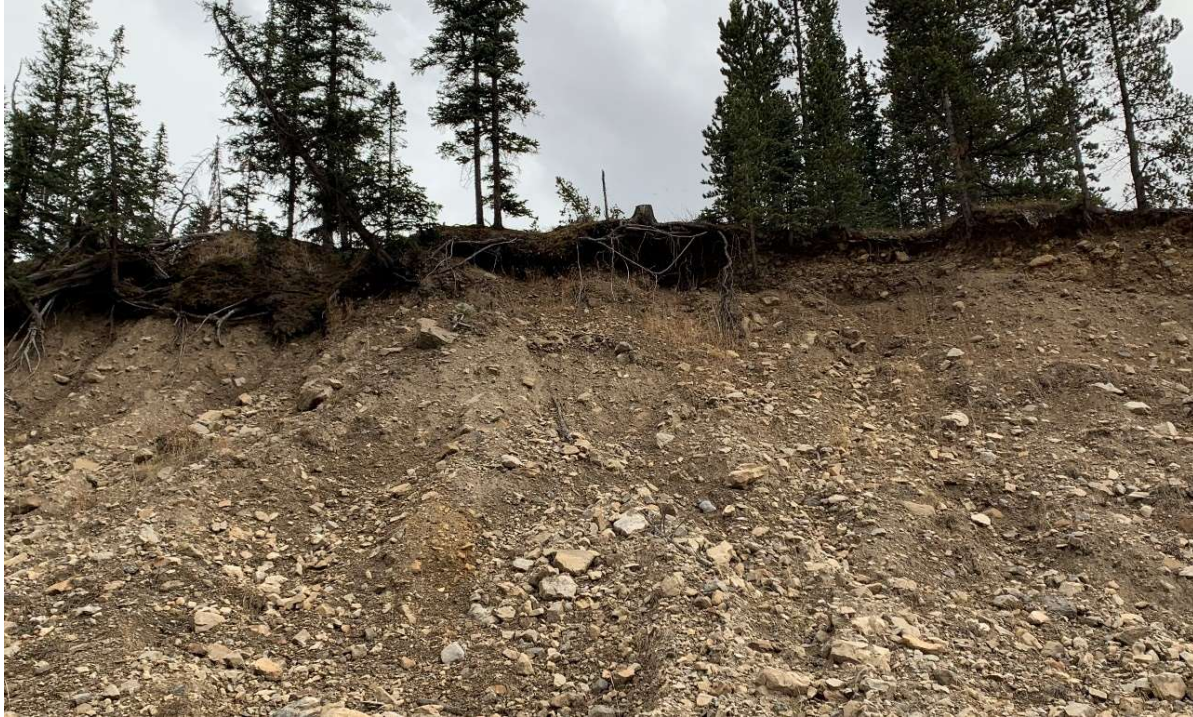
Photo I-3 S068-1: Erosion at the brow of the slope leading to overhanging topsoil mats. Photo taken facing north on October 22, 2021.

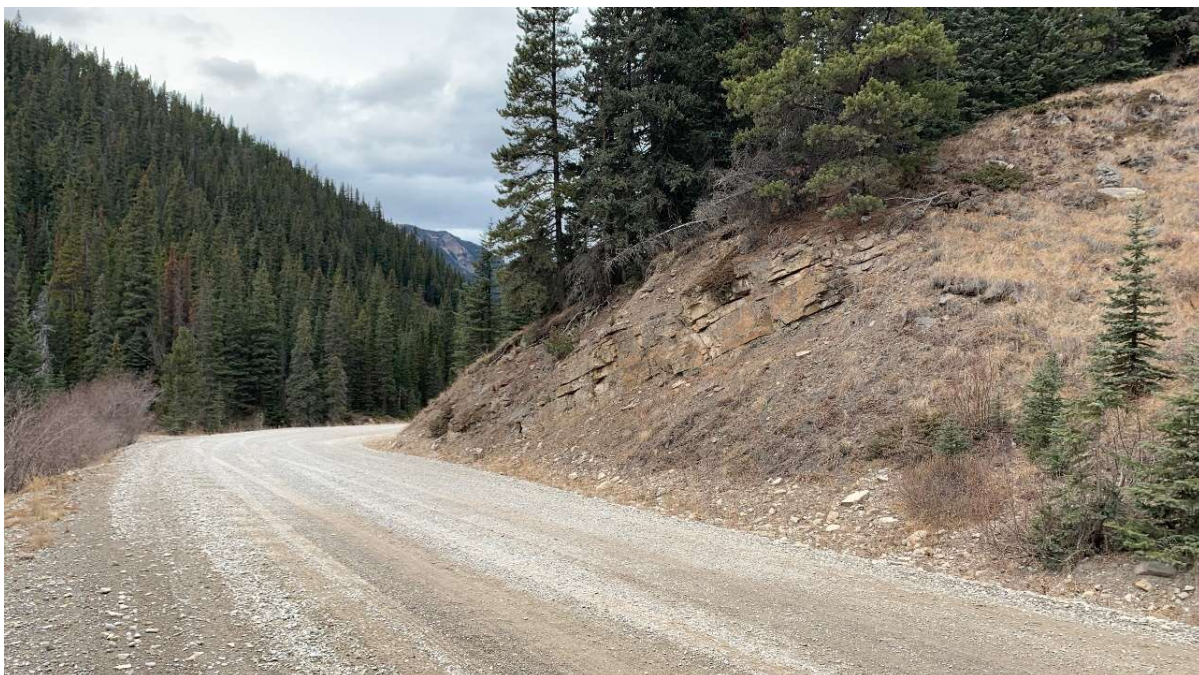
S068-2 (25001:02 C1 8.713)	<p>S068-2 consists of a 5 m to 6 m high bedrock back slope on the north side of the road, adjacent to a curve in the highway. A shallow rockfall ditch is present on the upslope side of the highway, estimated to be approximately 1.5 m wide and less than 0.5 m deep.</p> <p>Bedrock appears to be sedimentary with visible bedding planes. The bedrock is dipping towards the highway and the geometry of the back slope allows weathered bedrock to roll downslope into the ditch. At the time of inspection, eroded bedrock particles appeared tabular with limited capacity to roll. Erosion at the crest of the slope has created overhanging vegetation mats. KCB also noted cobbles and boulders weathering out of the soil portion of the back slope which overlies bedrock, possibly capable of reaching the highway.</p> <p>Wilkinson Creek is located at the toe of the highway embankment and appeared to be less than 0.2 m deep at the time of the inspection. The creek bank / highway embankment toe was approximately 1.5 m high, angled at 1H:1V, and vegetated with shrubs. Erosion riling was observed along the edge of the road embankment due to surface water runoff.</p> <p>S068-2 was damaged due to the 2013 flooding but appears to have been repaired to approximately the original road geometry. In general, there were no significant changes noted in 2021 when compared to</p>

Photo I-4 S068-2: Bedrock slope on the north side of the highway. Photo was taken facing west on October 22, 2021.

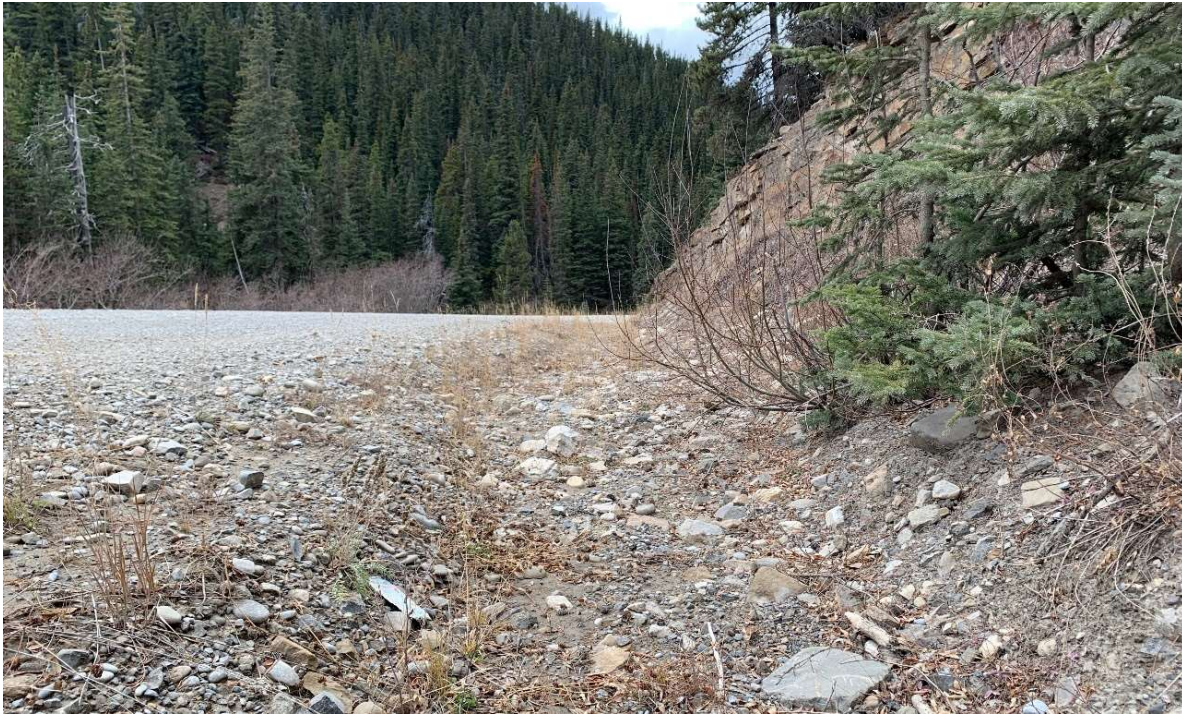
Photo I-5 S068-2: Toe of backslope was clear of debris at time of inspection. Photo was taken facing west on October 22, 2021.

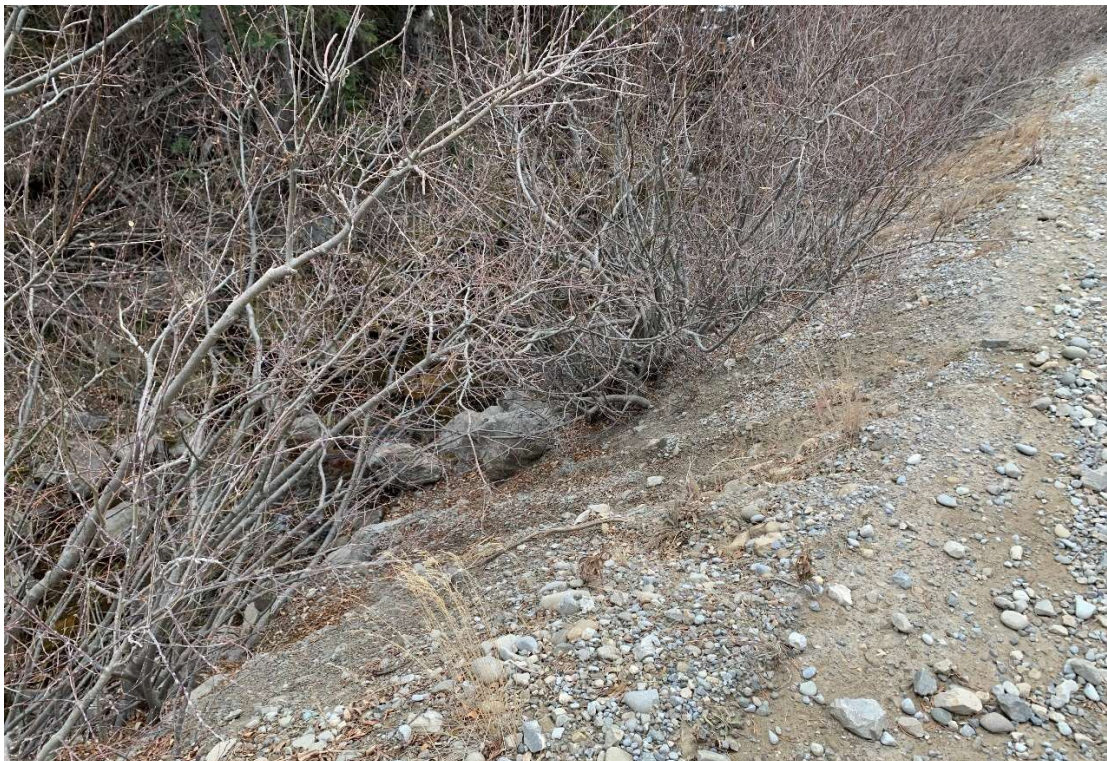
Photo I-6 S068-2: Creek at toe of highway embankment. Photo was taken on October 22, 2021.

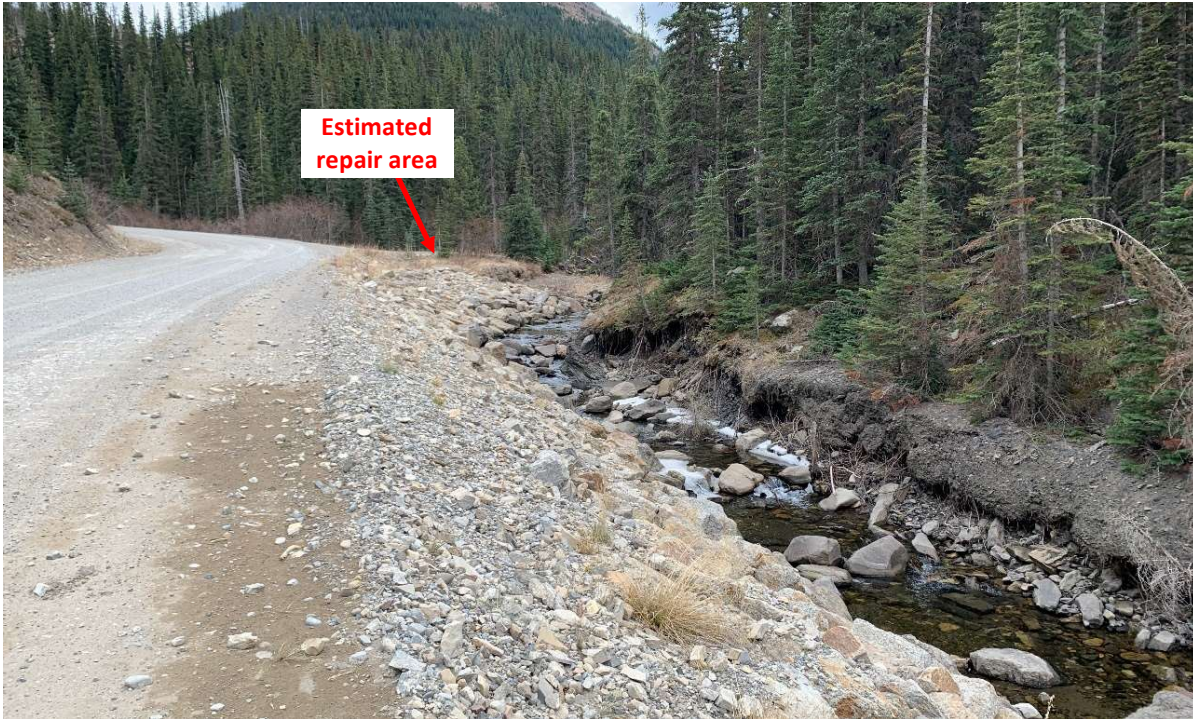
Site No.	2021 Observations (Changes since 2008)
	<p>observations reported in the AMEC 2008 geohazard review for the Highway 940 corridor, and the 2009 site inspection.</p>
<p>S068-3 (25001:02 C1 9.668)</p>	<p>S068-3 consists of a section of highway with an earth back slope on the upslope side and a creek channel at the toe of the highway embankment. The back slope varies in height but was up to approximately 6 m high in places.</p> <p>At the toe of the embankment is Wilkinson Creek. The creek channel is relatively narrow and approximately 2 m deep. At the time of the inspection the creek appeared to be less than 0.3 m deep. Parts of the creek channel were noted to have cut or been blasted into bedrock, and parts of the channel were cut through soil. Overhanging root mats were observed on the west bank. The downstream slope of the highway embankment was approximately 1H:1V. The channel appeared to be stable and in good condition.</p> <p>S068-3 was damaged due to the 2013 flooding but appears to have been repaired to approximately the original road geometry. In general, there were no significant changes noted in 2021 when compared to observations reported in the AMEC 2008 geohazard review for the Highway 940 corridor, and the 2009 site inspection.</p>

Photo I-7 S068-3: Right bank of Wilkinson Creek repaired following the 2013 floods. Photo was taken facing east on October 22, 2021.

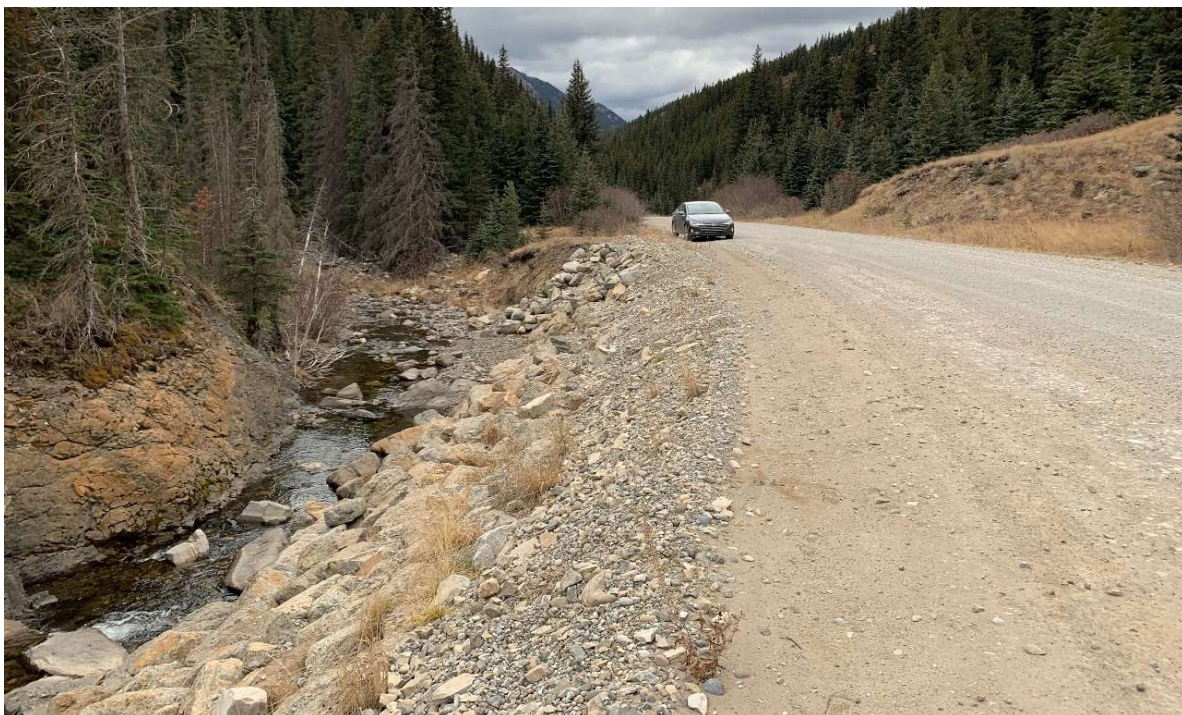
Photo I-8 S068-3: Right bank of Wilkinson Creek repaired following the 2013 floods. Photo was taken facing west on October 22, 2021.

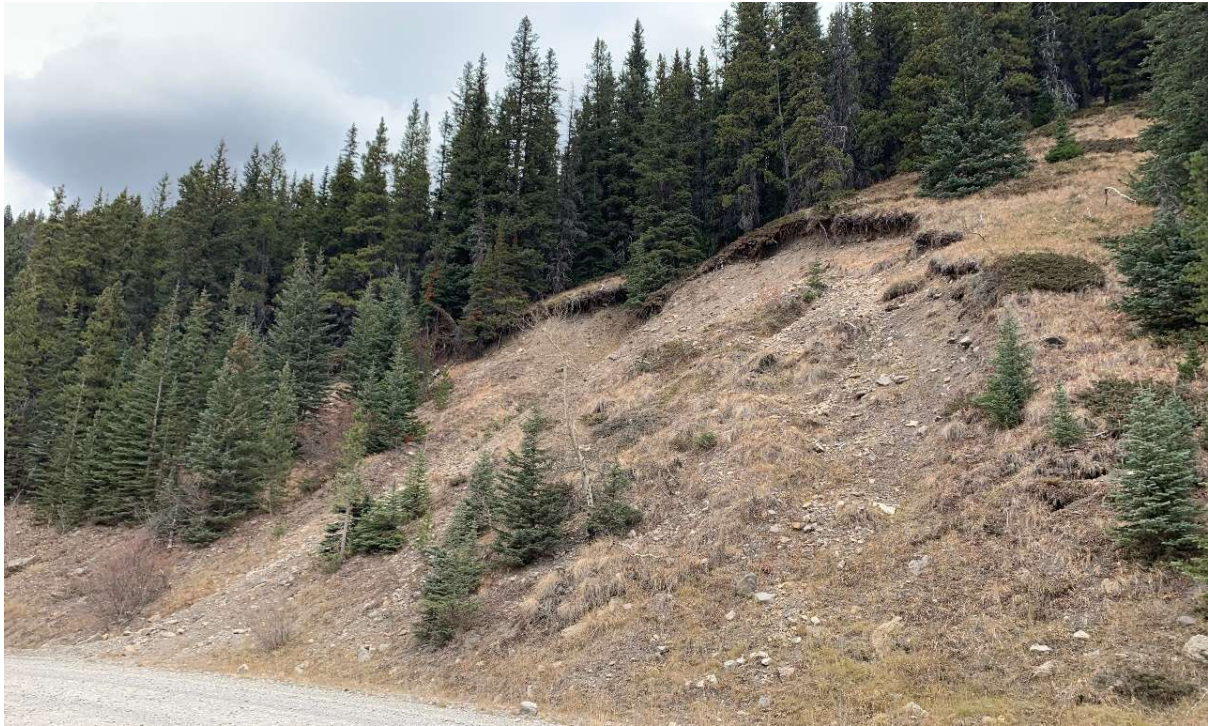
<p>S068-4 (25001:02 C1 8.631)</p>	<p>S068-4 consists of a 1H:1V back slope cut into the existing hillside. In 2021, KCB estimated the back slope to be up to 10 m high. The back slope consisted of rocky soil / colluvium type material. A creek channel is located downslope of the highway, at the toe of the highway embankment.</p> <p>AMEC had reported an erosion gully in 2008, and in 2021 the gully appeared to be inactive with very little change since 2008. A cone of debris was noted at the toe of the slope which had infilled the existing shallow ditch. Overhanging root mats were observed at the crest of the back slope.</p> <p>Wilkinson Creek is located at the toe of the embankment and the creek appeared to be less than 0.2 m deep at the time of the inspection.</p> <p>S068-4 was damaged due to the 2013 flooding but appears to have been repaired to approximately the original road geometry. In general, there were no significant changes noted in 2021 when compared to observations reported in the AMEC 2008 geohazard review for the Highway 940 corridor.</p>

Photo I-9 S068-4: Back slope on the upslope side of the highway. Photo was taken facing north on October 22, 2021.

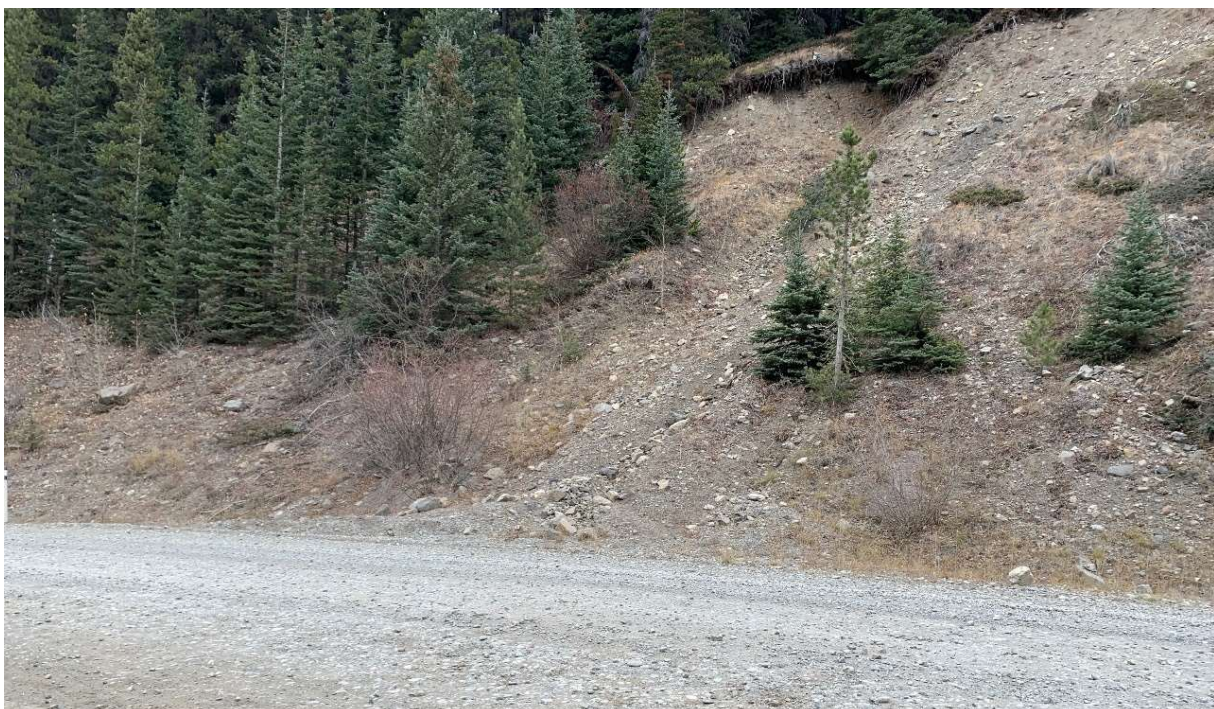
Photo I-10 S068-4: Surface runoff leading to a debris cone at toe of back slope that reduces the available ditch capacity. Photo taken facing north on October 22, 2021.

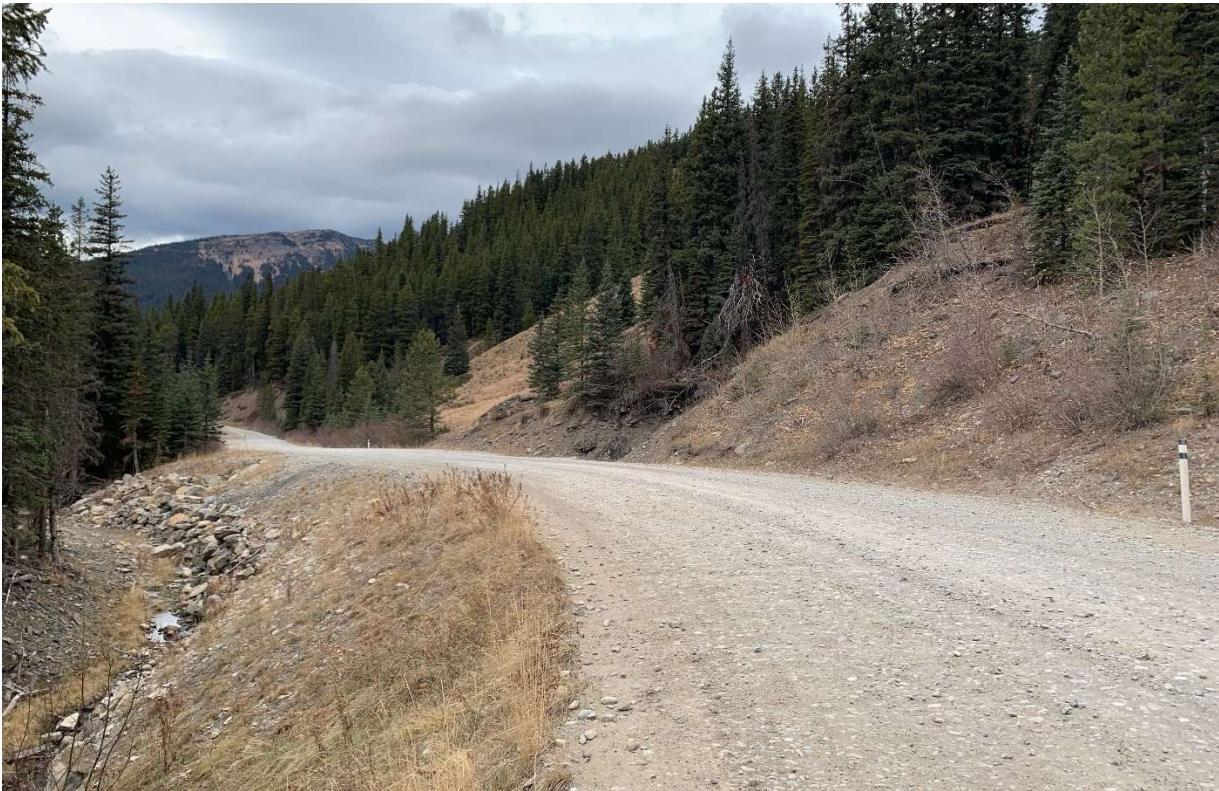
Photo I-11 S068-4: Creek at toe of highway embankment. Photo taken on October 22, 2021.

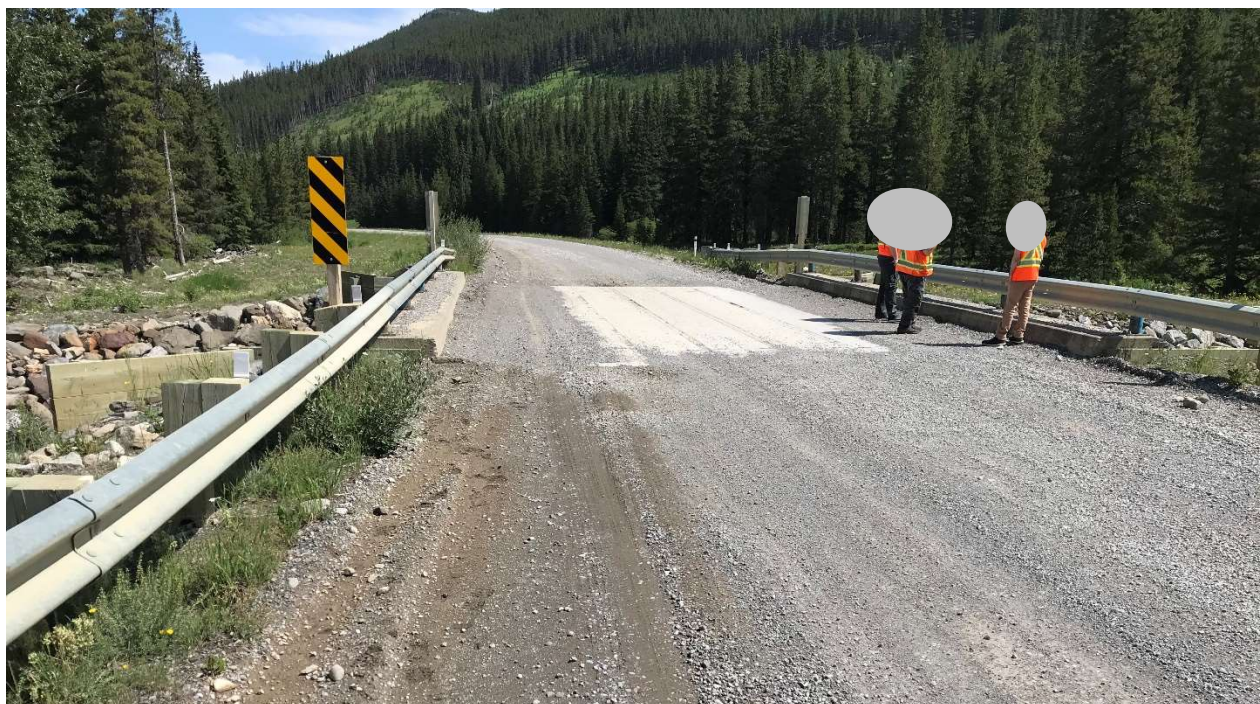
<p>S068-5 (25001:02 C1 17.236)</p>	<p>S068-5 is located at the Wilkinson Creek bridge. At the time of KCB inspection, the highway washout from the 2013 flooding had been repaired and the creek restored to the former channel alignment prior to the 2013 flood. AMEC had noted that the original channel had been infilled with sediment during the 2013 flood, therefore it appears that the channel has been re-excavated.</p> <p>The bridge was intact after the 2013 flooding and no obvious geotechnical issues were observed relating to the bridge in 2021. Repairs appear to have included riprap armoring along the banks, including the outside of the bends.</p> <p>On the west side of the highway, the floodplain area that becomes the new creek channel alignment each time the highway washes out (reportedly at least four times since 1996) is visible and has not been infilled. At the time of inspection, standing water was present in the floodplain area and overhanging root mats were observed along the bank.</p>

Photo I-12 S068-5: Bridge at Wilkinson Creek. Photo was taken on July 9, 2021.

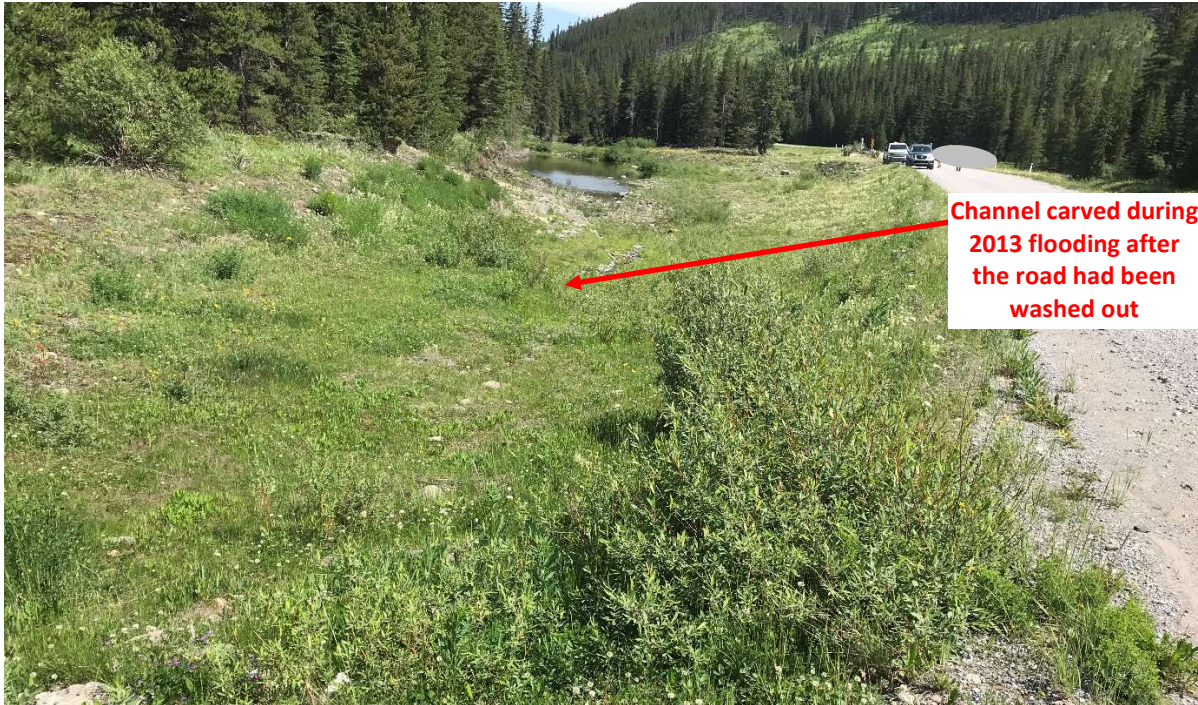
Photo I-13 S068-5: The creek jumped its banks during the 2013 flooding and washed out the road. Photo was taken on July 9, 2021.

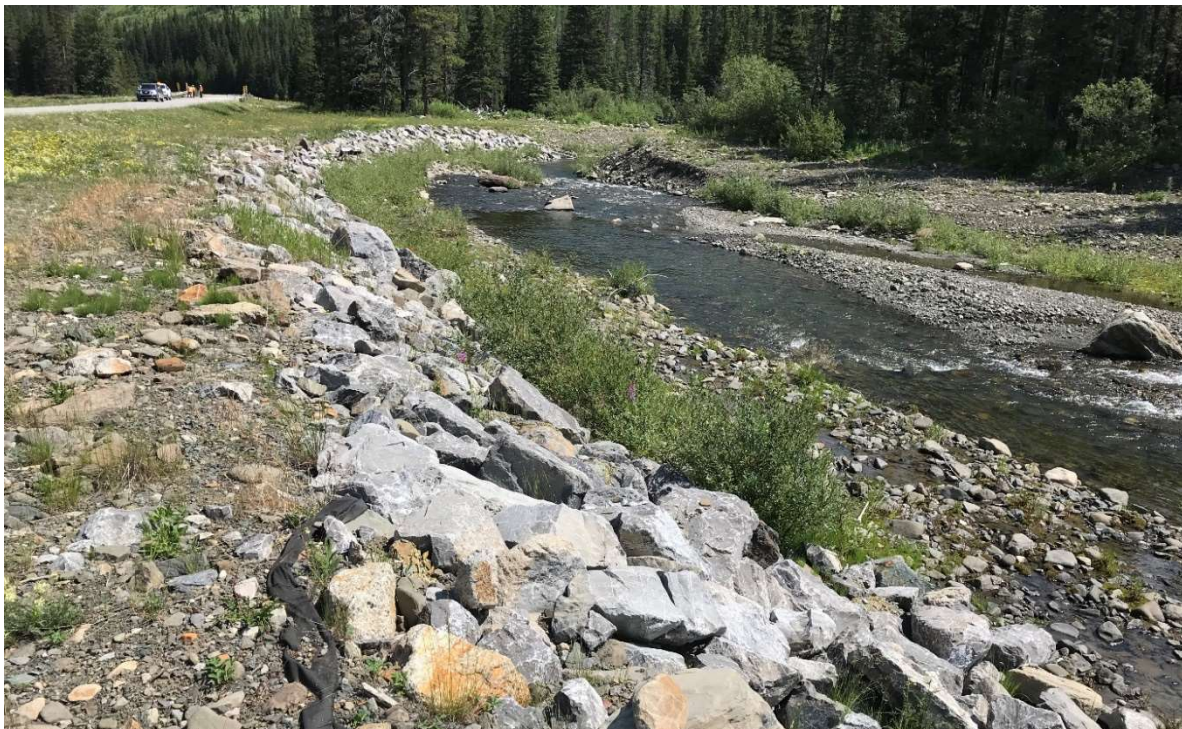
Photo I-14 S068-5: Repaired and riprap lined bank of Wilkinson Creek after 2013 washout. Photo was taken facing northwest on July 9, 2021.

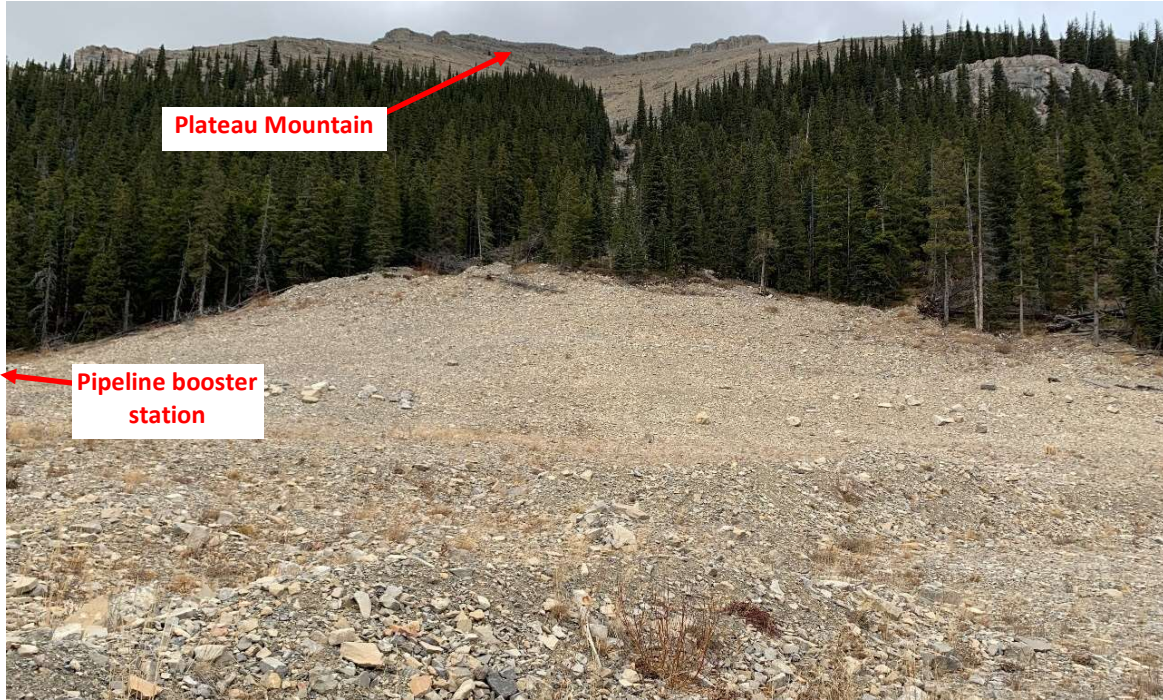
Photo I-15 S068-6: Debris flow path at the toe of Plateau Mountain. Photo was taken facing north on October 22, 2021.

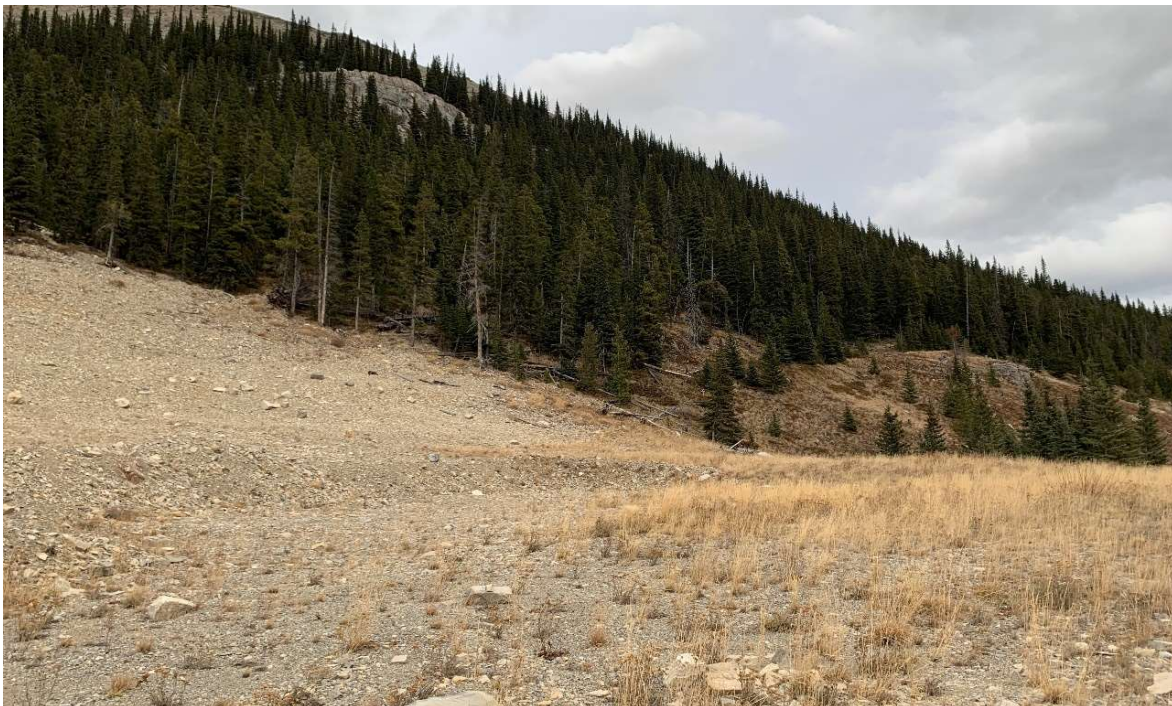
Photo I-16 S068-6: East side of debris fan. Photo taken facing east on October 22, 2021.
