Highway 940 – Upper Wilkinson Creek Valley, Km 81.4 Cut Slope

Alberta Transportation
Geohazards Review – Highway 940 Sites
Upper Wilkinson Creek Valley, Km 81.4 Cut Slope
CG25262
April 2009

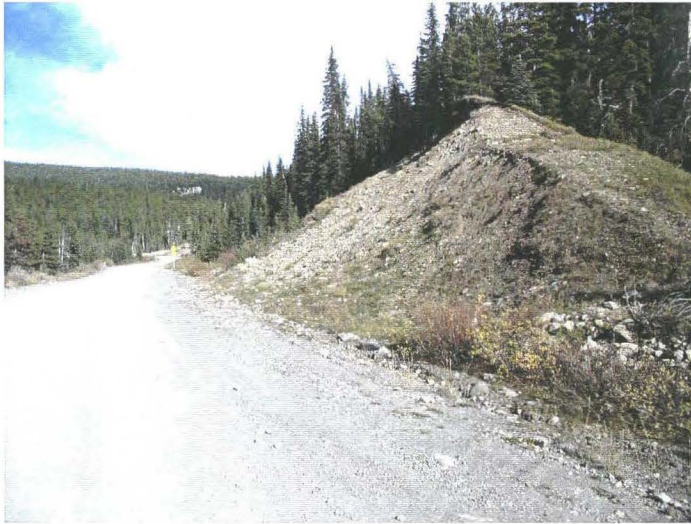
- There is an approximately 8 m high cut slope along the south side of the highway that exposes glacial till/rocky soil with up to boulder-sized rocks visible. The cut slope angle is approximately 30 to 33°. Photo 940-39 shows the cut slope.
- The road surface is approximately 9 m wide and there is no effective ditch along the toe of the cut slope.
- There was an accumulation of gravel to cobble-sized rocks along the south edge of the road, as shown in Photos 940-40 and 940-41. This material had eroded out from the cut slope and rolled/slid downslope to the edge of the road.
- Surface runoff along the road was visible flowing through the debris along the toe of the cut slope, as shown in Photo 940-41.

Photo 940-39 (top) – Facing southbound along the highway with the approximately 8 m high cut slope along the south side visible on the right. Note the lack of a ditch along the toe of the slope. The cut slope is marginally stable at 30 to 33° inclination, with eroded material from the exposed rocky soil rolling and sliding downslope to the road and accumulating along the toe of the slope.

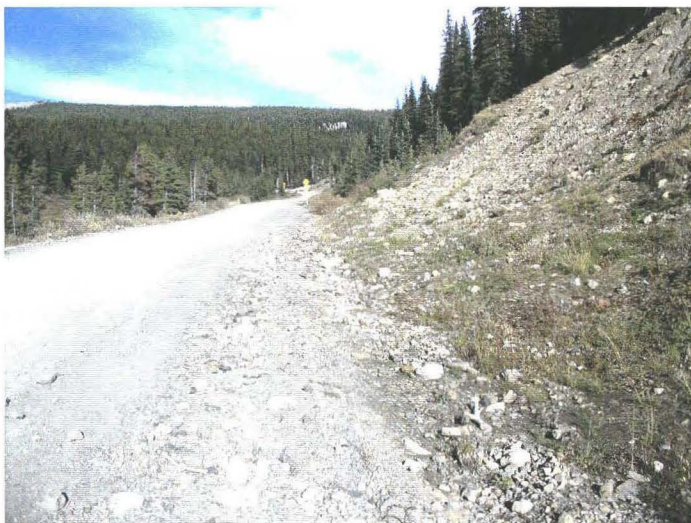
Photo 940-40 (bottom) – Closer view facing southbound along the toe of the slope. Note the accumulation of eroded material, including cobble-sized rocks, along the toe of the slope.

The accumulation of rocks along the south edge of the road should continue to be cleared out during the routine grading of the road. It appears that the maintenance contractor is already doing this as part of their operations.

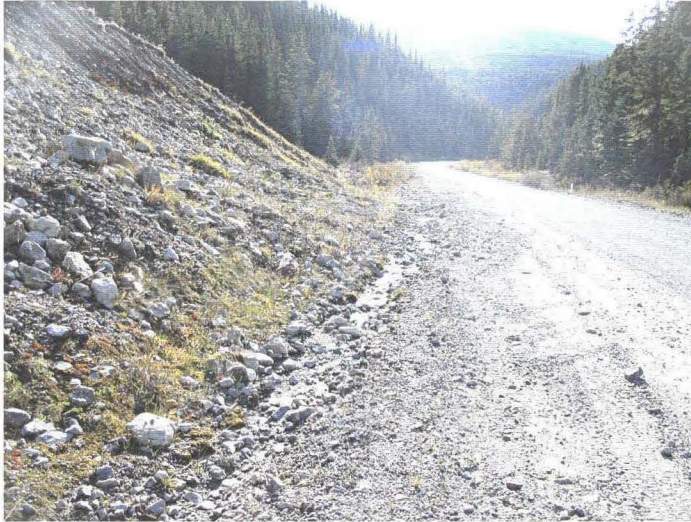
Photo 940-41 (top) – Facing northbound along the toe of the slope. Note the lack of ditch to contain the eroded material. Note also the surface runoff flowing through the debris along the toe of the slope.

The risk to traffic from the accumulation of rocks along the south edge of the road could be reduced by establishing a ditch that would contain the rocks that erode out from the cut slope and also ensure that surface runoff flowing along the road is not diverted into the traffic lanes by accumulations of debris along the toe of the cut slope. However, the existing road is too narrow to accommodate a new ditch without excavating into the existing cut slope, and the effort and site disturbance to excavate and "push back" the existing cut slope to gain road width for a ditch is judged to outweigh the benefit of reducing the currently low risk level at this site. Other options, such as steepening the cut slope to gain road width for a ditch and/or applying erosion protection measures to the slope face to reduce the amount of rock debris accumulating along the toe of the
