Highway 940 – Upper Wilkinson Creek Valley, Km 82.2 Cut Slope

The site inspection was performed on September 27, 2008 by Mr. Andrew Bidwell, P.Eng. of AMEC.

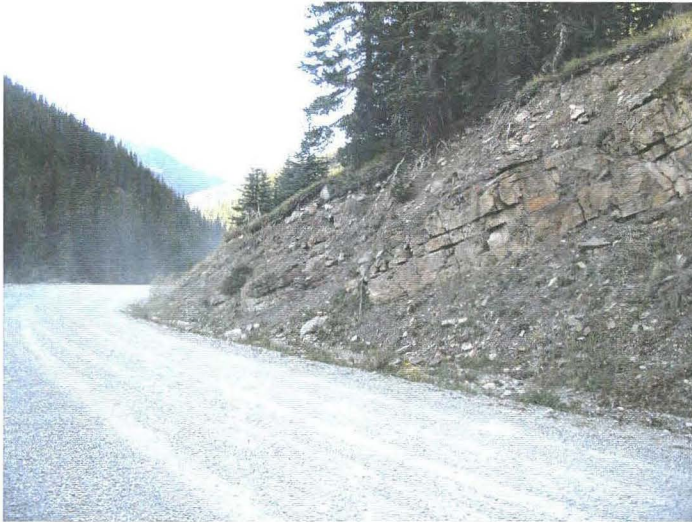
- There is an approximately 5 to 6 m high rock cut slope along the northeast side of the highway. The cut slope angle varies and the overall cut slope angle is approximately 45°. Photo 940-42 shows the cut slope.
- The ditch along the toe of the cut slope is roughly 1 to 1.5 m wide with a depth varying from 0 to 0.5 m. There were cobble-sized rocks from the cut slope filling the ditch in places, as shown on Photos 940-43 and 940-44.
- The downslope edge of the highway is at risk of becoming undermined by erosion along the right bank of Wilkinson Creek, which is a few metres downslope of the highway. Any such erosion would be similar to that described for the Km 82.4 Creek Erosion site.

Photo 940-42 (top) – General view of the cut slope, facing northbound.

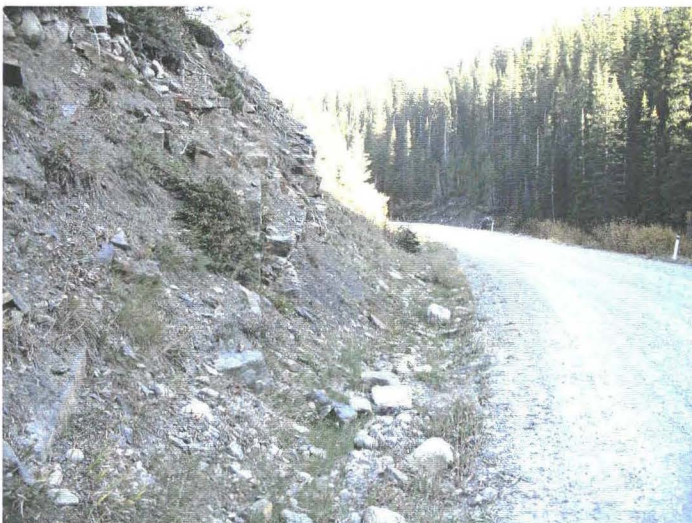
There is a hazard of rockfall debris from the cut slope spilling out from the ditch and onto the road surface. The ability of the existing ditch to contain rockfall debris from the cut slope appears to be marginal. For reference, the rockfall catch ditch design chart attached as Figure C1 in Appendix C suggests a ditch approximately 3.7 m wide and

from 1 to 1.3 m deep for a cut slope in rock of this height and inclination. The existing ditch is smaller than this.

Photo 940-43 (middle) – Facing southbound along the toe of the cut slope. Note the very small ditch, and the cobble-sized rocks that have fallen from the cut slope.

The ditch should be cleaned as necessary to keep it as close as practical to maximum capacity.

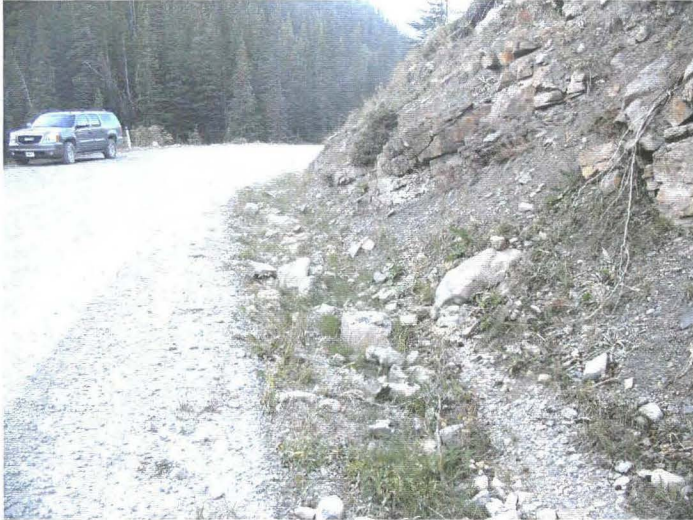
Photo 940-44 (bottom) – Facing northbound along the toe of the cut slope. Note the very small ditch, and the cobble-sized rocks that have fallen from the cut slope.
