August 28, 2009

CG25309.B

**Re: Southern Region Geohazard Assessment Program
Highway 940, KM 82.2 – 82.4, Creek Erosion
June 10, 2009 Inspection Report**

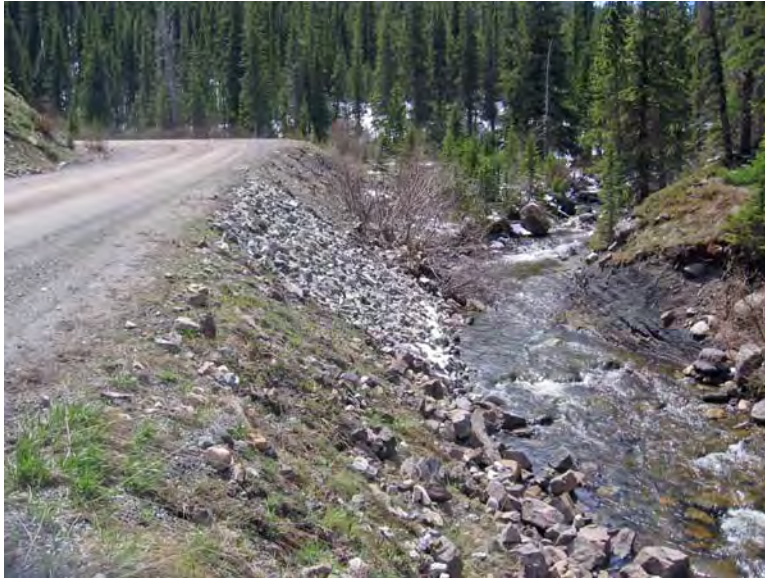
Photo 1 – June 2009

- The rock fill slope between the road and the creek channel is approximately 6 m high at 38° inclination.
- Relatively fresh cobble to boulder-sized rock fill was visible along an approximately 10 m segment of the slope between the downslope edge of the road and the right creek bank. The rock fill was present during the September 2008 inspection and is understood to have been end-dumped onto the slope as a repair earlier in 2008 in response to erosion along the right creek bank beginning to undermine the road surface. Refer to Photo 1.
- Overall, the site appeared to be in the same condition as was observed in September 2008.

The rock fill appears to have been successful in buttressing the slope between the road and the right creek bank and providing protection against ongoing creek erosion. There was no damage noted due to the spring runoff.

Creek erosion site at KM 82.2, repaired with rip-rap. The site was not damaged by the Spring 2009 runoff, however there is potential for future erosion at, or near, the repaired area.

AT's Maintenance Contract Inspector should check the condition of the site periodically to watch for erosion that may affect the road.

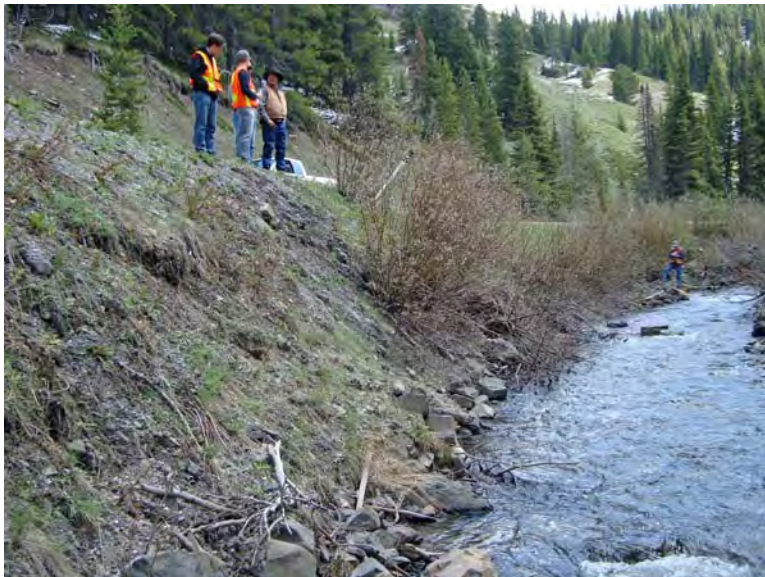
Photo 2 – June 2009

- The downslope edge of the highway is at risk of becoming undermined by erosion along the right bank of Wilkinson Creek, which is a few metres downslope of the highway.
- The creek bank at this site is 5 to 6 m high at 48 to 50° slope, with gravel to boulder sized bed and bank material. Willows are abundant in places on the slope. Refer to Photo 2.
- There is minor erosion occurring from the crest of the slope due to runoff from the road.
- The toe of the slope that is exposed to streamflow appears stable.

There is a risk of erosion along the right bank of Wilkinson Creek destabilizing the slope between the creek bank and the downslope edge of the road and in turn destabilizing the road itself. This did not appear to be occurring at the time of the September 2008 and June 2009 site inspections, but bears watching in case a situation similar to the Km 82.2 Creek Erosion site begins to develop.

Creek erosion site at KM 82.4. Erosion does not appear to be occurring, however there is a risk that peak flow events may trigger erosion in the future that would affect the road.

AT's Maintenance Contract Inspector should check the condition of the site periodically to watch for erosion that may affect the road.
