Highway 940 – Upper Wilkinson Creek Valley, ~Km 82.4 Creek Erosion

The site inspection was performed on September 27, 2008 by Mr. Andrew Bidwell, P.Eng. of AMEC.

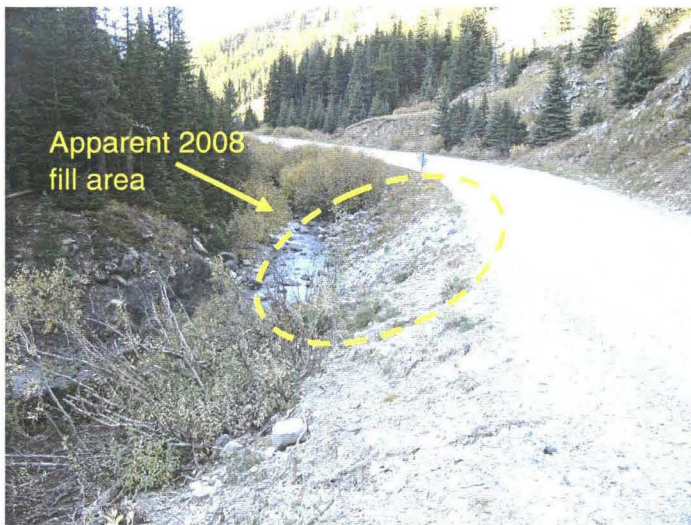
- As shown on Photos 940-45 and 940-46, at this site the highway is just above the right bank of Wilkinson Creek.
- The rock fill slope between the road and the creek channel is approximately 6 m high at 38° inclination.
- Relatively fresh cobble to boulder-sized rock fill was visible along an approximately 10 m segment of the slope between the downslope edge of the road and the right creek bank at the time of the September 2008 site inspection. As shown in Photo 940-47, this location is a short distance downstream of the outside of a bend in the creek channel. It appeared that the rock fill had been placed earlier in 2008 to buttress the downslope edge of the highway after erosion along the right creek bank may have been starting to undermine the road.

The rock fill appears to have been successful in buttressing the slope between the road and the right creek bank. However, the effectiveness of the repair should be checked again after spring runoff in 2009.

Photo 940-45 (top) – Facing northbound along the highway and downstream along the creek. The rock fill area that appears to have been placed in 2008 to buttress the downslope edge of the road is marked.

This site should be included in the 2009 Southern Region inspection tour in order to check the condition of the 2008 repair after the spring 2009 runoff in the creek.

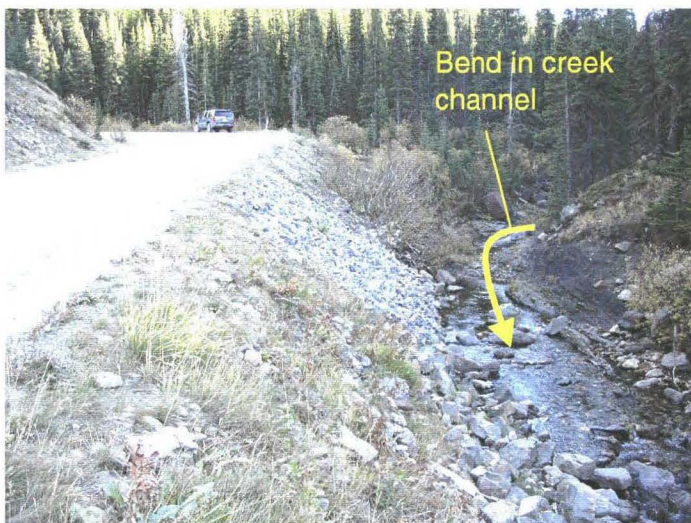
Photo 940-46 (middle) – Closer view of the 2008 repair area, facing southbound along the highway and upstream along the creek. Note how the repair area is a short distance downstream of a bend in the creek channel.

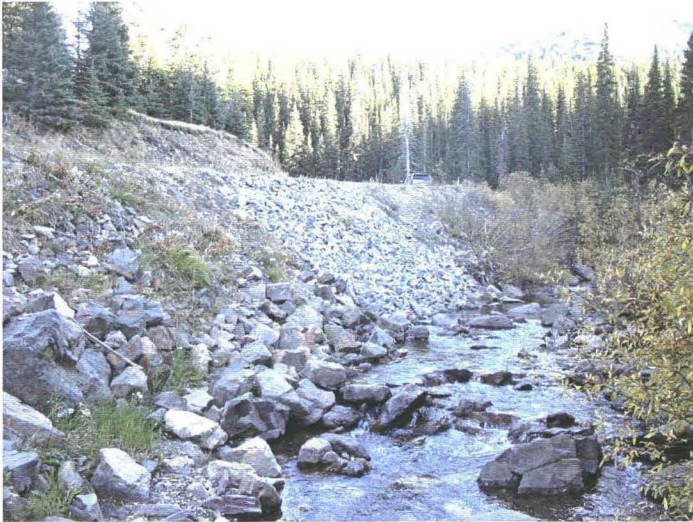
Photo 940-47 (bottom) – Facing upstream along the creek, towards the 2008 repair area.
