Highway 742 – Blackshale Creek (Km 57.3)

The site inspection was performed on October 18, 2008 by Mr. Andrew Bidwell, P.Eng. of AMEC.

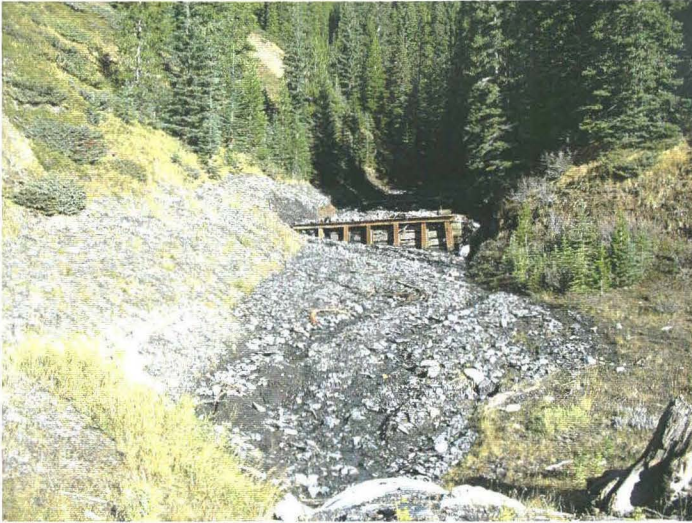
- The highway crosses the Blackshale Creek channel via a fill embankment and culvert. There is a check-dam structure installed approximately 30 m upstream from the highway. Photos 742-54, 742-55 and 742-56 show general views of the check dam structure. The check dam structure consists of a row of steel H-beams driven as vertical piles and with a single H-beam approximately 10 m long welded onto the tops of the driven H-beams. There are four layers of timber lagging on the upstream side of the driven H-beams, each of the lagging measuring approximately 0.3 m by 0.17 m (12 inches by 6.5 inches) in cross section.

Photo 742-54 (top) – Facing upstream towards the check-dam structure, as seen from the highway.

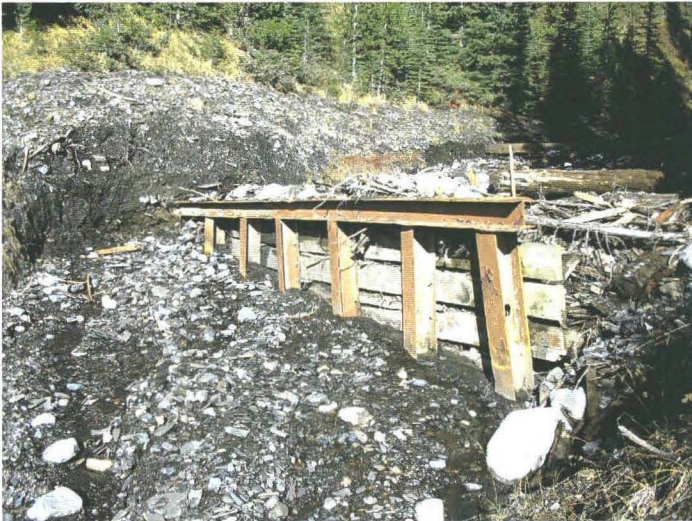
- The creek flow has outflanked the check-dam along the left bank of the creek. A similar flanking channel was also developing along the right bank of the creek at the time of the October 2008 inspection, as shown in Photo 742-57.

Photo 742-55 (middle) – Closer view of the check-dam structure. Due to debris accumulating behind it, the creek flow has outflanked the structure. One of the flanking channels visible in the right foreground of this photo.

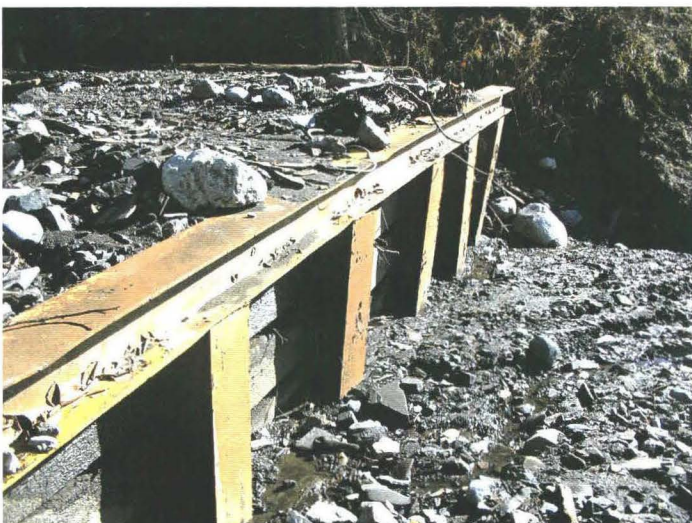
- The top of the check-dam structure is approximately 1.8 m above the channel elevation.
- Debris, predominantly gravel to cobble-sized pieces of shale along with soil and organic material, has accumulated upstream of the check-dam structure, as shown in Photo 742-56, and filled it to capacity. Debris that has more recently flowed over the check-dam structure is starting to accumulate in the inlet end of the culvert, as shown in Photo 742-58. An accumulation of debris was also visible along the base of the culvert near the outlet, as shown on Photo 742-59.

The circumstances leading to the installation of the check dam are not known, however it was presumably a mitigative measure for debris from the creek channel blocking the culvert. The area behind the check-dam structure is now completely full of debris and the check-dam does not have any capacity to retain further debris being washed down the creek channel. This creates a debris flow hazard to the highway, as follows:

Photo 742-56 (bottom) – Another view of the check dam structure. Note the debris accumulation behind the structure.

- The accumulated debris should be removed from behind the check-dam structure. This could be done using a tracked excavator, taking care not to damage the check-dam structure during the work. Environmental permitting along with sediment control measures would be required for this work along the creek channel.
- After the debris has been removed, inspect the timber lagging in the check-dam structure and replace pieces if necessary.

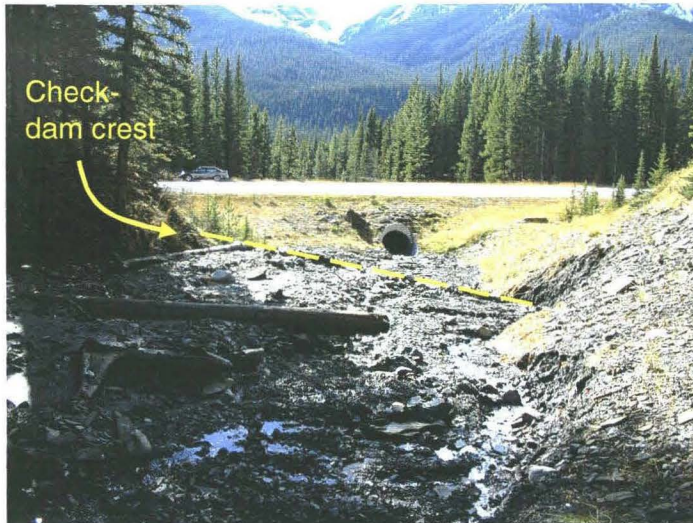
Photo 742-57 (top) – Facing downstream towards the highway from a short distance upstream of the check-dam structure. Note how the creek flow has outflanked the structure to the right. There is a similar flanking channel on the left side of the channel, but it is hidden in shadow in this photo.

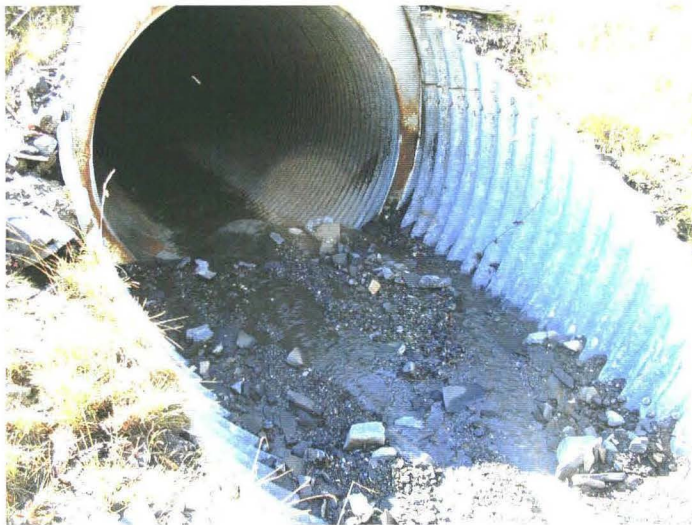
1. Ongoing creek flow that either flows over or around the check-dam structure will continue to transport debris to the culvert. Debris has already started to build up along the base of the culvert. The debris in the culvert may get washed out during peak flows in the spring of 2009, however the accumulation that was noted during the October 2008 inspection illustrates that potential for debris being transported along the channel to begin to block the culvert.
2. A possible collapse of the check-dam structure, which would lead to the large volume of debris from behind the check-dam being washed towards the culvert

Photo 742-58 (middle) – Culvert inlet. Note the debris accumulation on the base of the culvert.

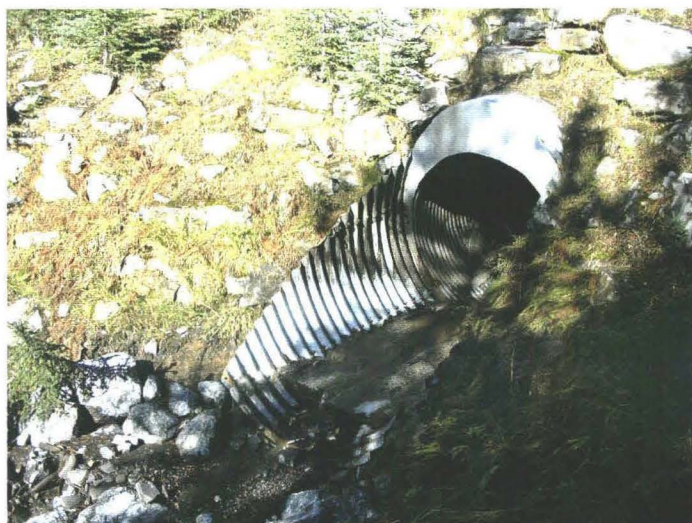
Photo 742-59 (bottom) – Culvert outlet below the highway. Note the debris accumulation along the base of the culvert.

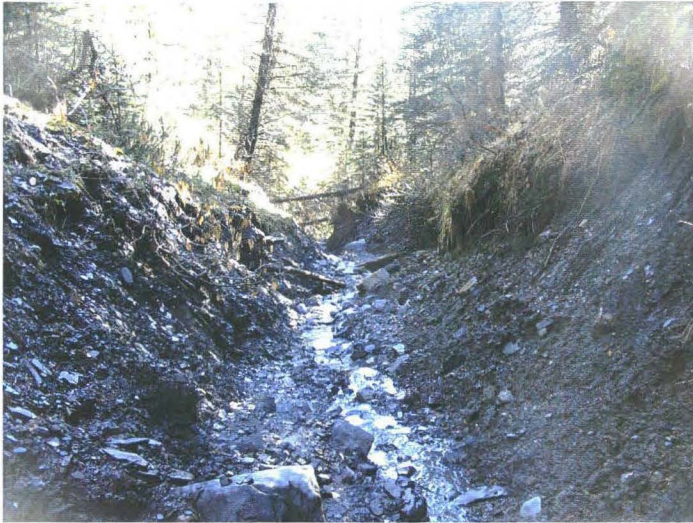
- The creek channel was traversed for a distance of approximately 250 m upstream from the check-dam. The channel gradient was approximately 10 to 12° along this segment of the channel. Photos 742-60, 742-61 and 742-62 show views from along the channel.

- The channel is narrow and there is abundant debris along the channel. The debris consists of material that has been transported along the channel and also from local and active channel bank slumping.

Photo 742-60 (top) – Typical view of the creek channel upstream of the check-dam structure. Note the unstable channel banks with exposed till soil.

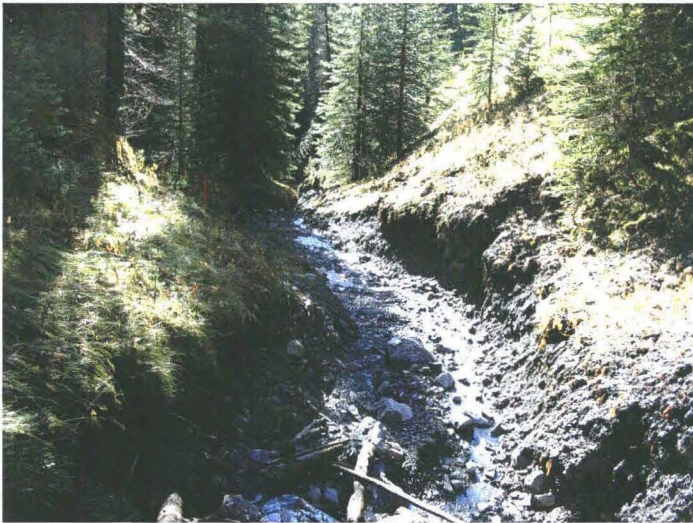
Photo 742-61 (middle) – Another view of the creek channel upstream of the check-dam structure.

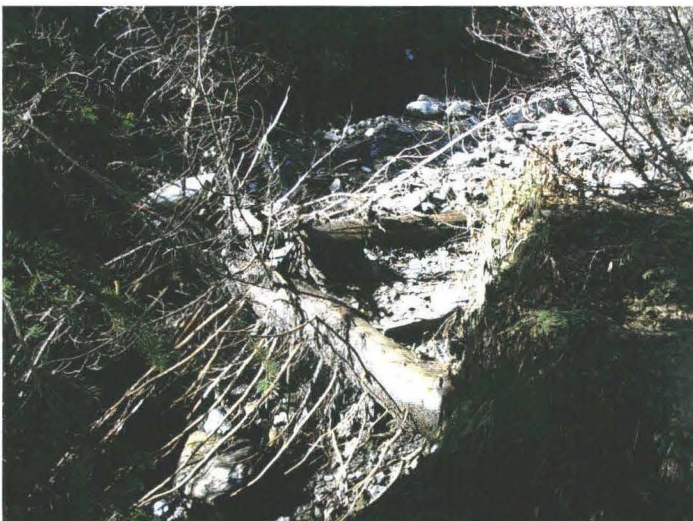
- There is a broad range of debris particle sizes, ranging from fine grained soil to cobble and boulder-sized material. There are also many logs and other pieces of organic debris that in many places have formed natural check-dams along the channel. An example of one of the natural check-dams is shown on Photo 742-62.

Photo 742-62 (bottom) – One of many natural check-dams along the creek channel upstream of the highway, with a large volume of soil, rock and organic debris built up behind a log that has fallen across the channel. The creek flow overtops and percolates through this debris, but when the natural dam eventually collapses the debris will be transported further downstream towards the highway.

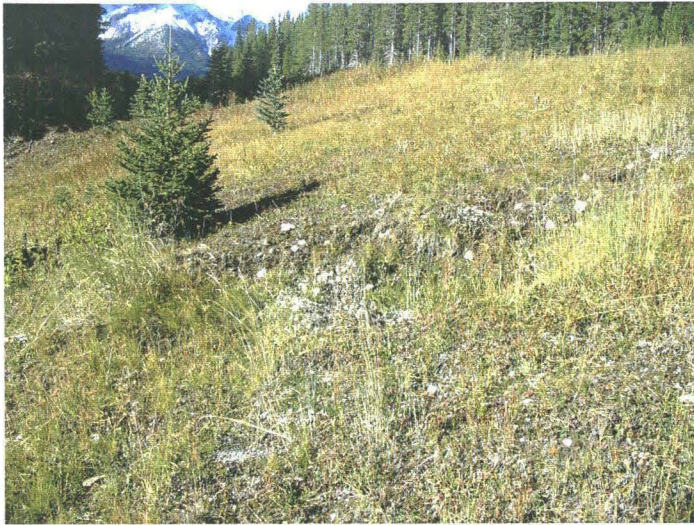
- The downstream face of the highway embankment is sloped at approximately 18 to 20°. A low and possibly settled area was visible on the vegetated embankment face over the culvert alignment (see Photo 742-63). This area was approximately 3 m by 1.5 m and appeared to be possibly due to erosion from surface runoff. However, due to its position above the culvert it could possibly be the result of some settlement or even sinkhole development over a breach in the culvert and internal erosion of the embankment.

With respect to the surface erosion feature, and possible settlement or sinkhole area over the culvert, on the downstream face of the road embankment – this does not appear to be of any significant consequence to the stability of the embankment at this point. However, follow-up visual inspections are warranted to check if the feature changes or worsens over time.

Photo 742-63 (top) – Settlement feature in the downslope face of the highway embankment. This feature is roughly above the culvert alignment, and may be an indicator of internal erosion of the embankment (sinkhole development) over a breach in the culvert pipe.

- Visually monitor the rate of debris accumulation behind the check-dam after cleanup.
- Visually monitor the erosion feature and possible settlement/sinkhole in the downstream embankment face.
