## **Highway 742 – Goat Pond, South Fan**

The site inspection was performed on October 18, 2008 by Mr. Andrew Bidwell, P.Eng. of AMEC.

## Hwy 742 – Goat Pond, South Fan

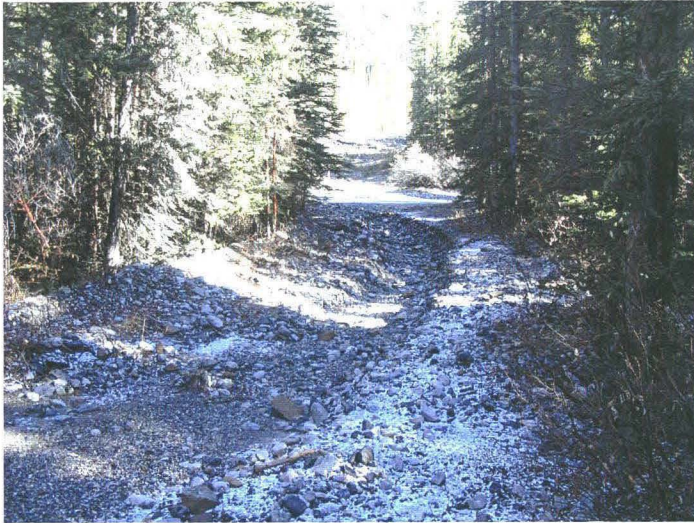
The highway crosses a small creek channel at this site, as shown on Photo 742-40. There was no surface flow within the creek channel at the time of the October 2008 inspection. No culvert, or delineator posts marking a culvert, were visible where the highway crosses the creek channel shown in Photo 742-40.

As shown in Photo 742-40, the segment of the creek channel immediately downstream of the highway and extending for approximately 20 m downstream from the highway appears to have been shaped and graded by an excavator within the last year or two. This would be consistent with clearing of debris deposited along the segment of the channel around the highway and possibly of debris that had flowed onto the highway.

**Photo 742-40** (top) – Facing upstream along the creek channel from below the highway crossing. Note how the creek channel has been shaped and graded at some point in recent years for a short distance downstream of the highway.

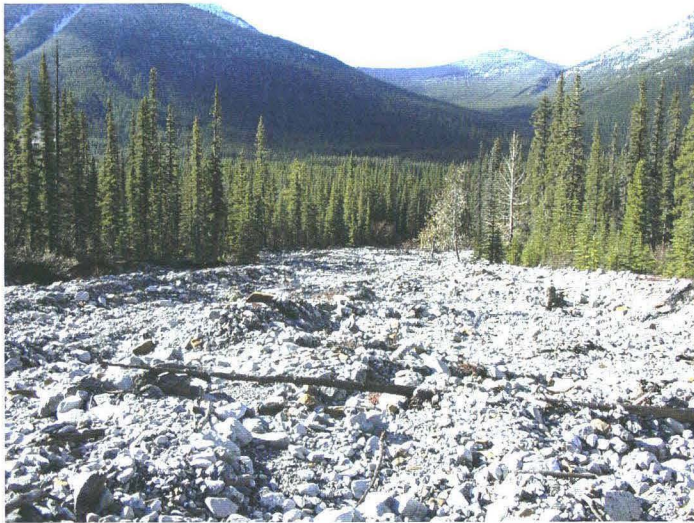
Roughly 200 m upslope from the highway, the creek channel is well confined between approximately 1.5 to 2 m high, near-vertical banks that expose gravel to cobble-sized material deposited earlier in the development of the fan (Photos 742-41, 742-42 and 742-43). Closer to the highway, the height of the active creek channel banks incised into the fan surface taper down.

**Photo 742-41** (middle) – Facing downstream along the creek channel, approximately 200 m upstream from the highway crossing. Note the broad, open channel area and the rocky debris along the channel. See Photo 742-40 for a view facing upstream from this location.

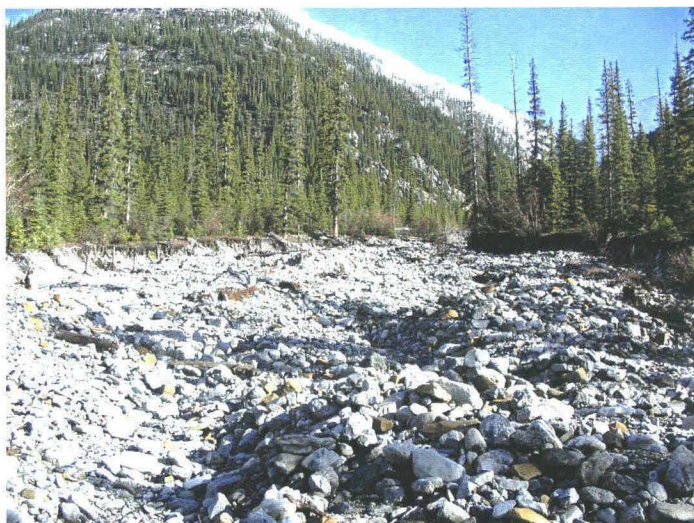
**Photo 742-42** (bottom) – Facing upstream along the creek channel, above the highway crossing. This photo was taken at the same location as Photo 742-39.

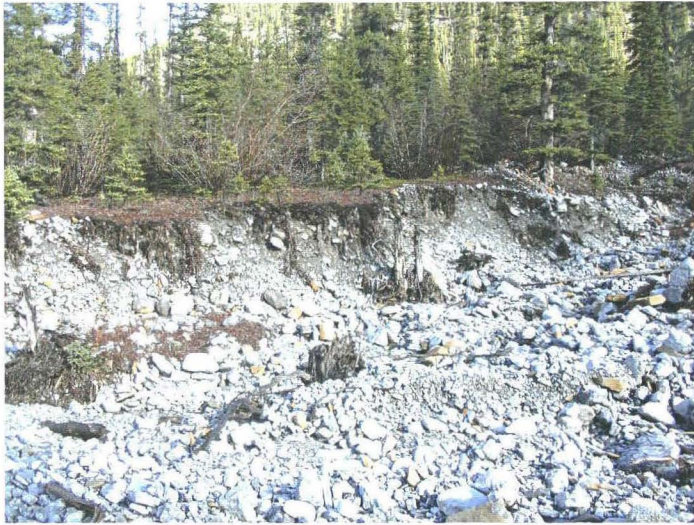
**Photo 742-43** (top) – Typical view of the banks along the main creek channel, a short distance upstream from the highway crossing.

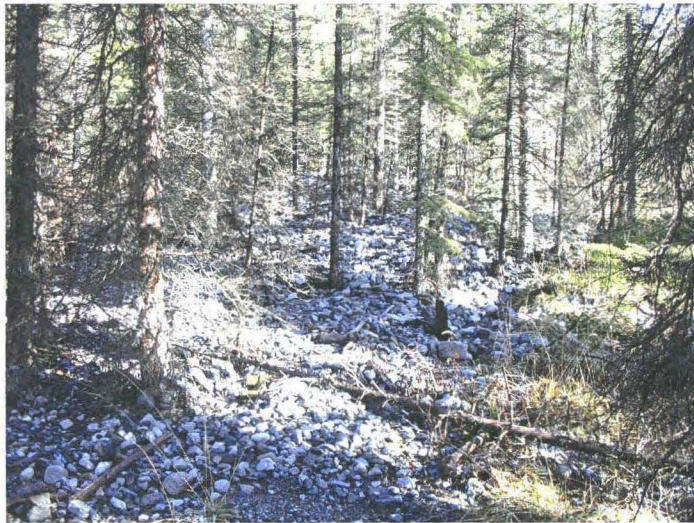
Within approximately 50 m of the highway, it appears that in recent years during periods of peak runoff the creek flow has jumped the banks of the main channel and flowed into the treed areas on either side of the main channel at several locations. These flows have deposited lobes of debris that meander through the treed areas a short distance upslope of the highway. These lobes of gravel to cobble-sized debris appear to have been deposited in recent years during peak seasonal flows of an active channel that frequently shifts laterally in the area upslope of the highway. Photo 742-44 shows a typical view of one of these debris lobes. It does not appear that any of these lobes of debris reached the highway.

**Photo 742-44** (bottom) – Typical view of debris deposition in the treed areas adjacent to the main creek channel. It appears that during peak flows, the creek “jumps” the main channel banks and flows into the adjacent treed areas. There were several deposits like this one on the slope a short distance above the highway, but none of them appeared to have reached the highway. An approximately 100 m long segment of the highway, roughly centered around the crossing of the main channel, appears to be at risk from these debris flows.
