August 28, 2009

CG25309.B

**Re: Southern Region Geohazard Assessment Program  
Highway 742:02 – Goat Pond, South Fan  
2009 Annual Inspection Report**

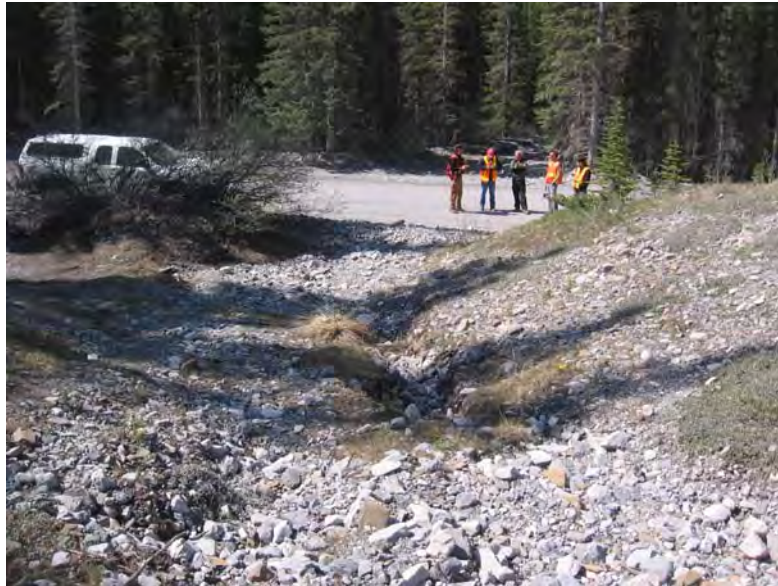
- There was no surface flow along the creek channel for at least 200 to 300 m upstream of the highway crossing nor was there any flow visible for the short distance that the defined channel extends downstream of the highway crossing. Photos 1 and 2, attached, show views of the creek channel from the June 11, 2009 site inspection.
- There were little to no apparent changes to the site appearance since the October 2008 site inspection. It remains unclear as to whether or not there is a culvert below the highway at the crossing.
- The Parks Division personnel remarked that they are not aware of any issues with debris being deposited onto the highway at this site in recent years, but that there is typically “water running across the road each spring”.

**Photo 1 – June 2009 (top)**  
Facing downstream along the creek channel towards the highway crossing. Note the lack of surface flow in the channel.

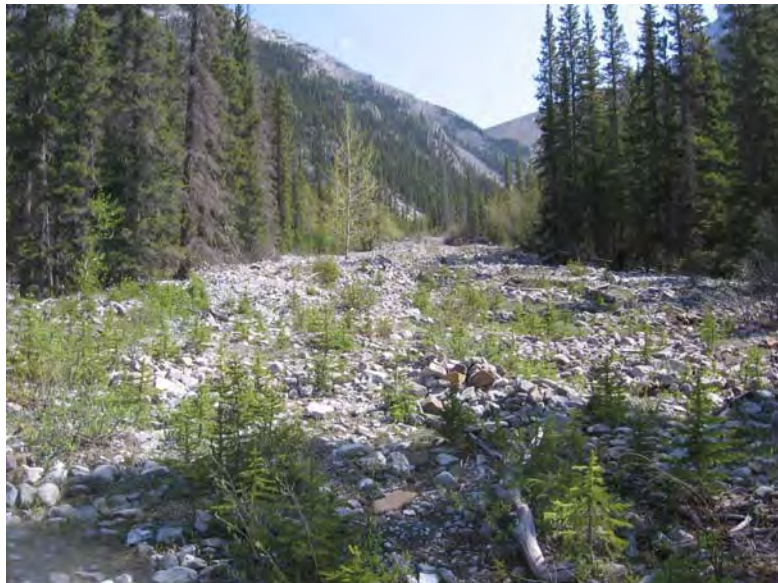
**Photo 2 – June 2009 (bottom)**  
Facing upstream along the creek channel from the same location that Photo 1 was taken from.
