CG25309.B

**Re: Southern Region Geohazard Assessment Program
Highway 742:02 Avalanche Areas
2009 Annual Inspection Report**

This letter documents the 2009 annual site inspection of the avalanche areas along Highway 742:02, southbound of Canmore, AB.

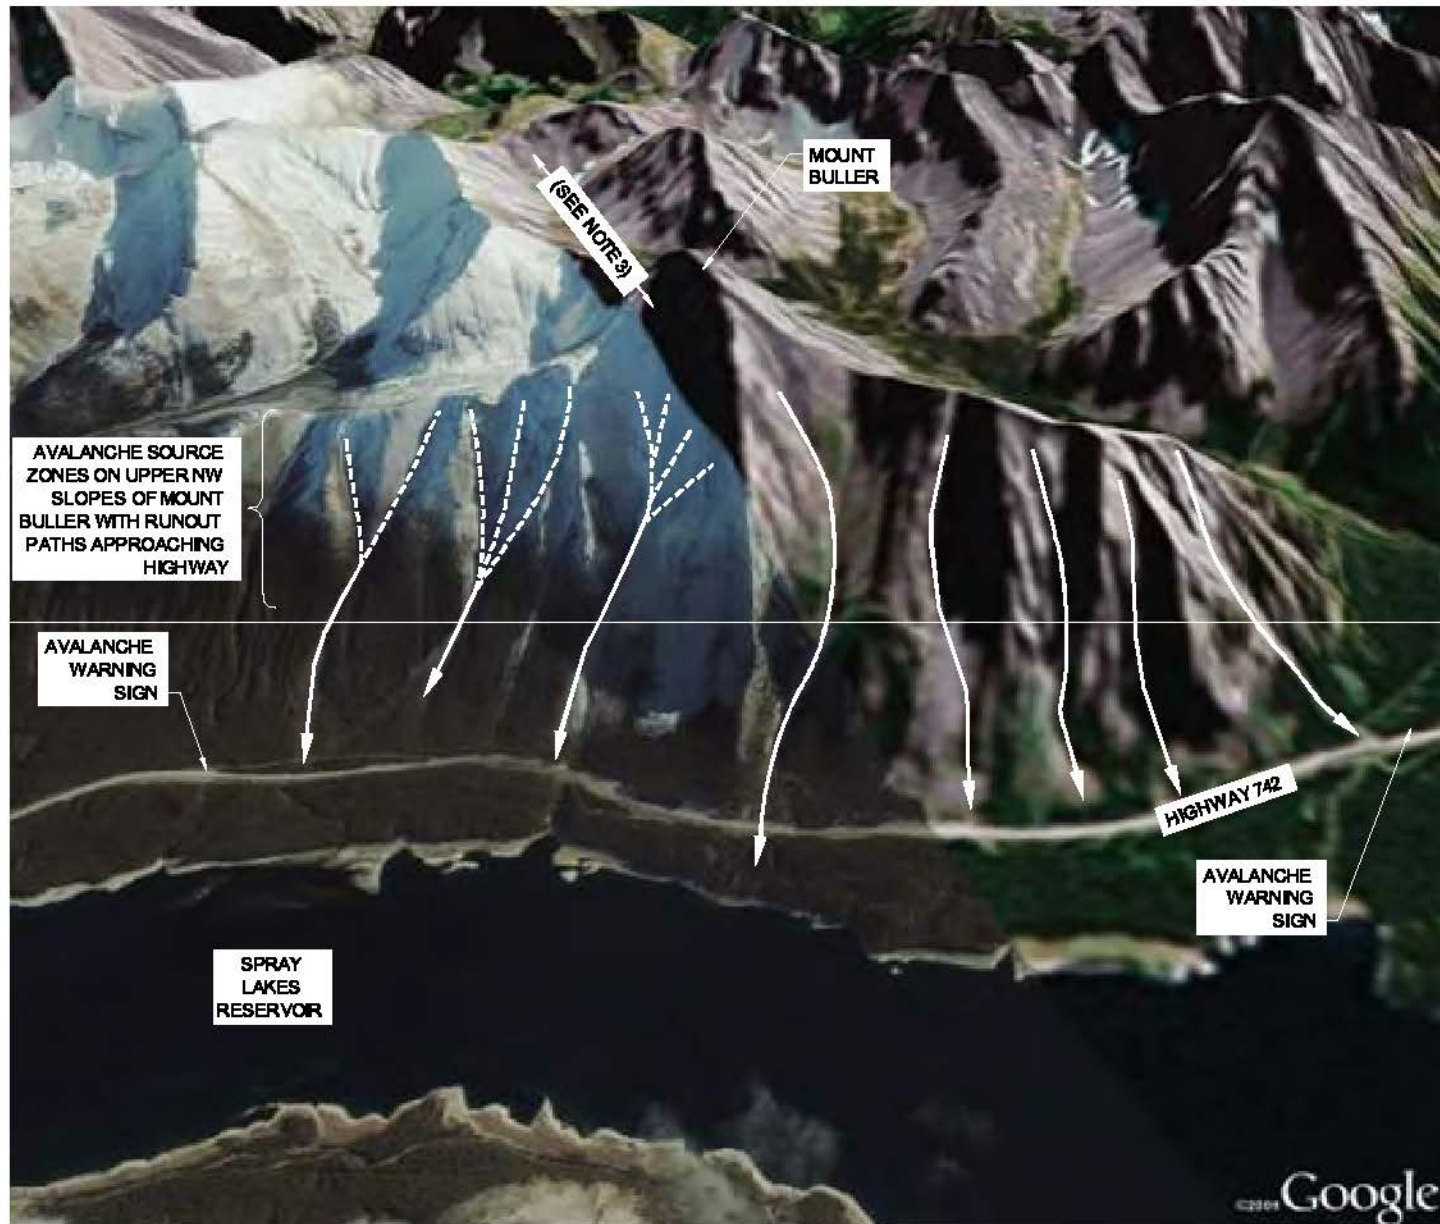
PROJECT: SOUTHERN REGION GEOHAZARD ASSESSMENT				
	TITLE: "BULLER CORNER" AVALANCHE AREA OBLIQUE VIEW SHOWING AVALANCHE PATHS				
CLIENT:

There is an avalanche hazard to the highway from the west/northwest slopes of Mount Buller. The approximate location of the avalanche source zones and runout paths above the highway are shown on Figure 4, attached.

It is understood from the Parks Division that this area typically produces avalanches throughout each winter season, and in the last approximately 20 years avalanche runout has come close to the highway on occasion but has not reached the road surface. However, the potential for future avalanche runout to reach the highway cannot be entirely ruled out. It is also understood that heli-bombing avalanche control measures have been applied at this site on one occasion in the past.

This area is reported to be the second-most active avalanche area among the three sites, typically producing avalanches throughout each winter season but with the avalanche runout rarely reaching the highway.

If the tree cover on this slope is reduced due to pine beetle infestation, forest fire or other issues, then the potential for avalanche runout onto the highway may increase. This may increase the need for avalanche control measures in this area. This can be assessed in future years.

- Probability Factor of 7 because the avalanche paths extending across the highway are not active each year but at least one avalanche has reached the ditch in recent years.
- Consequence Factor of 3, which is likely slightly conservative based on the single report of an avalanche reaching the upslope highway ditch but not spilling onto the road surface. This value for the Consequence Factor is intermediate between:
 - A value of 2 that would be associated with negligible amounts of snow deposited on the road, and
 - A value of 4 that would be associated with closure of the road while heavy equipment clears snow from the road surface and also the possibility for vehicles on the highway to be at least partially buried but likely not swept off the highway.

Therefore, the recommended Risk Level for this site is 21. This Risk Level does not account for any mitigative measures, such as temporary road closure when judged to be warranted due to avalanche conditions or heli-bombing to trigger avalanching of an unstable snow pack. It is understood that such measures are not routinely applied at this site (aside from one heli-bombing occasion in the past).
