Highway 742 – Unnamed Creek At Mount Buller (Km 29.7)

Hwy 742 – Unnamed Creek At Mount Buller

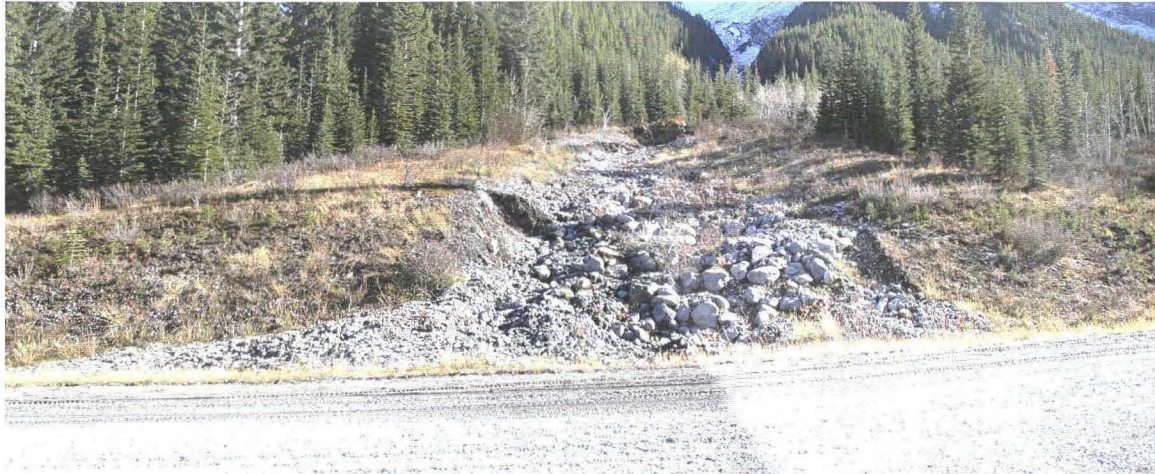
- The highway crosses a seasonal, unnamed creek channel at this site, as shown on Photo 742-46. The creek drains a basin on the west side of Mount Buller. The creek channel is conveyed below the highway via a 1400 mm diameter culvert.

- The overall appearance and incision depth of the channel does not suggest that it is prone to lateral shifting within the fan above the highway.

Photo 742-46 (top) – Facing upstream along the creek channel from the highway. Note how the seasonally-active channel is incised into a broader fan.

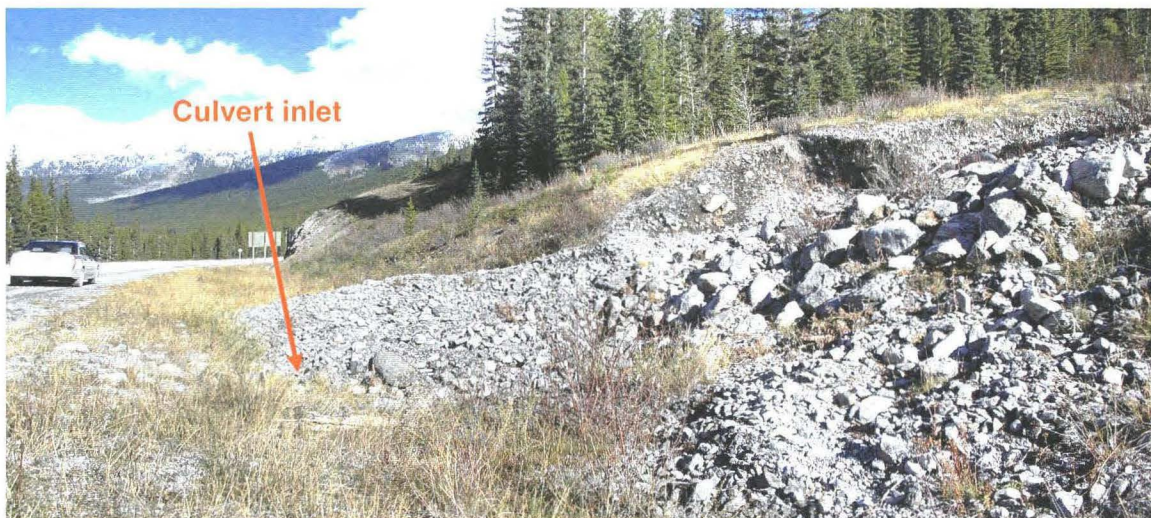
The debris in the upslope ditch northbound of the culvert inlet may have been deposited if the culvert was partially blocked at one point, with creek flow being diverted northwards along the ditch. However, it did not appear that creek flow has overtopped the road surface due to culvert blockage. It is also possible that creek flows had blocked

the culvert inlet with debris, and that the debris around the culvert inlet was excavated and simply placed in the ditch to the north of the culvert inlet.

- Probability Factor of 6 to reflect an apparent flow event or events in recent years that deposited the debris in the road ditch but also considering the possibility that the debris in the ditch was actually material excavated from around the culvert inlet only.
- Consequence Factor of 2 to allow for the possibility of debris spilling onto the road but likely without requiring road closure.

Photo 742-47 (bottom) – Facing northbound along the upslope road ditch. Note the up to boulder-sized material deposited in the upslope road ditch, northbound of the culvert inlet.

The debris in the upslope road ditch should be excavated in order to restore the ditch to full capacity.

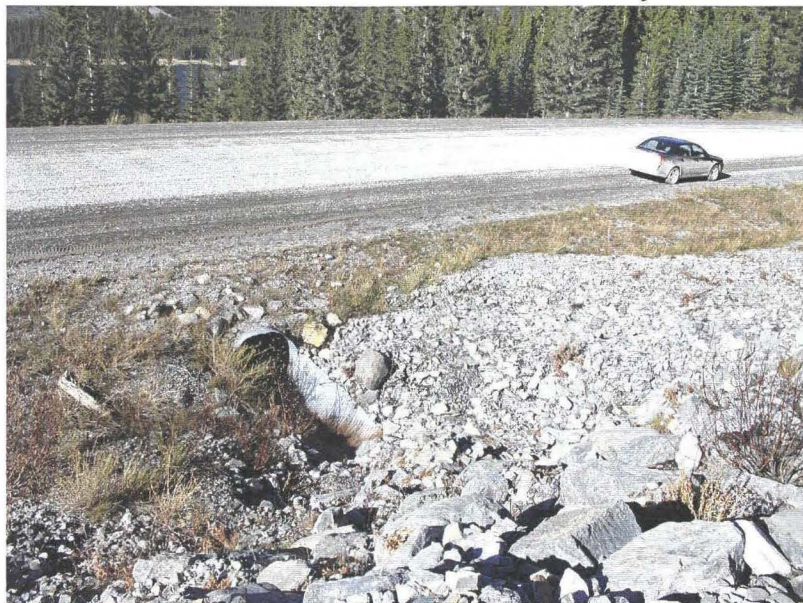
- There was no flow in the creek at the time of the October 2008 site inspection. As shown in Photo 742-46, the creek channel is incised slightly into a broader colluvial/fluvial fan upslope of the highway. The active channel is lined with up to boulder-sized rocks. It appears that in recent years, seasonal flow in the creek has deposited up to boulder-sized material into the upslope road ditch (see Photo 742-47), filling the ditch around the culvert inlet and with debris filling the ditch for approximately 10 to 15 m northbound from the culvert. The culvert inlet itself was clear of debris at the time of the inspection, as shown in Photo 742-48.

Photo 742-48 (top) – Facing downslope along the creek channel towards the culvert inlet. Note the debris extending northbound (to the right) along the ditch.

This site should be included in the summer 2009 annual Southern Region inspection tour in order to review the site conditions after the spring 2009 runoff and check the amount of debris accumulation in the upslope road ditch and around the culvert inlet. The recommended Risk Level for this site can be re-evaluated at that time.
