SITE NUMBER AND NAME: S067-I and II Sparrowhawk Rockfalls		HIGHWAY & KM: 25291:02, 11.761 to 12.816	PREVIOUS INSPECTION DATE: None	INSPECTION DATE: May 17, 2022	
LEGAL DESCRIPTION:	NAD 83 COORDINATES: UTM Northing Easting		RISK ASSESMENT:		
S067-I: NE-10-23-10-M5	11	5645143 618432	PF: 5	CF: 4	TOTAL: 20
S067-II: SW-10-23-10-M5	11	5644081 618318	PF: 5	CF: 4	TOTAL: 20
AVERAGE ANNUAL DAILY TRAFFIC (AADT): 220 (north) & 360 (south) (Reference No. 70000955 & 70000954)			CONTRACTOR MAINTENANCE AREA (CMA): 28

PROJECT
 SOUTHERN REGION GEOHAZARD RISK MANAGEMENT PROGRAM

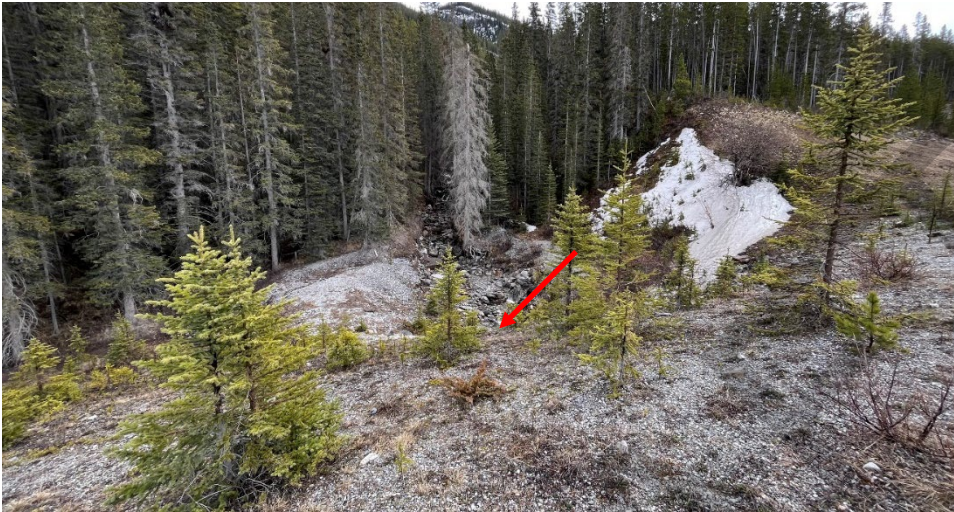
Photo 1 East highway embankment slope. The inlet of the 2 m diameter CSP culvert underlying the highway (orientated approximately east-west) is indicated by red arrow (near WP 91). Photo taken May 17, 2022, facing southeast.

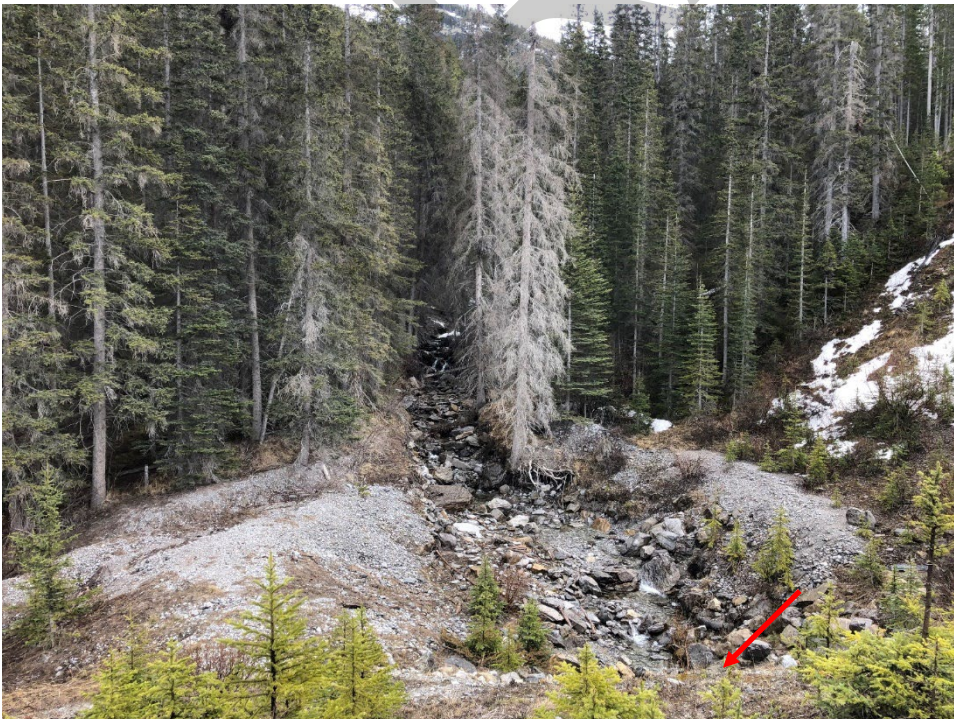
Photo 2 The inlet of the 2 m diameter CSP culvert underlying the highway (orientated approximately east-west) is indicated by red arrow (near WP 91). Photo taken May 17, 2022, facing southeast.

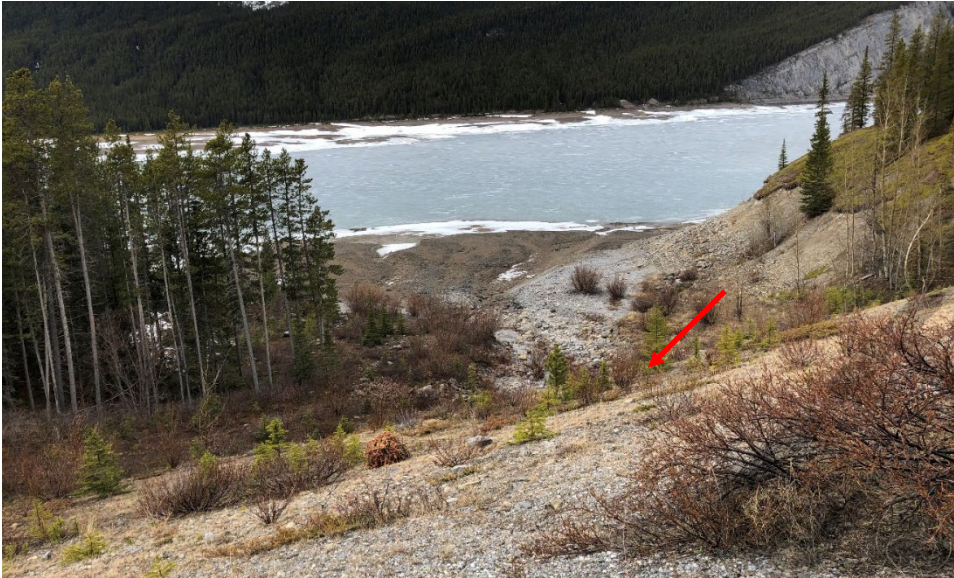
Photo 3 West highway embankment slope. The outlet of the 2 m diameter CSP culvert is indicated by red arrow. Photo taken May 17, 2022, facing northwest.

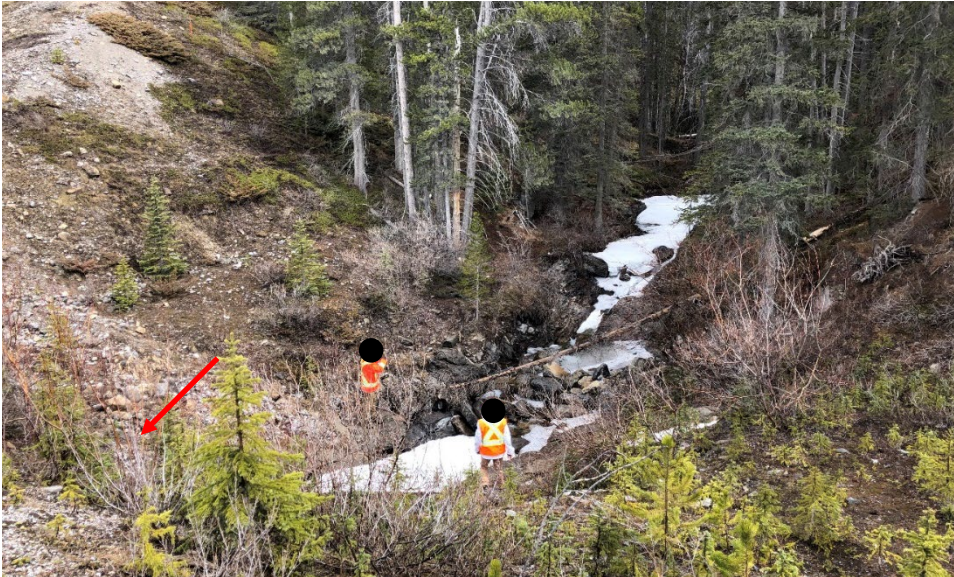
Photo4 East highway embankment slope. Inlet of 2 m diameter CSP culvert is indicated by red arrow Photo taken May 17, 2022, facing east.

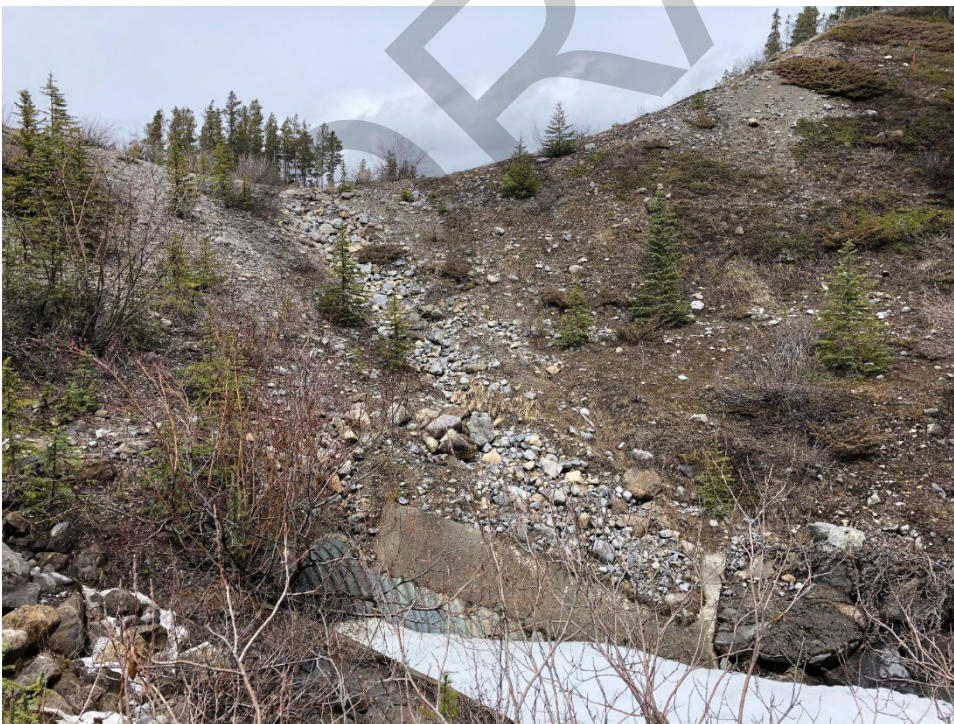
Photo 5 Inlet of the 2 m diameter CSP culvert and east highway embankment slope. Photo taken May 17, 2022, facing north.

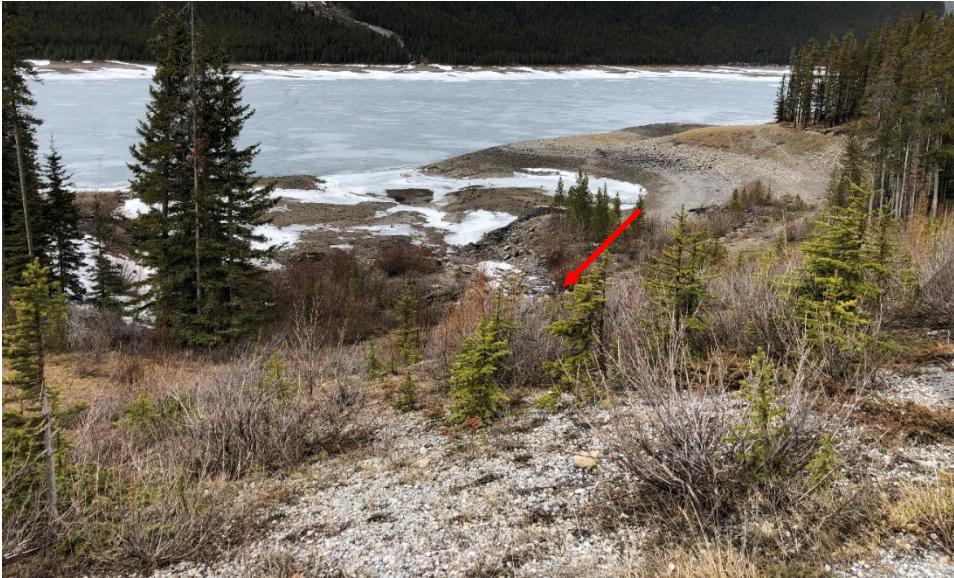
Photo 6 West highway embankment slope. The outlet of the 2 m diameter CSP culvert is indicated by red arrow. Photo taken May 17, 2022, facing northwest.
