Highway 742 – Mount Sparrowhawk Area Hazards

PROJECT:		HWY 742 GEOHAZARDS REVIEW							
TITLE:		SOUTH SPARROWHAWK CREEK DEBRIS FLOW FAN							
DATE:	JANUARY 2009	JOB No.:	CG25262	CAD FILE:	25262Z09.dwg	FIGURE No.:		REV.	A

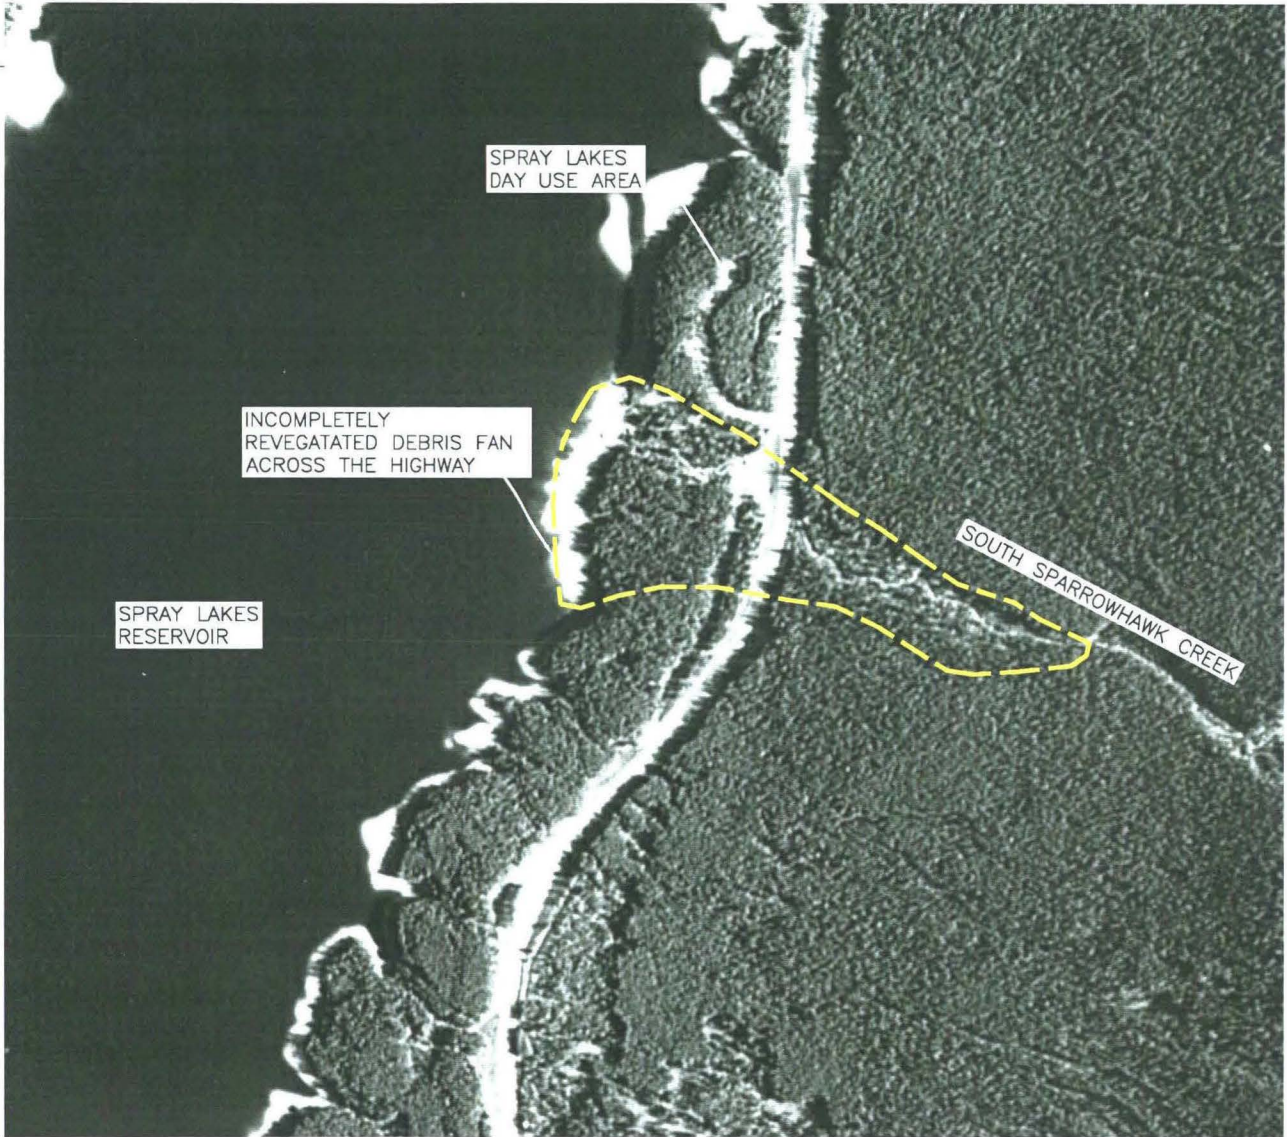
The highway crosses an alluvial fan on the lower section of the creek that has been covered with numerous debris flow deposits. As shown on the attached airphoto figure, the fan and debris flow deposits are not completely revegetated. This suggests that debris flows occur often enough to prevent natural revegetation of these areas. Cruden and Eaton also noted that rockslides further upstream have blocked the South Sparrowhawk Creek drainage in the past, perhaps generating debris flow activity as these natural dams burst. Short duration, high intensity rainfall events similar to the localized storm that was likely a triggering factor for the 1999 Five Mile Creek Debris Flow near Banff, AB (Cullum-Kenyon et al., 2003) could also be a factor at this site.

The debris flow hazard could affect Highway 742 at the crossing of South Sparrowhawk Creek, at approximately Km 26, a short distance southbound of the Spray Lakes Day Use Area turnoff.

The potential debris flow hazard is judged to be a low risk to the highway, however the risk of a debris flow impacting the highway cannot be entirely ruled out particularly given the possibility of a future rockslide creating a natural dam across the creek channel in the upper reaches of the valley and subsequently bursting. Therefore, the recommended Risk Level for this site, based on AT's debris flow risk matrix, is as follows:

- Probability Factor of 2 to represent such a debris flow being very improbable.
- Consequence Factor of 5 to represent consequences in the order of partial to complete closure of the highway following a debris flow while the maintenance crew uses heavy equipment to clear the roadway and/or remove debris plugging the culvert.

Therefore, the recommended Risk Level relative to a debris flow along South Sparrowhawk Creek is 10.
