| SITE NUMBER AND NAME: S067-III Sparrowhawk Rockfalls | | HIGHWAY & KM: 25291:02, 10.491 | PREVIOUS INSPECTION DATE: None | INSPECTION DATE: May 17, 2022 |

PROJECT
 SOUTHERN REGION GEOHAZARD RISK MANAGEMENT PROGRAM

TITLE
 Site Plan
 S067-3 - Sparrowhawk Rockfall Hazards
 Hwy 25291:01, km 10.491

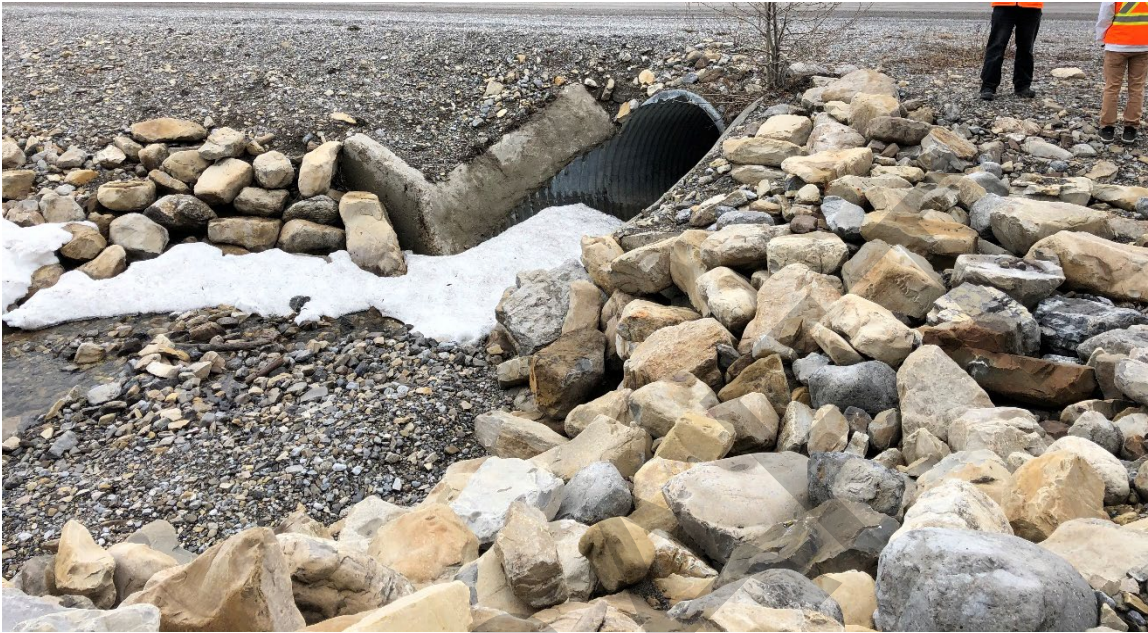
| The site consists of a bridge size CSP culvert (2.3 m diameter) under the highway east of Spray Lakes Reservoir (oriented approximately east-west). Sparrowhawk Creek and surface water runoff flow into the culvert and discharges in the Spray Lakes Reservoir. The CSP culvert inlet is armoured with a concrete wing wall (Photo 1). |

Photo 1 CSP culvert inlet on east highway embankment slope. Concrete wing walls were installed on either side of the culvert inlet. Photo taken May 17, 2022, facing southwest.

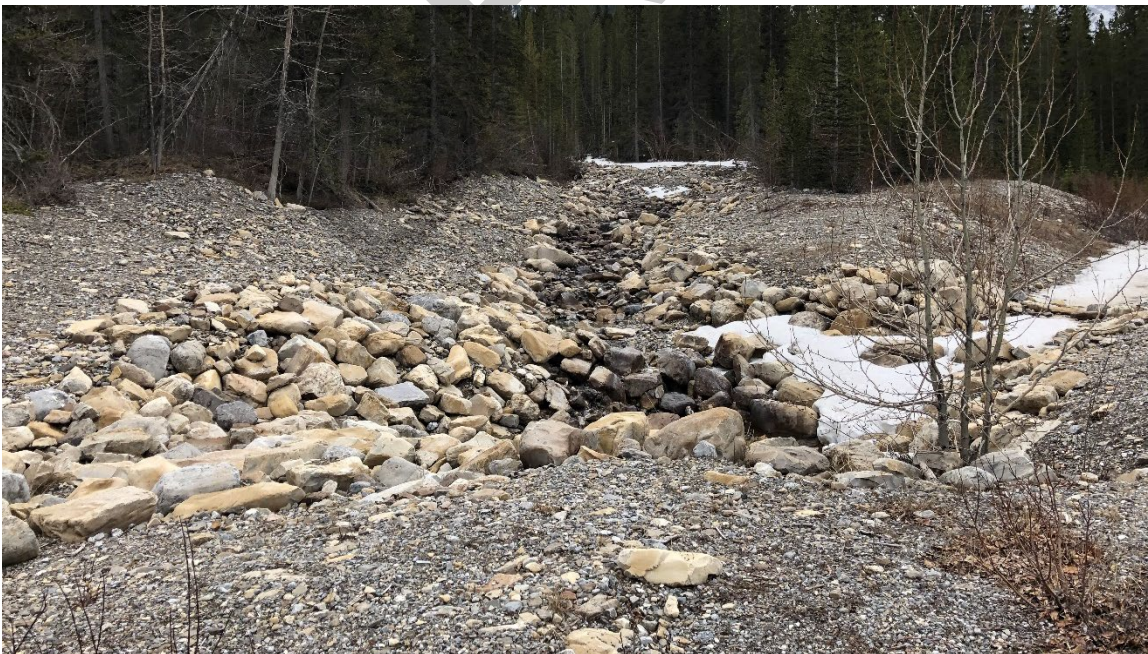
| The channels upstream and downstream of the CSP culvert are well defined, armoured with riprap, and appear to be in good condition (Photo 2 and 3). |

Photo 2 Riprap armoring on the channel upstream of the CSP culvert inlet, on the east side of the highway. Photo taken May 17, 2022, facing southeast.

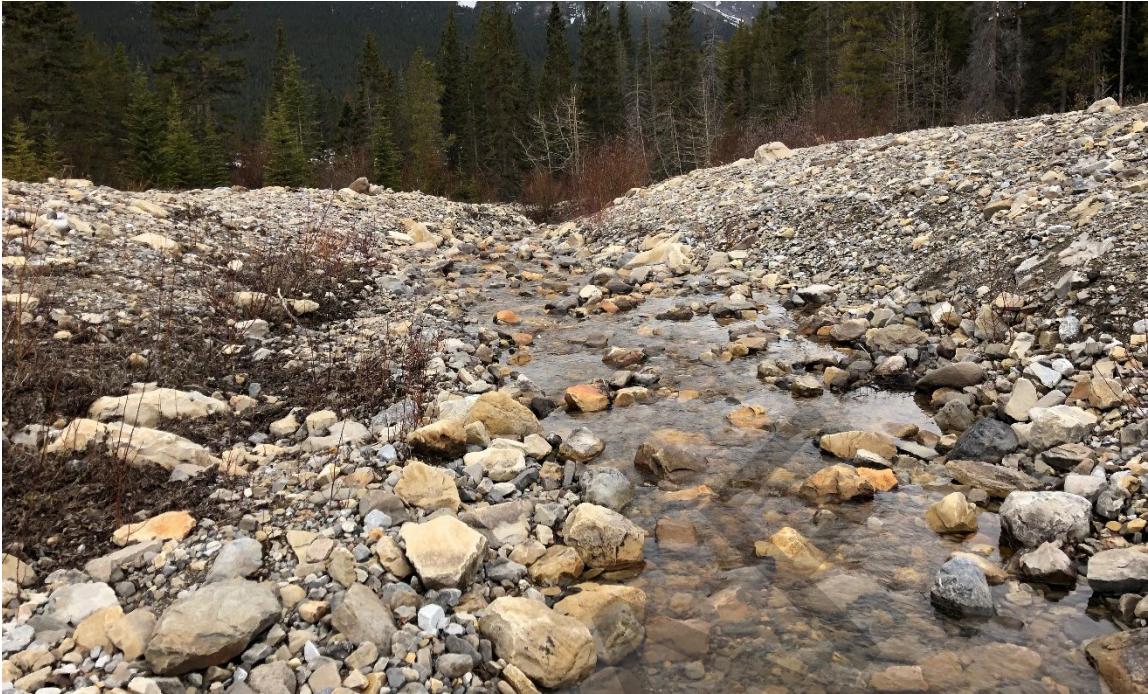
Photo 3 Culvert discharge on west highway embankment slope. Photo taken May 17, 2022, facing west.
