## SOUTHERN REGION GRMP SITE INSPECTION FORM

SITE NUMBER AND NAME: S030 Gabion Wall	HIGHWAY & KM: 742:02, 30.940	PREVIOUS INSPECTION DATE: May 1, 2018	May 7, 2019	
LEGAL DESCRIPTION: 02-25-024-11 W5M	NAD 83 COORDINATES: UTM Northing Easting 11 5658981 611421	RISK ASSESMENT: PF: 1 CF: 2 TOT	AL: 2	
AVERAGE ANNUAL DAILY 800 (west), 1260 (east), (Ref		CONTRACTOR MAINTENANCE AREA (CMA): 28

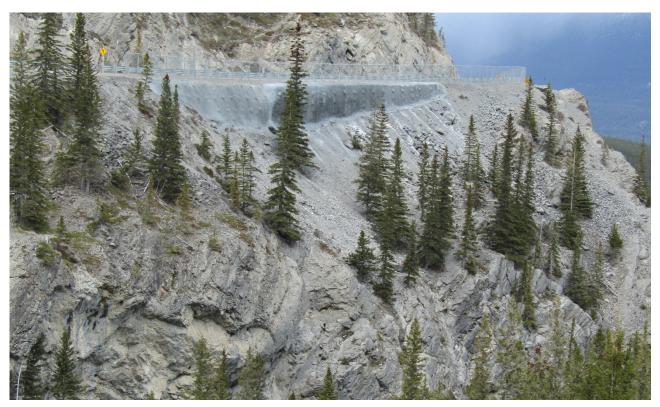
Photo 1 Completed gabion wall repairs. Photo taken facing north on May 7, 2019.

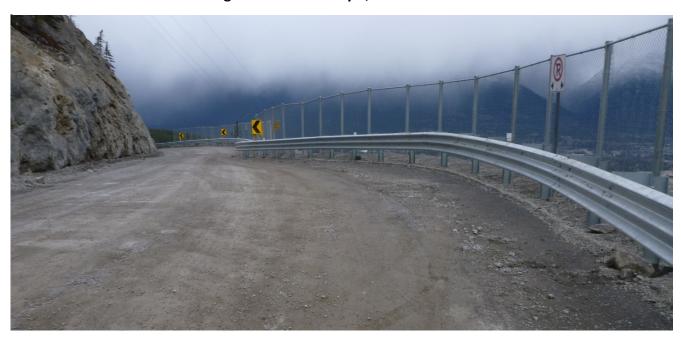
Photo 2 New guard rail barrier and chain link fence after completion of the gabion repairs. Photo taken facing northeast on May 7, 2019.
