SITE NUMBER AND NAME: <b>S030 Gabion Wall</b>		HIGHWAY & KM: 742:02, 30.940	PREVIOUS INSPECTION DATE: May 7, 2019	INSPECTION DATE: <b>July 6, 2020</b>
LEGAL DESCRIPTION: 02-25-024-11 W5M	NAD 83 COORDINATES: UTM Northing Easting 11 5658981 611421		RISK ASSESMENT: PF: 1 CF: 2 TOTAL: 2	
AVERAGE ANNUAL DAILY TRAFFIC (AADT): 1220 (west), 1540 (east), (Ref. No. 70000698)			CONTRACTOR MAINTENANCE AREA (CMA): 28

SUMMARY OF SITE INSTRUMENTATION:  None  LAST READING DATE: N/A	INSPECTED BY: Chris Morgan (KCB) Margot Lederman (KCB) Kristen Tappenden (AT) Alex Frotten (AT)
PRIMARY SITE ISSUE: Gabion wall at the site had been toppling due to undermining.	
APPROXIMATE DIMENSIONS: N/A. Previous failure had included approximately 17 m of gabion wall.	
DATE OF ANY REMEDIAL ACTION: The gabion wall was repaired in 2018 with shotcrete and tie-back rock anchors. A new chain link fence and w-beam guardrail was erected.

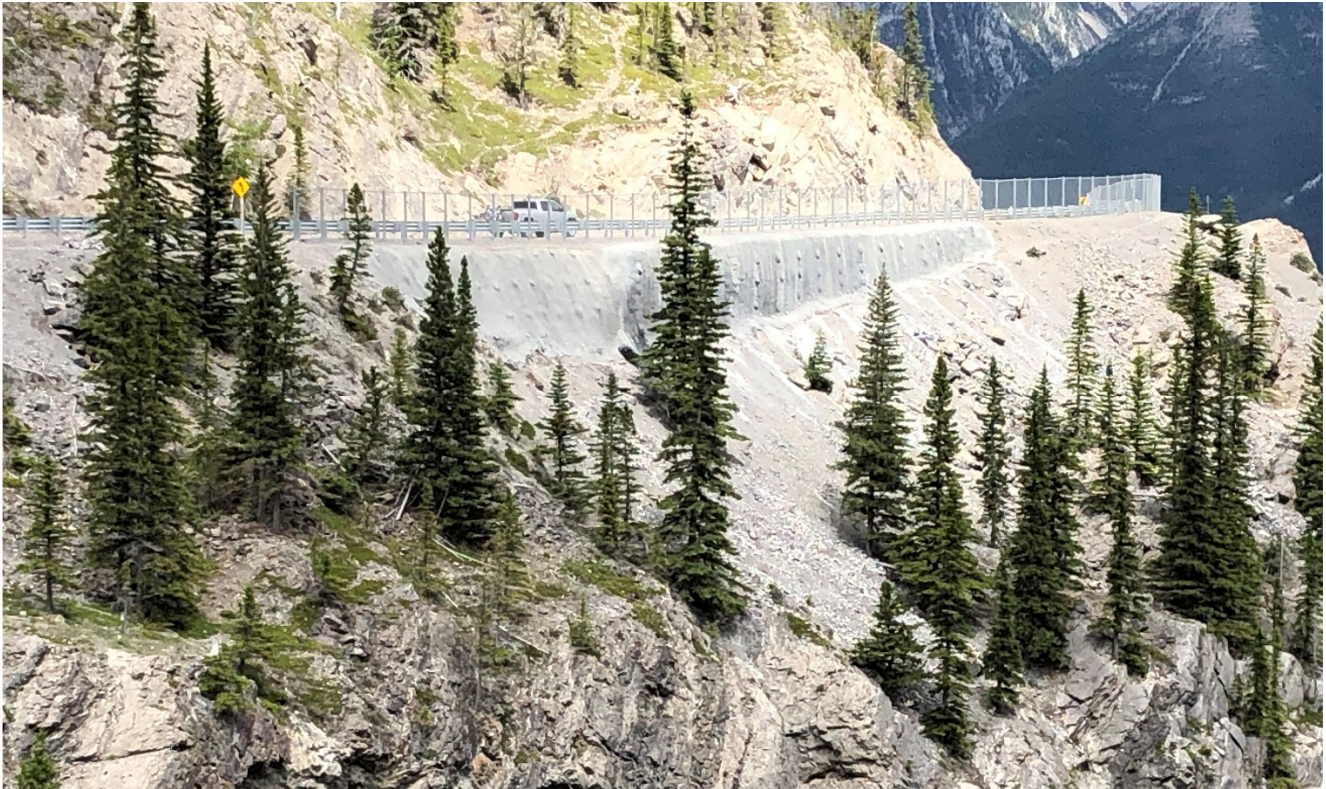
**Photo 1** Completed gabion wall repairs. Photo taken facing north on May 7, 2019.

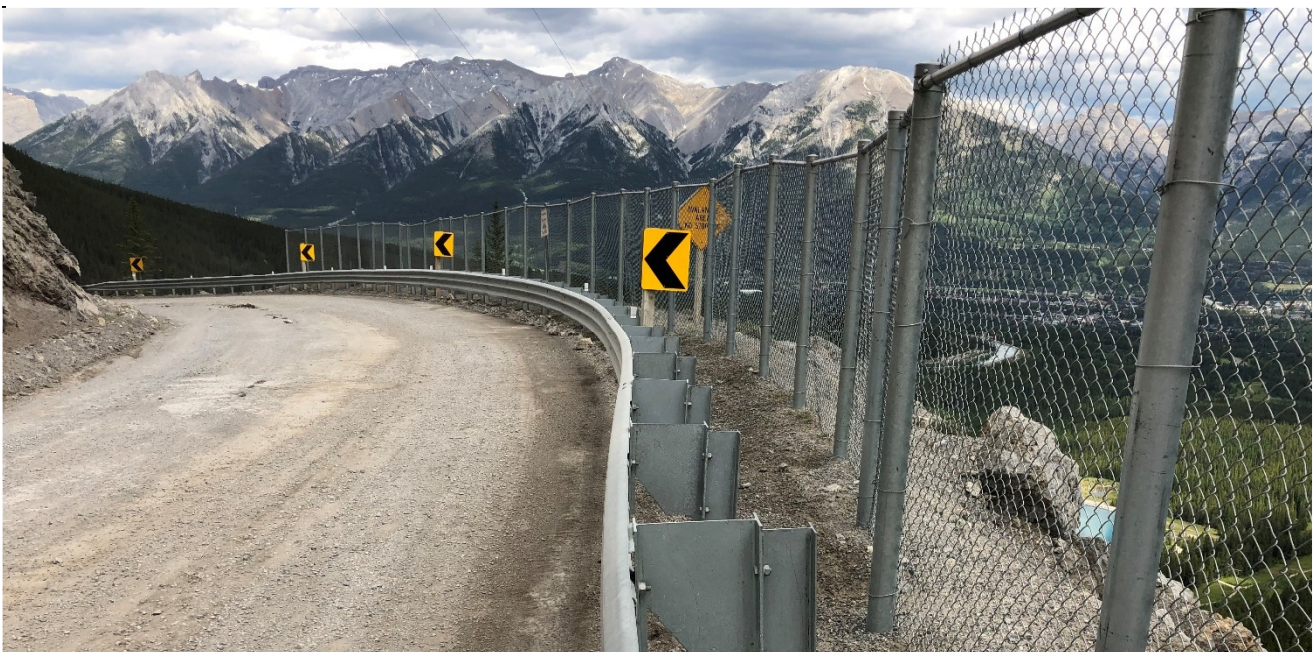
**Photo 2** New guard rail barrier and chain link fence after completion of the gabion repairs. Photo taken facing northeast on July 6, 2020.
