**SOUTHERN REGION GEOHAZARD ASSESSMENT
ANNUAL ASSESSMENT REPORT
2007**

November 2007

4.20 S23 – HIGHWAY 507:02 – EAST OF MILL CREEK

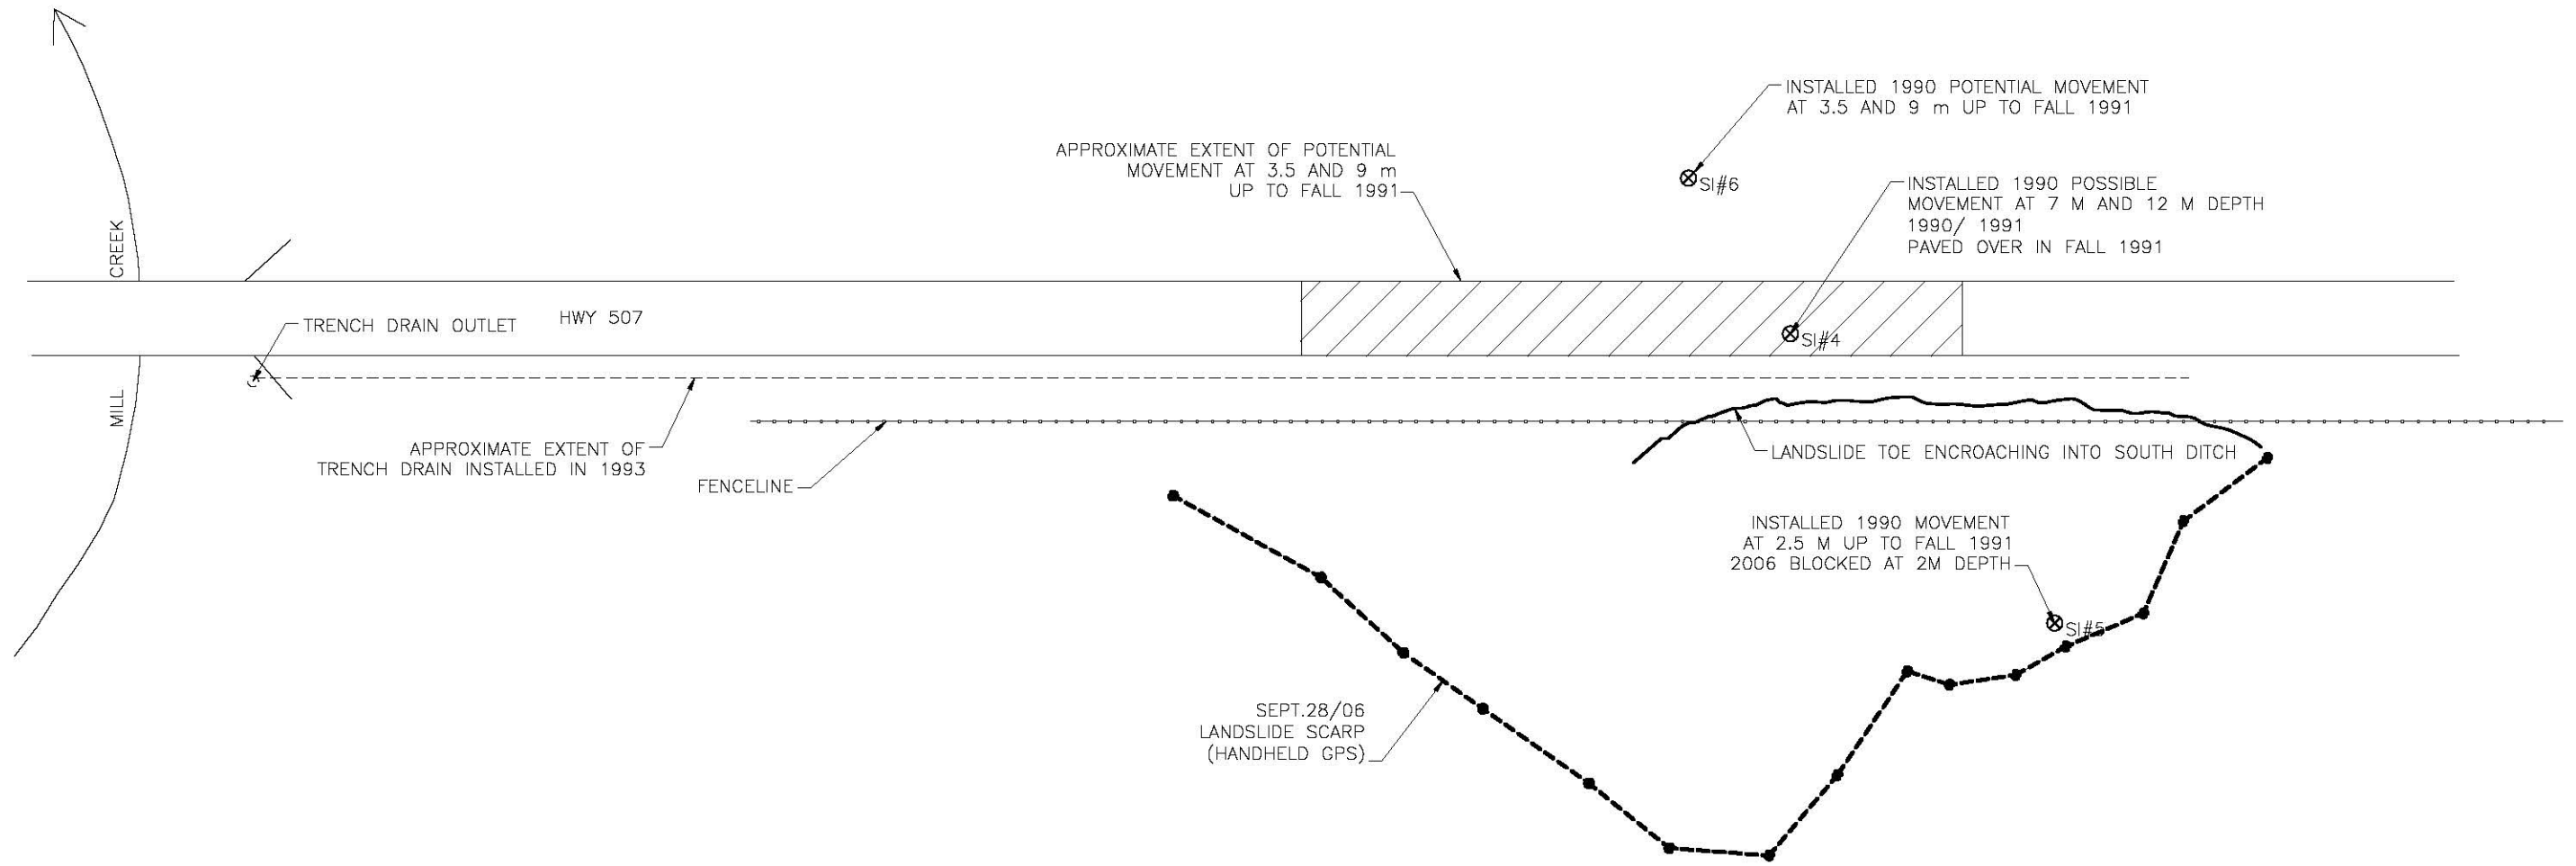
PROJECT: SOUTHERN REGION GEOHAZARD ASSESSMENT				
	TITLE: S23 - EAST OF MILL CREEK SITE PLAN				
CLIENT:	DATE: AUGUST 2007	JOB No.: CG25263	CAD FILE: 25263X00.dwg	FIGURE No.: S23-2	REV: A

2. Three SI's were installed in November 1990 at the locations marked as SI #4, SI #5 and SI #6 on the plan view of the site (see Figure S23-2 in Appendix S23). The SI data up to the fall of 1991 showed potential and confirmed movement in each of these SI's at the depths noted on Figure S23-2. These movement depths are within the native clay and clay till soils and possibly the underlying clay shale bedrock as well. There was no data after the fall of 1991 for these SI's in the AIT files that were reviewed.

- b. A trench drain was installed along the south ditch. The approximate extent of the trench drain relative to the landslide area is illustrated on Figure S23-2 in Appendix S23.

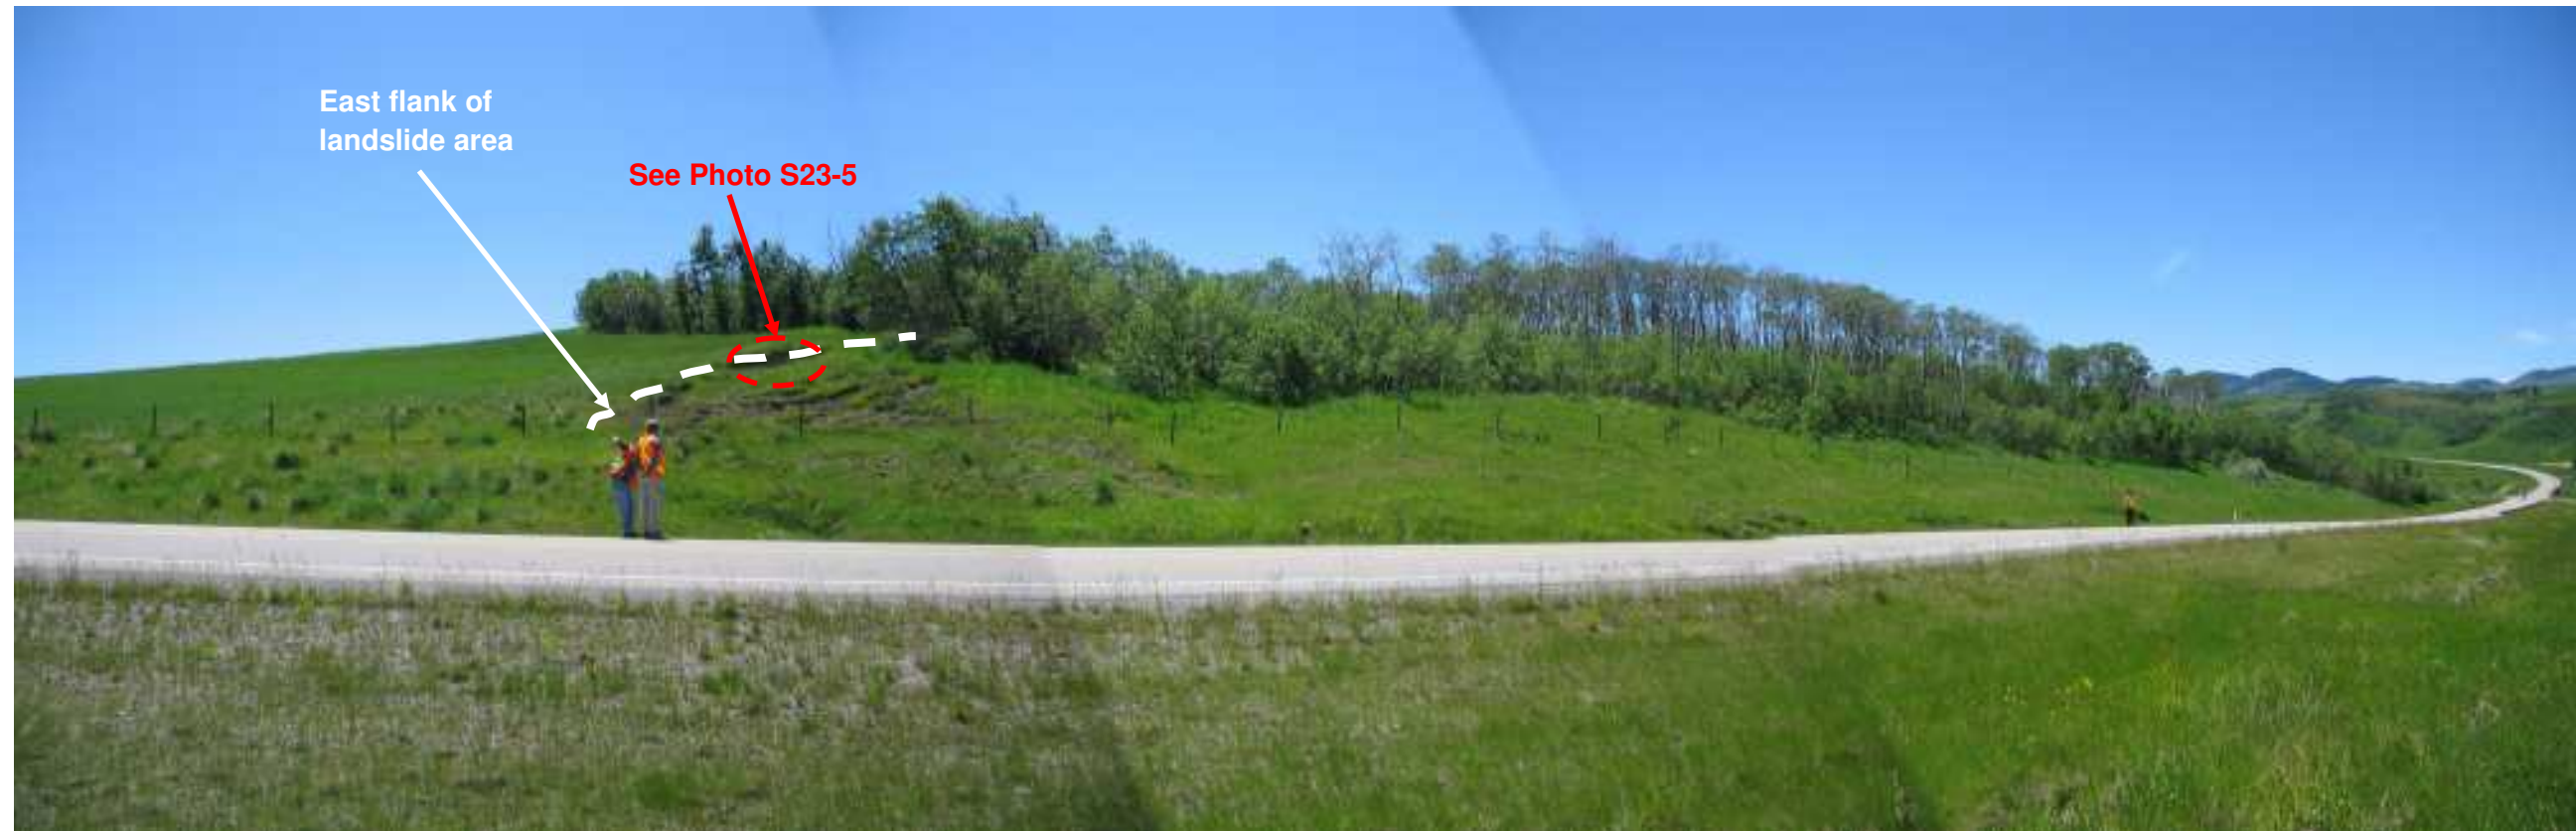
- The site conditions and the appearance of the landslide area in the slope above (south) of the highway did not appear to have changed significantly since the September 2006 inspection. Photo S23-1 shows a general view of the landslide area. Photos S23-2 to 5 show closer views of the toe bulge of the landslide along the south road ditch and a well-defined portion of the landslide headscarp above the road.

Photo S23-1 – June 2007 (top)
Facing south across the highway towards the landslide area. The visible east flank of the landsliding is labelled along with the location shown in more detail on Photo S23-5.

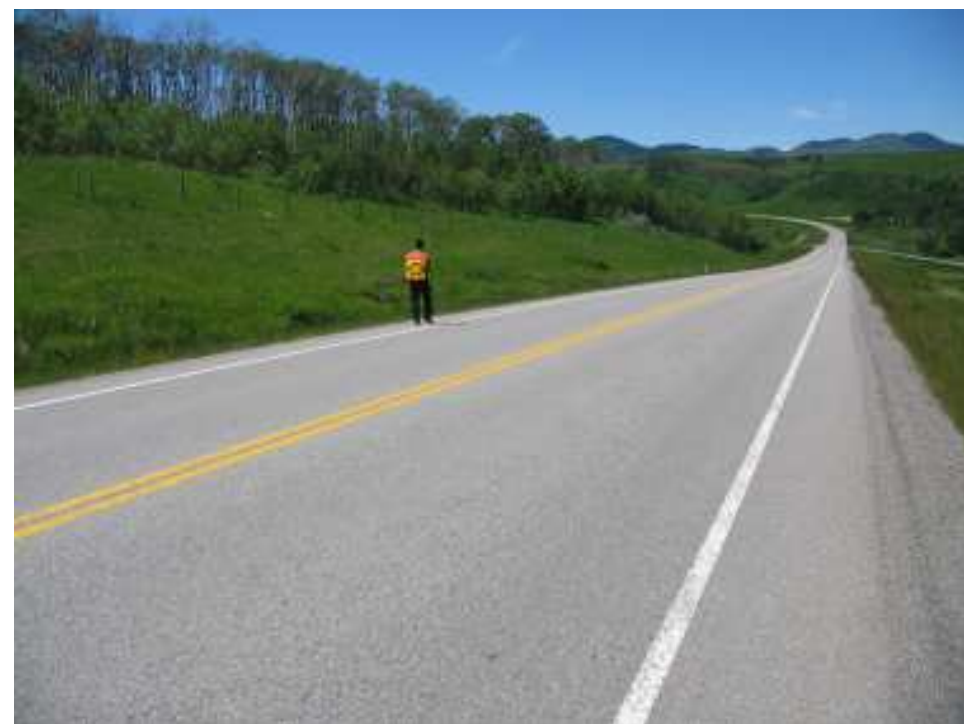
Photo S23-2 – June 2007 (lower left)
Facing west along the highway across the toe of the landslide area.

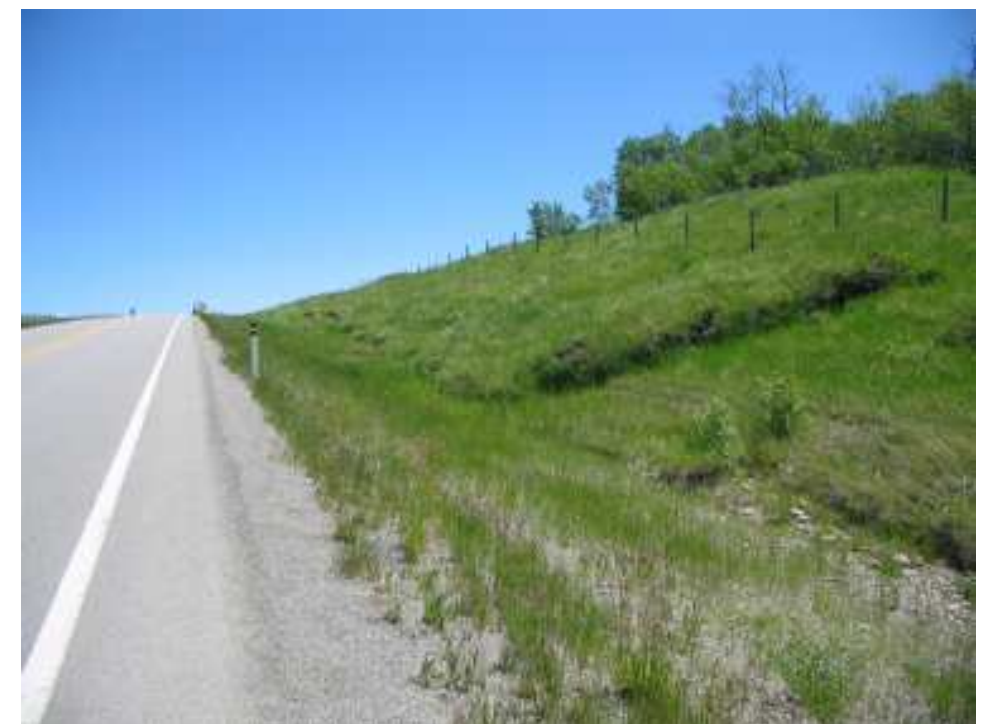
- The current main geotechnical risk at this site appears to be the potential loss of capacity of the south road ditch due to the active landslide toe encroaching into the ditch. The buried trench drain that was installed along the south ditch in 1993 may serve to mitigate any loss of surface capacity in the south ditch, provided that any ditch flow is able to percolate downwards into the trench drain.
- There is also a risk that future landslide movements will eventually push the toe of the landslide area into the eastbound lane of the highway.
- It is also possible that the landowner to the south of the highway may contact AIT with concerns regarding the encroachment of the landslide headscarp into the cleared field south of the highway.

Photo S23-3 – June 2007 (lower right)
Facing east along the highway across the toe of the landslide area. The toe bulge of the landslide that encroaches into the ditch is visible.

The most practical measure to reduce the landslide risk to the south ditch and highway would likely be to drill a series of sub-horizontal drain pipes into the landslide area above the road to attempt to relieve groundwater pressures in the landslide mass. The concept and intent of the sub-horizontal drain pipes would be the same as the finger drains that were installed into the

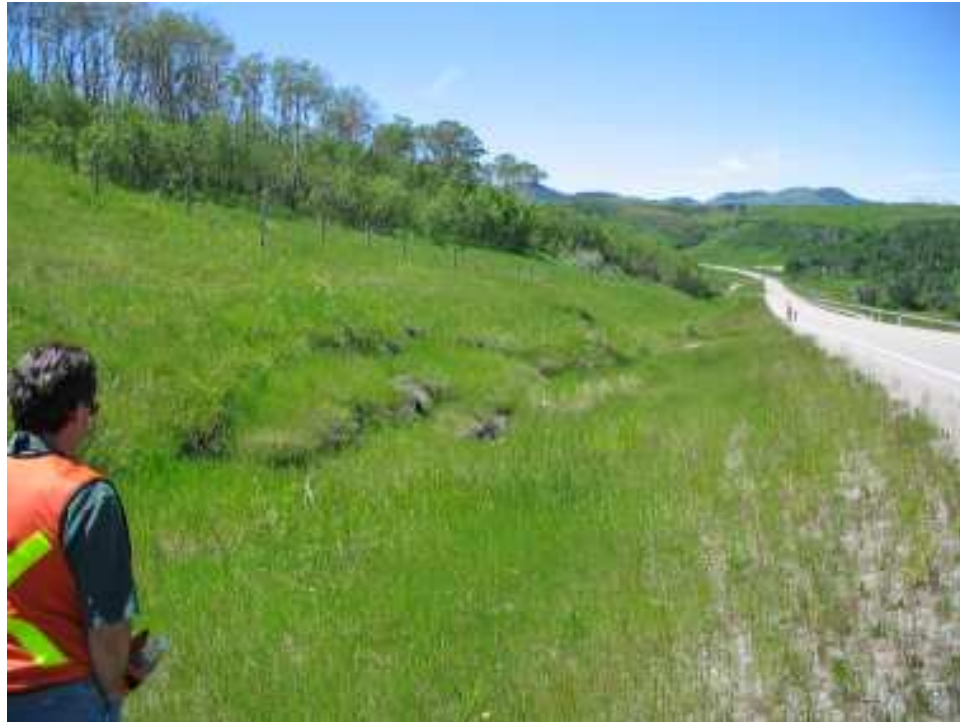
Photo S23-4 – June 2007 (left)
Closer view, facing west, across one of the visible toe bulges in the landslide.

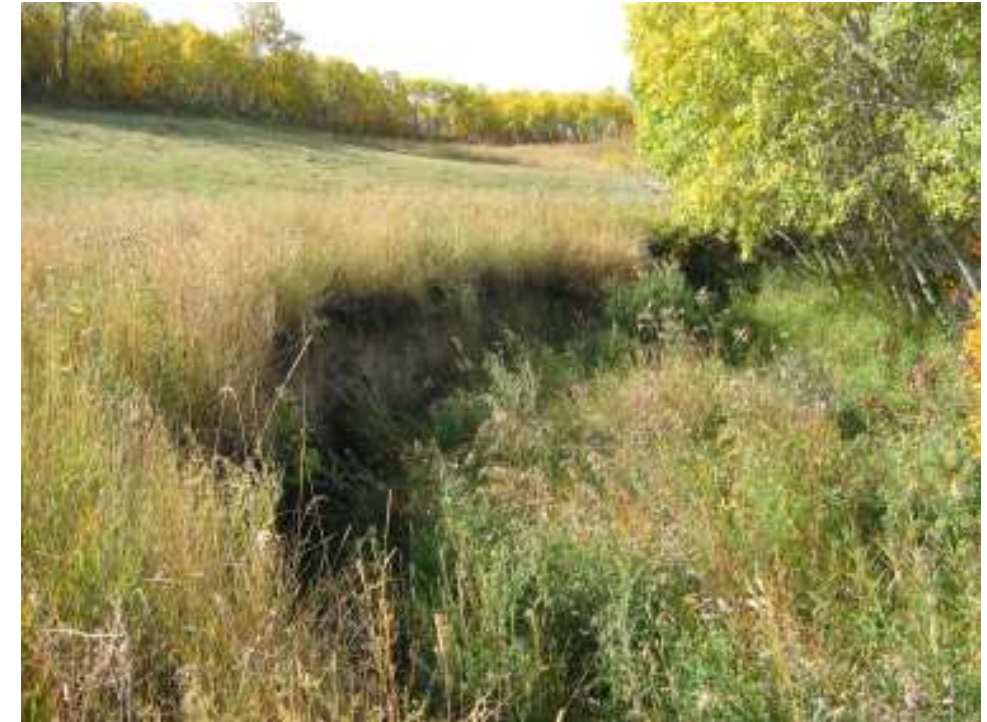
Photo S23-5 – September 2006 (right)
Landslide scarp in the vicinity of SI #5 around the upper east flank of the landslide area (see Figure S23-2 for an illustration of this location). This 2 to 2.5 m high, near-vertical scarp has presumably formed since SI #5 was installed in 1990 because the SI is located at the base of the scarp at a location that would not be accessible for the drilling equipment with the scarp in place.

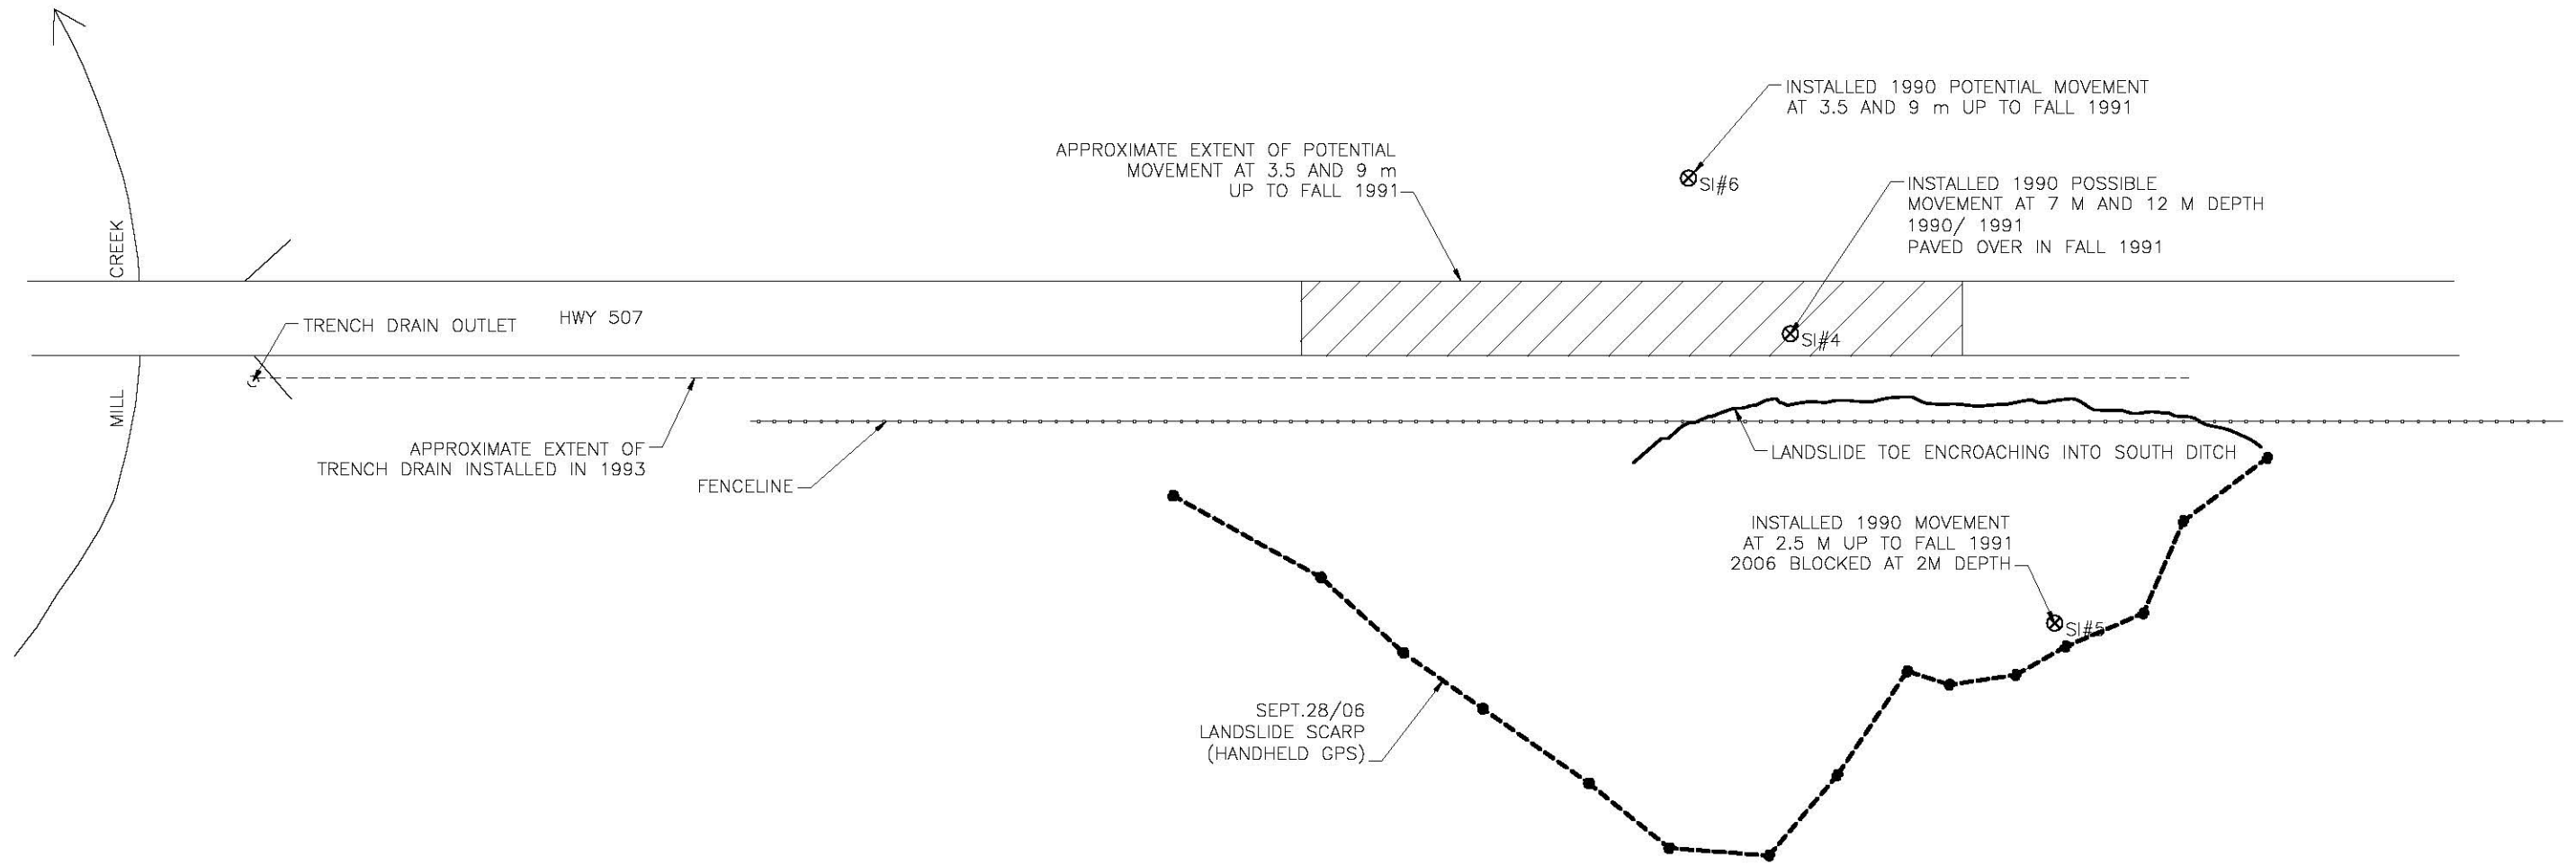
PROJECT: SOUTHERN REGION GEOHAZARD ASSESSMENT				
	TITLE: S23 - EAST OF MILL CREEK SITE PLAN				
CLIENT:	DATE: AUGUST 2007	JOB No.: CG25263	CAD FILE: 25263X00.dwg	FIGURE No.: S23-2	REV: A

APPROXIMATE EXTENT OF POTENTIAL
MOVEMENT AT 3.5 AND 9 m
UP TO FALL 1991

INSTALLED 1990 POTENTIAL MOVEMENT
AT 3.5 AND 9 m UP TO FALL 1991

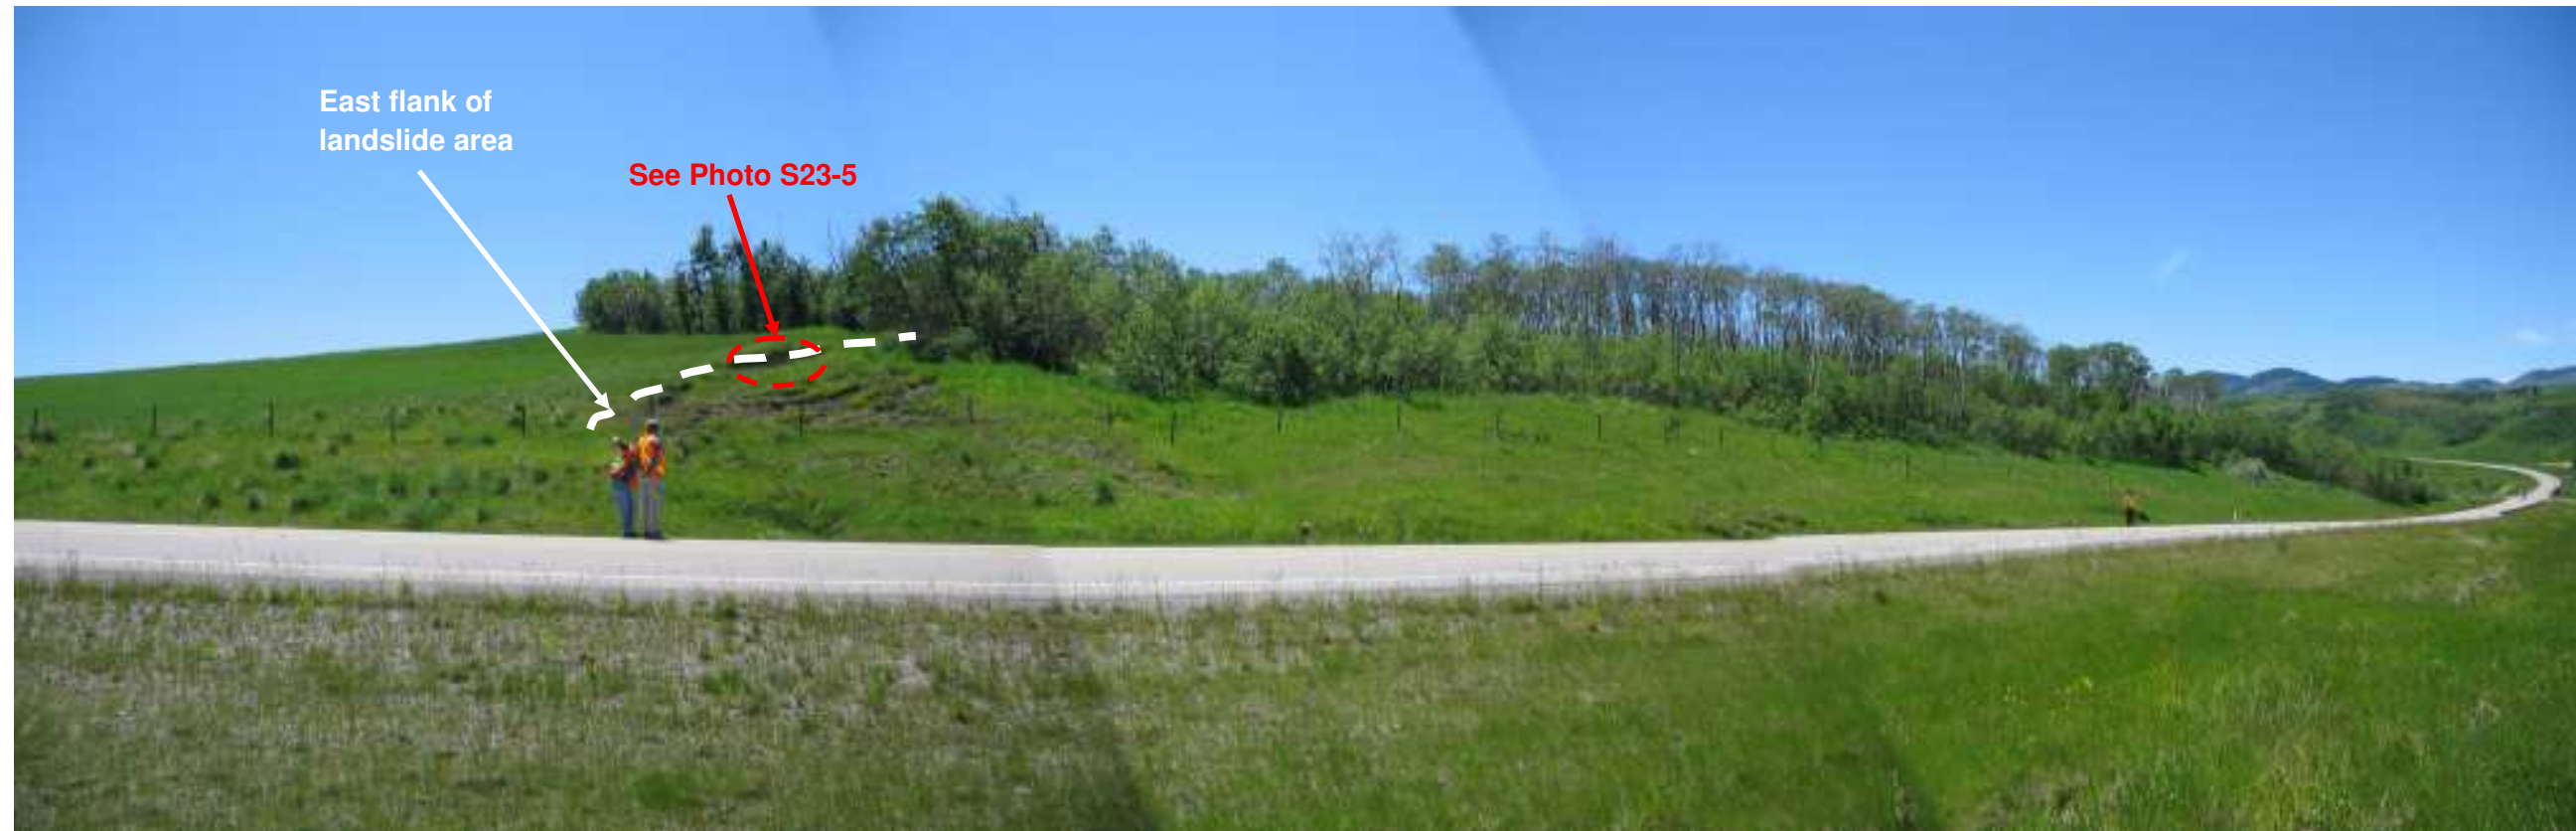
Photo S23-1 – June 2007 (top)
Facing south across the highway towards the landslide area. The visible east flank of the landsliding is labelled along with the location shown in more detail on Photo S23-5.

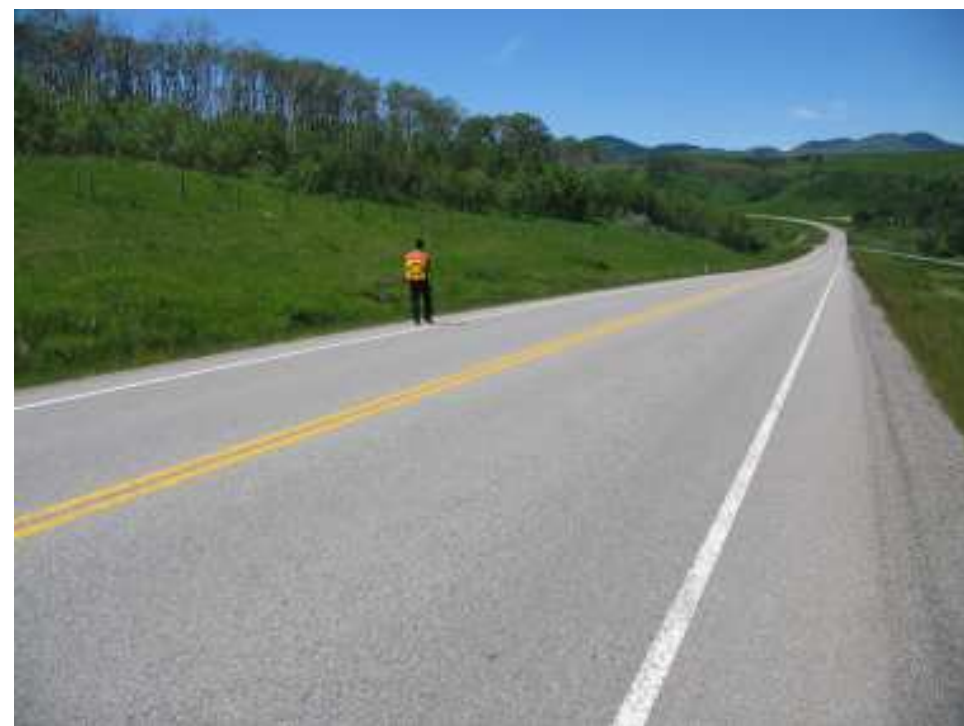
Photo S23-2 – June 2007 (lower left)
Facing west along the highway across the toe of the landslide area.

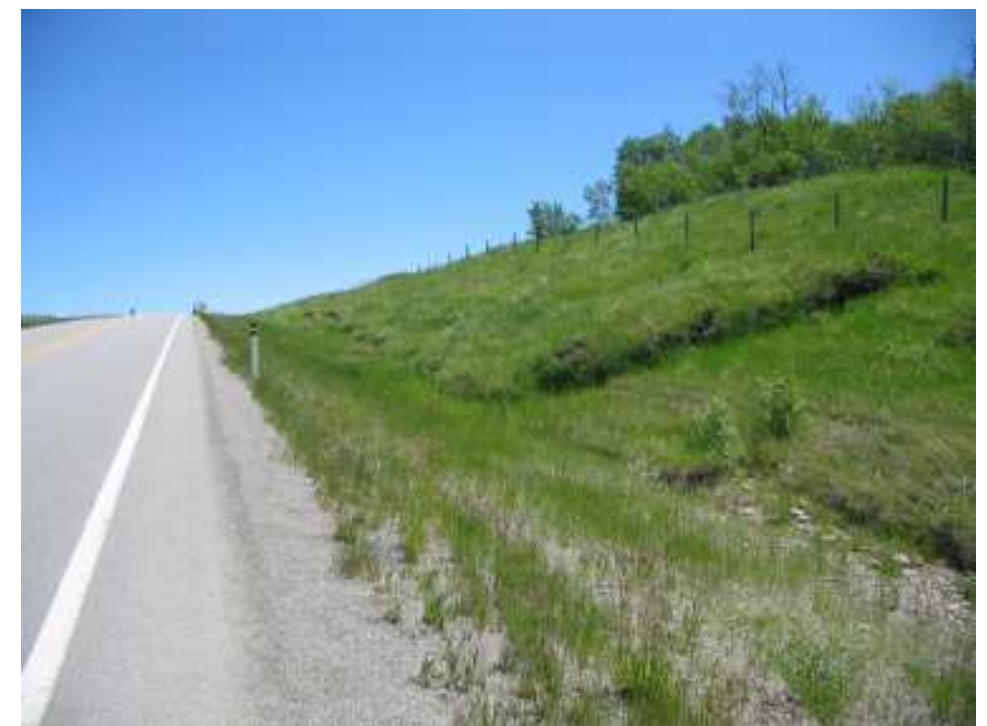
Photo S23-3 – June 2007 (lower right)
Facing east along the highway across the toe of the landslide area. The toe bulge of the landslide that encroaches into the ditch is visible.

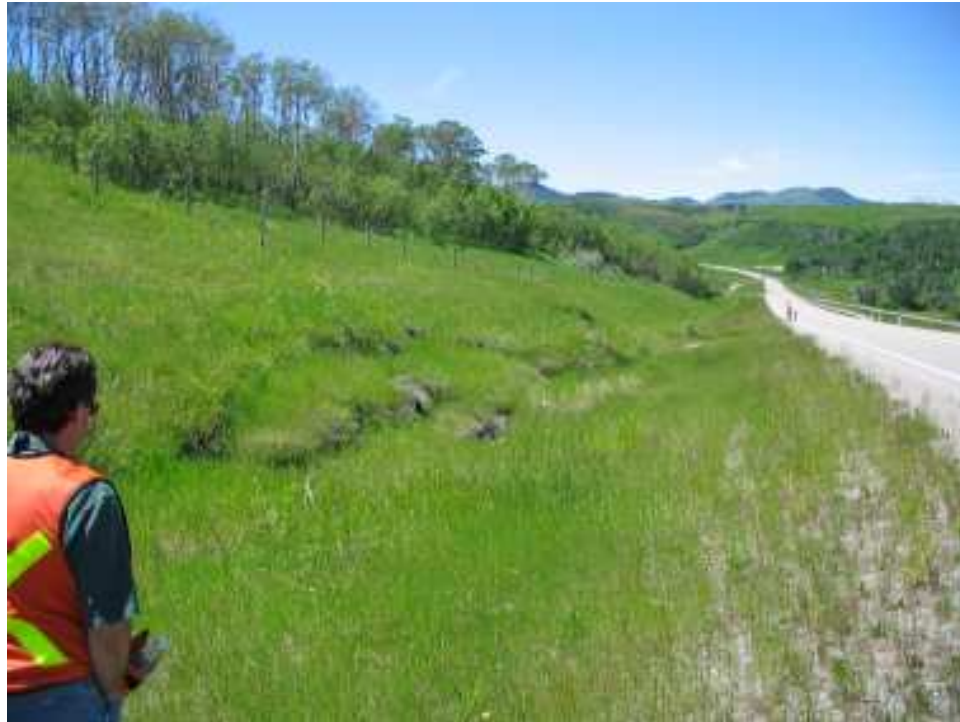
Photo S23-4 – June 2007 (left)
Closer view, facing west, across one of the visible toe bulges in the landslide.

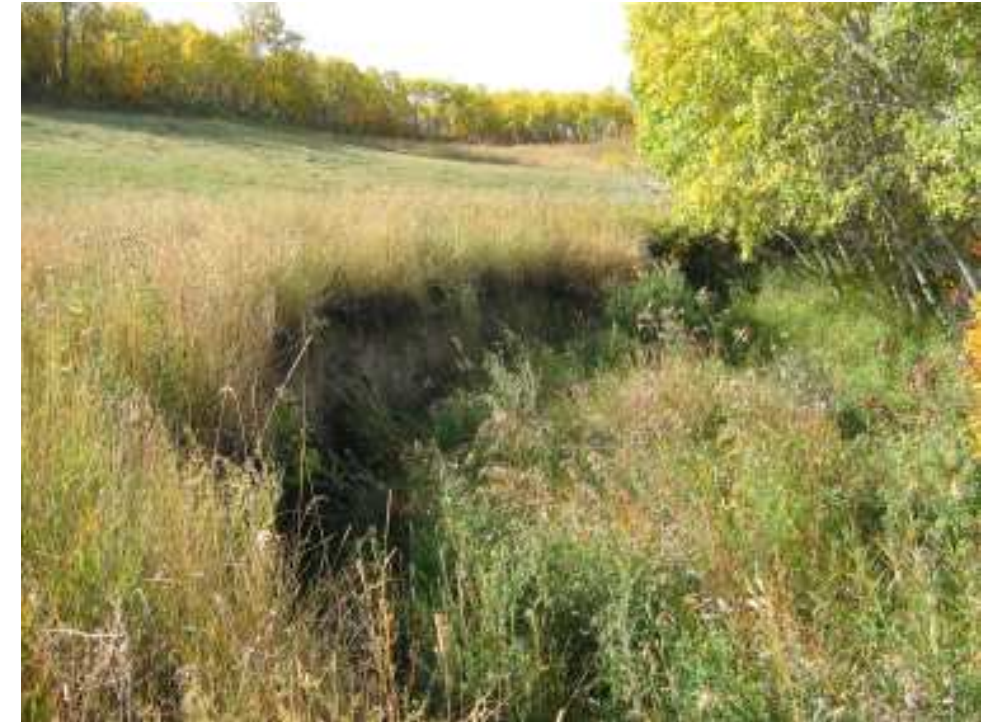
Photo S23-5 – September 2006 (right)
Landslide scarp in the vicinity of SI #5 around the upper east flank of the landslide area (see Figure S23-2 for an illustration of this location). This 2 to 2.5 m high, near-vertical scarp has presumably formed since SI #5 was installed in 1990 because the SI is located at the base of the scarp at a location that would not be accessible for the drilling equipment with the scarp in place.
