September 8, 2008

CG25277.B

**Re: Southern Region Geohazard Assessment Program
Site S23 – Slide East Of Mill Creek, Highway 507:02
2008 Annual Inspection Report**

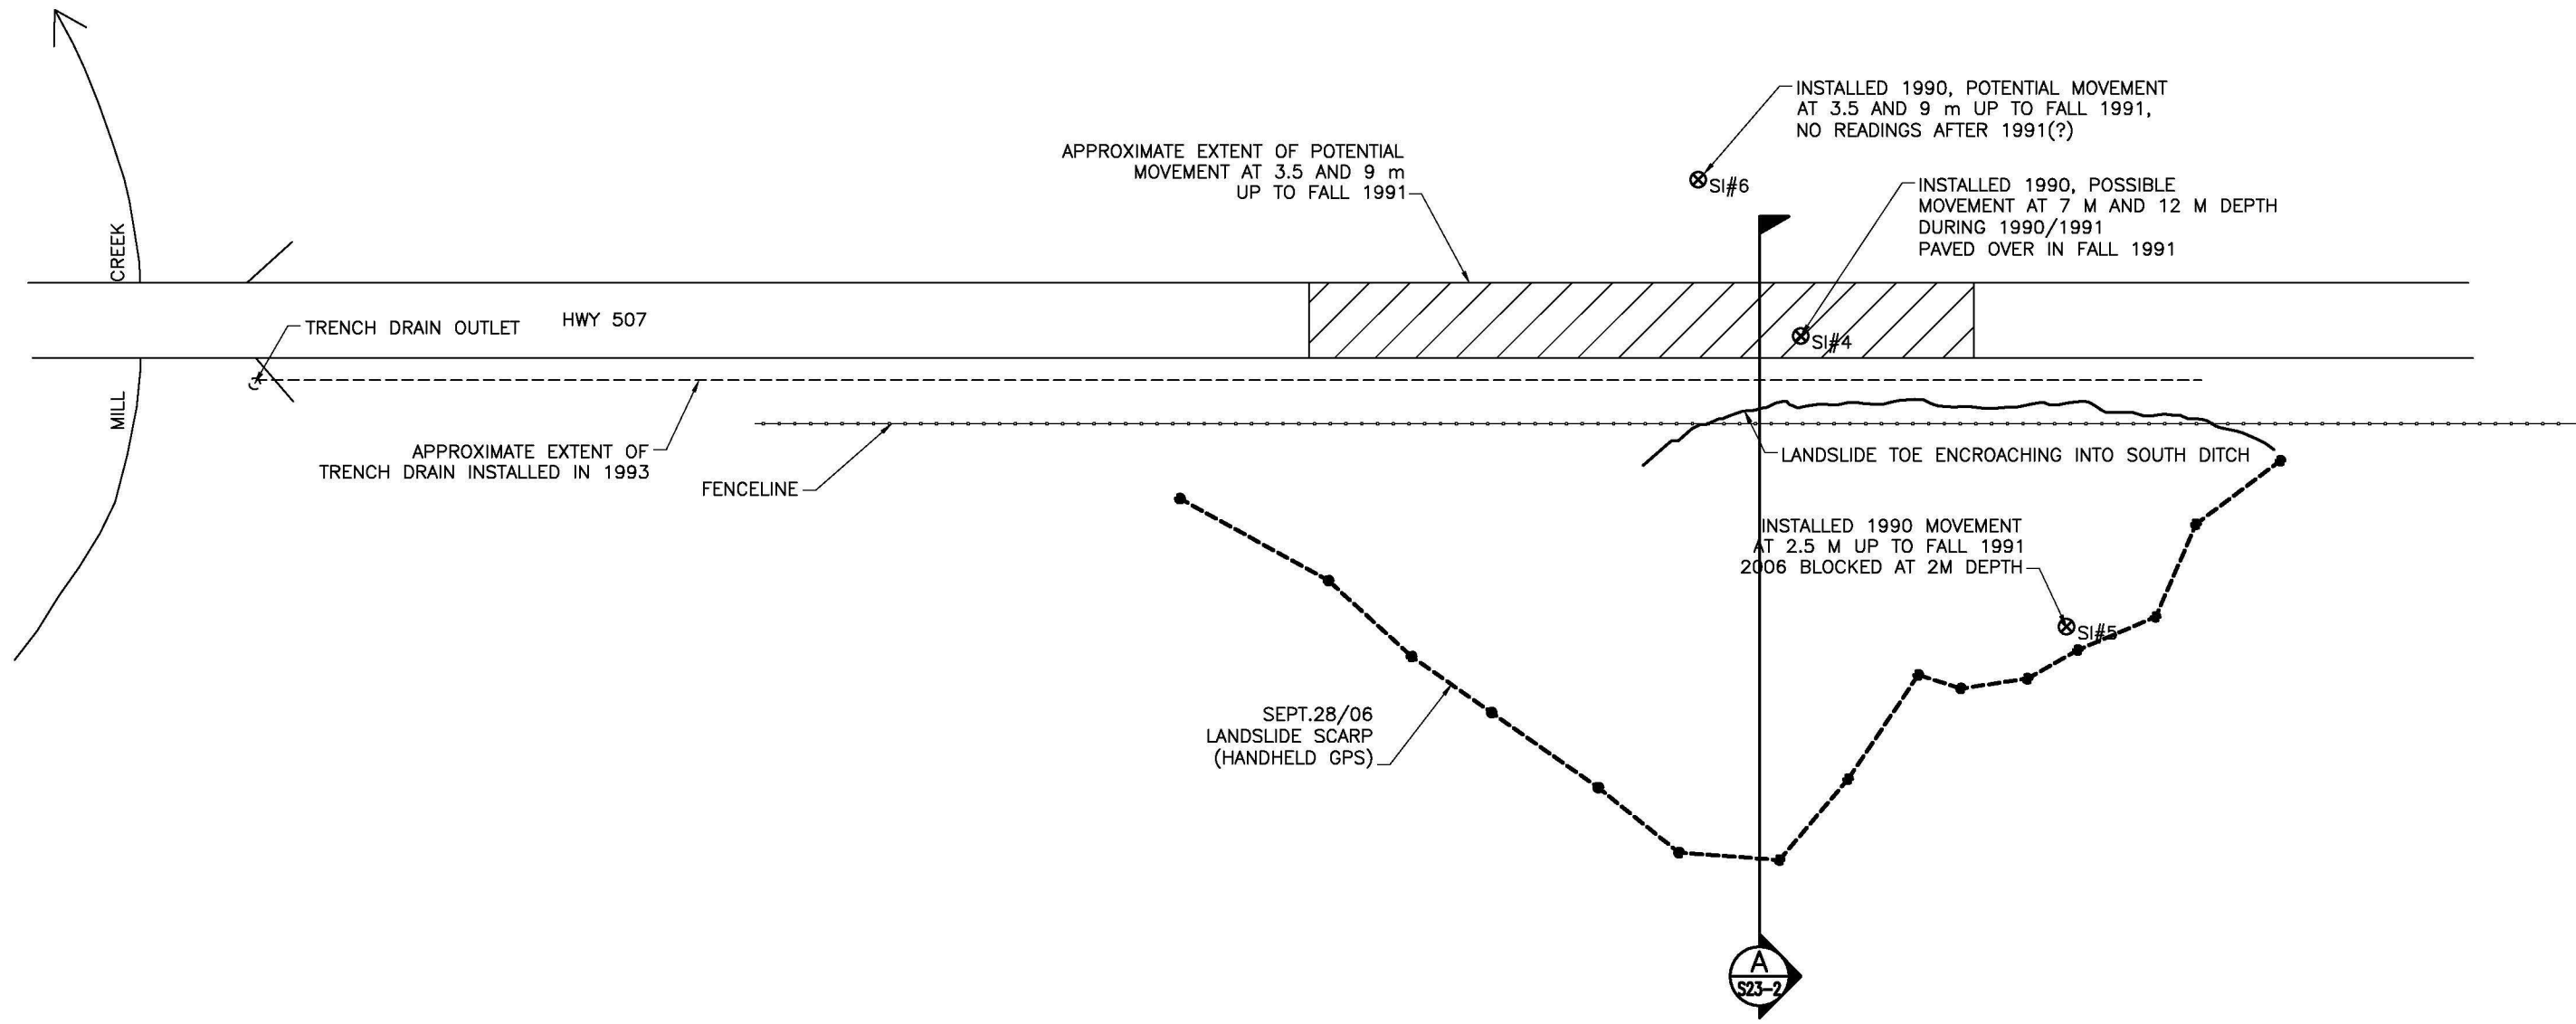
PROJECT: SOUTHERN REGION GEOHAZARD ASSESSMENT			
		TITLE: SITE S23 - SLIDE EAST OF MILL CREEK SITE PLAN			
CLIENT:		DATE: AUGUST 2008	JOB No.: CG25277.B	CAD FILE: 25277N01.dwg	FIGURE No.: S23-1
				REV. A

APPROXIMATE EXTENT OF TRENCH DRAIN INSTALLED IN 1993

LANDSLIDE TOE ENCRANCHING INTO SOUTH DITCH

SEPT. 28/06 LANDSLIDE SCARP (HANDHELD GPS)

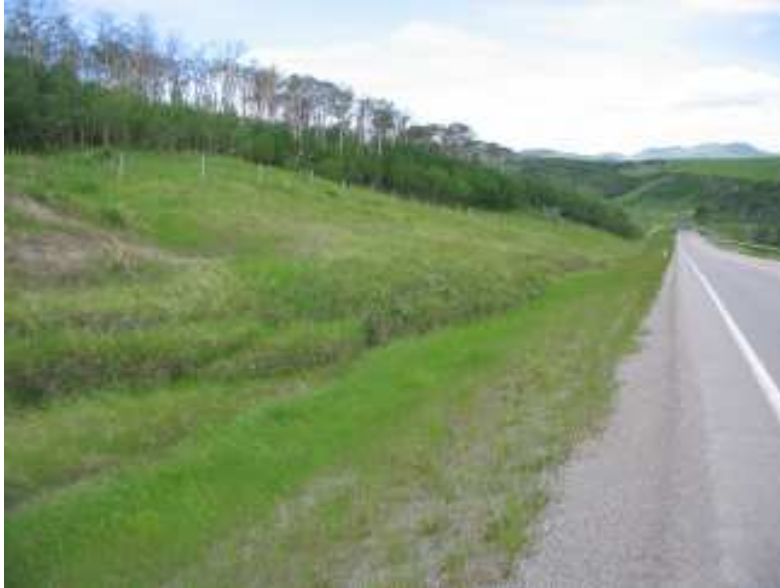
Photo S23-1 (top) – June 2008

- The toe lobe from the landslide above the highway appeared to have encroached very slightly more into the south ditch since the 2006 and 2007 inspections, however the fenceline crossing the toe area of the landslide was straight and did not appear to have been deformed by significant landslide movement in recent years. The ditch was still able to convey surface flow despite the encroachment. There were no signs of significant erosion in the ditch to constriction of its width by the landslide toe lobe. Photos S23-1 and S23-2 show views of the toe lobe in the south ditch.

Facing west along the south highway ditch. The toe lobe from the landslide upslope of the highway is visible encroaching into the ditch, however at the time of the inspection the ditch was still able to pass surface flow and there were no signs of significant erosion due to constriction of the ditch width.

If the landslide movement worsens and begins to block the south ditch, then one of the following options could be used to restore and maintain the ditch capacity:

- Excavate the landslide debris as necessary to clear the ditch. This will only work for the short term as it will promote additional landslide movement that will "re-fill" the ditch.

- Install a one of two layer gabion wall or another type of reinforced block wall system keyed into the ditch base in order to attempt to hold the landslide toe lobe above the ditch base. This may work for a reasonable period of time if the gabion wall is sufficient to support the localized portion of the landslide mass. However, the gabion wall may get pushed over or even flowed over by continued landslide movement.
- Installation of additional trench drains extending up into the landslide area to try to lower the groundwater levels in the landslide area and increase the resisting force against landslide movement.
- Trim the slope in the landslide area back to a lower angle, in conjunction with additional trench drains in order to try to stabilize the landsliding. This option would be extremely costly and disruptive without a very high assurance of success, and is not recommended.

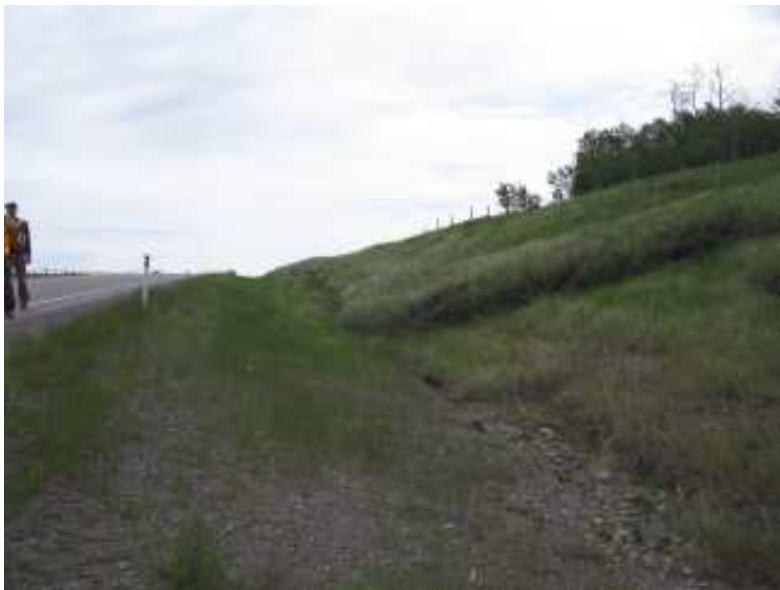
Photo S23-2 (bottom) – June 2008

Another view of the toe lobe encroaching into the south highway ditch, facing east. The toe lobe appeared to have possibly encroached further into the ditch since the 2007 inspection, however the fenceline across the toe lobe was straight and did not appear to have been disturbed or recently repaired after being deformed by ground movement.

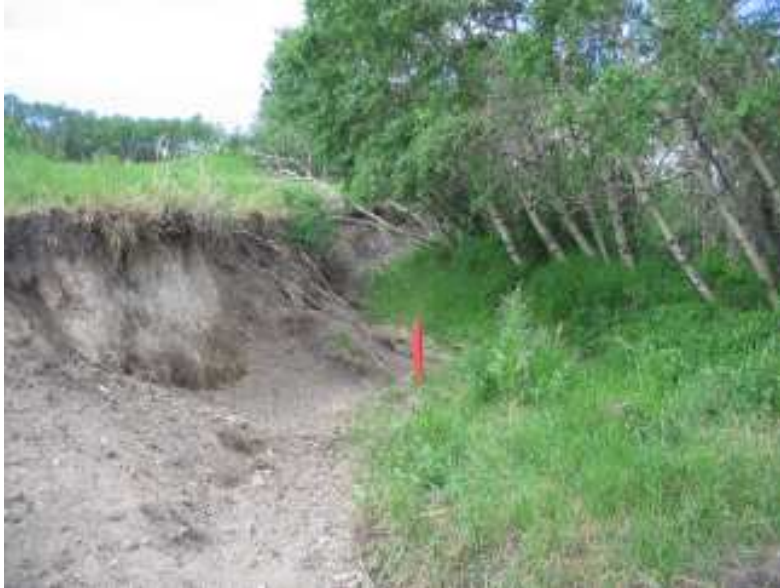
Photo S23-3 (top) – June 2008

- The eastern flank of the landsliding above the highway was traversed and it appeared that there had been some additional dropdown and lateral movement of the landslide body relative to the headscarp since the 2006 inspection, however the headscarp did not appear to have retrogressed any further upslope. Photo S23-3 shows the headscarp area as it appeared during the June 2008 inspection.

Typical view of the landslide headscarp above the highway and in the east end of the landslide area, as it appeared in June 2008. It appeared that there had been additional downdrop of the landslide mass since this area was last viewed in the fall of 2006, however without significant upslope retrogression of the headscarp.
