## **SECTION B – SITE VISIT AND ASSESSMENT**

### **2007 SITE INSPECTION**

PROJECT: SOUTHERN REGION GEOHAZARD ASSESSMENT

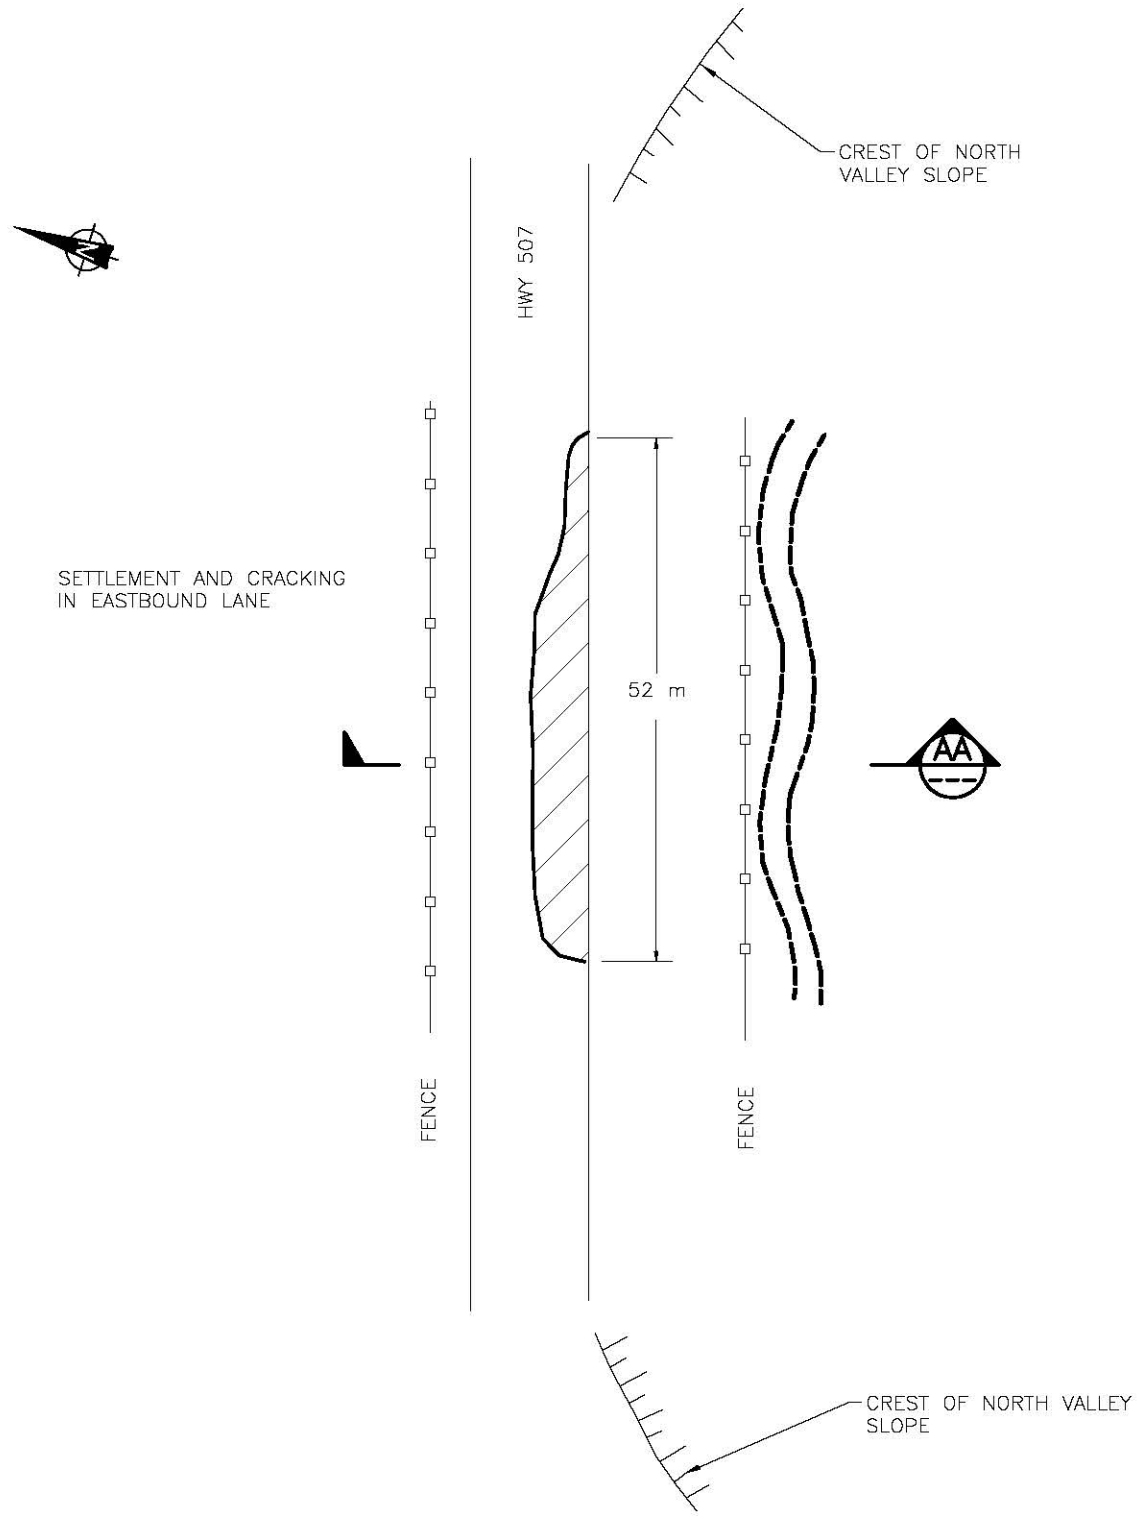
The highway is located approximately 500 m north of the channel of Pincher Creek and along the crest of the north Pincher Creek valley slope. This valley is a broad, relatively flat-bottomed valley incised approximately 30 m into a flat upland plain to the west of the town of Pincher Creek, AB. The local segment of the highway is straight along an east/northeast bearing of 074/254 and is approximately tangent to the curving crest of the north valley slope as shown on the plan view of the site, attached as Figure S24-2 in Appendix S24.

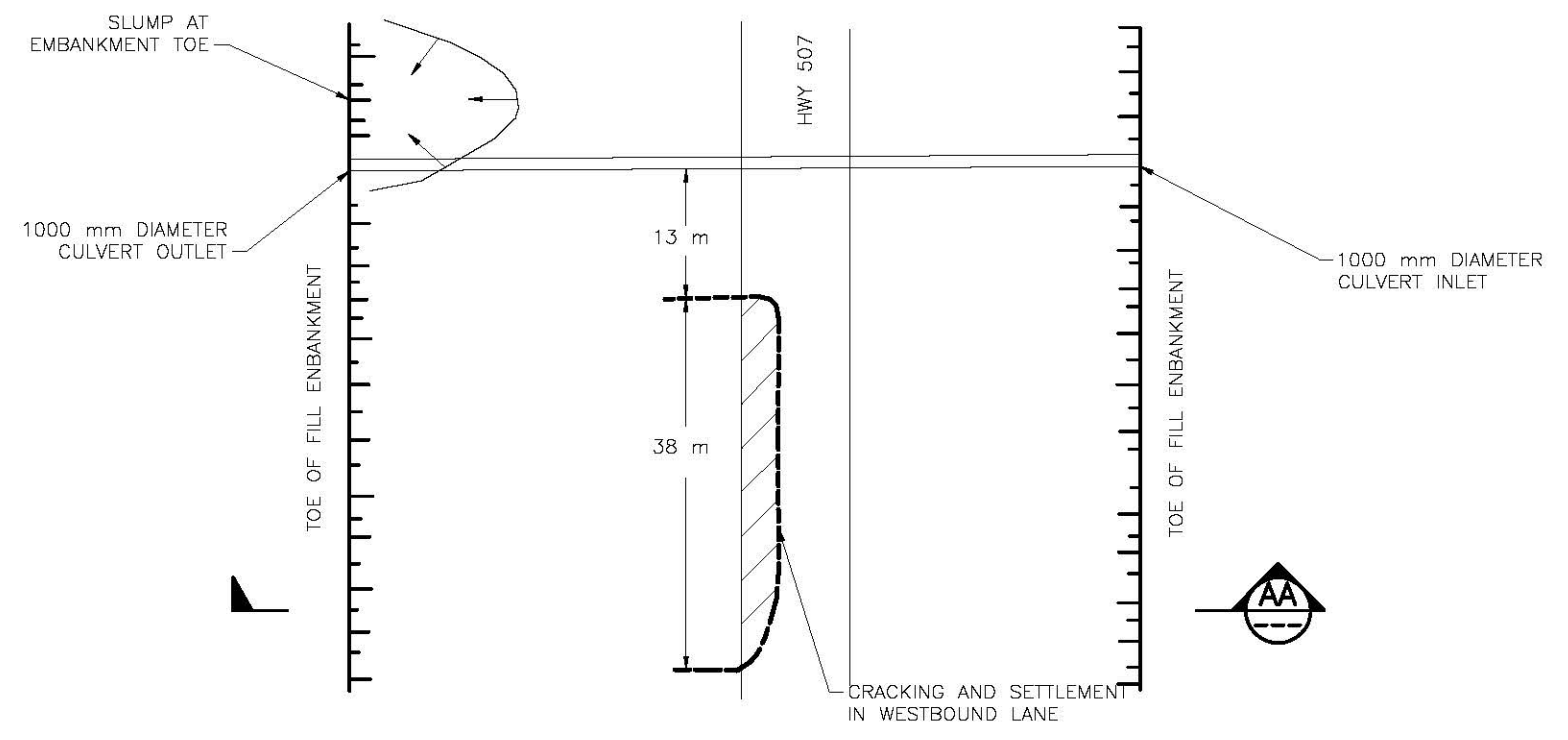
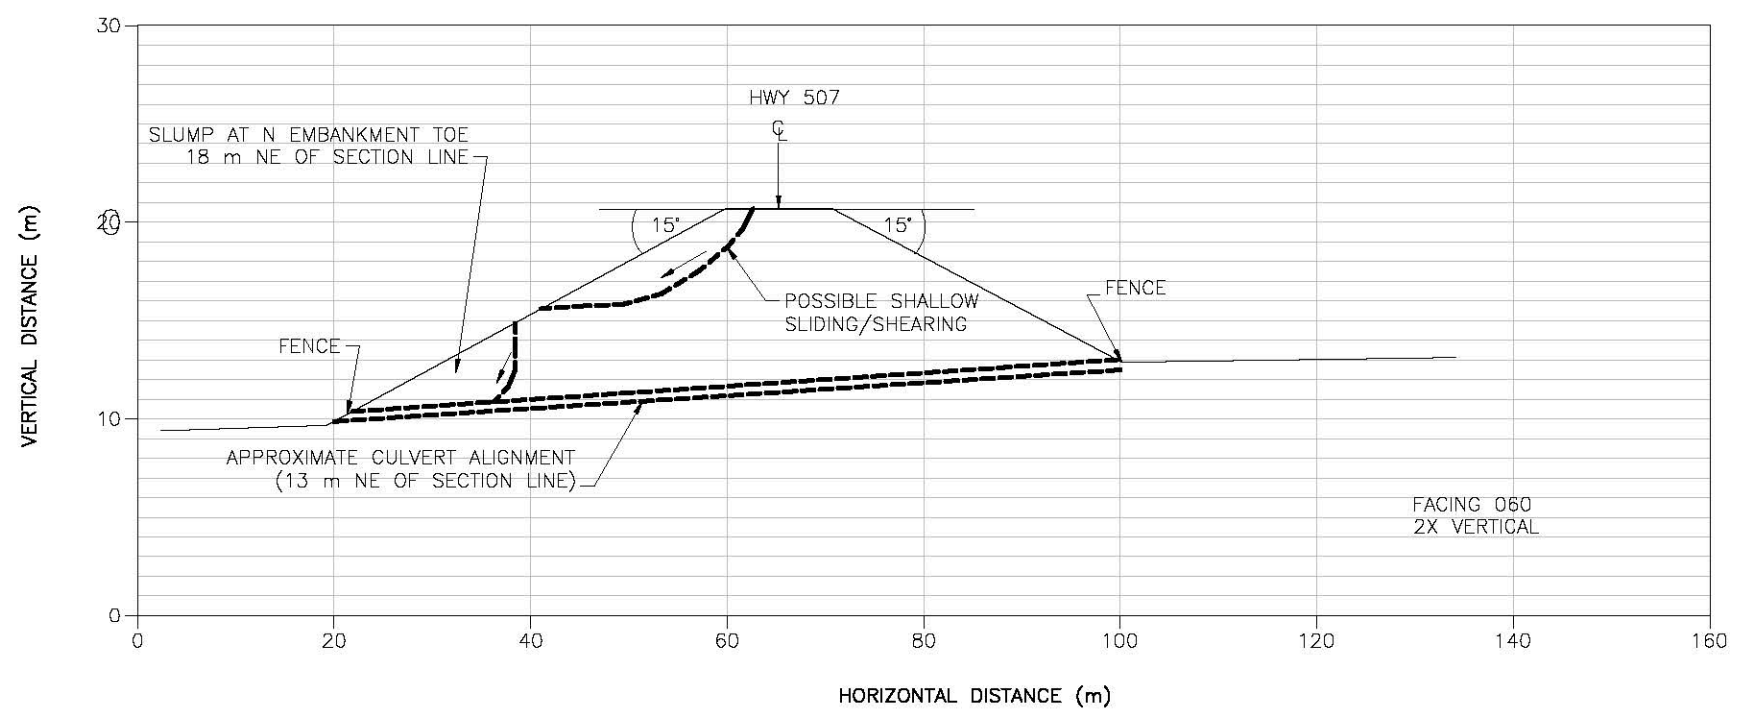
- The northeast limit of the damaged segment of the highway was approximately 13 m southwest of the culvert alignment, as illustrated on Figure S24-4.
- At the time of the September 2006 inspection, the aperture of the open cracks in the road surface was up to approximately 25 mm and the vertical settlement at the cracks was typically around 50 to 75 mm.

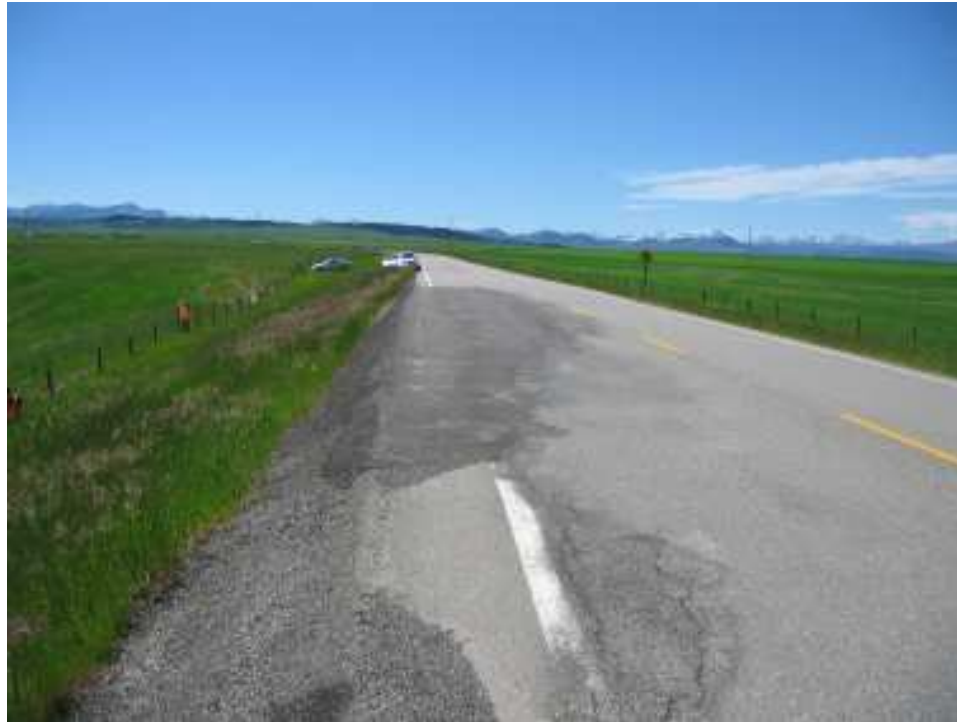
**Photo S24-1– Eastbound Lane Site – June 2007**

The cracking and settlement area on the road surface had been repaved in the spring/early summer of 2007 and the cracking had not re-formed as of the time of the site inspection. Therefore, it was not possible to make any detailed observations of the pattern and magnitude of damage to the road surface. Photos S24-1 to S24-4 in Appendix S24 show comparative views of the site from the September 2006 and June 2007 inspections.

Facing west across the recently repaved settlement and cracking area at the Eastbound Lane site. The north slope of the Pincher Creek valley is to the left of this photo. Compare with Photo S24-2 which shows the damage in this area as it appeared in September 2006 before the recent paving.

AMEC recommends that any future cracking and settlement of the road surface be treated as a maintenance issue with regrading and patching of the road surface as necessary. The weight of additional patches to the road surface are not likely to further destabilize the fill embankment. It is possible that after further settlement the fill embankment will eventually stabilize but this is not certain.

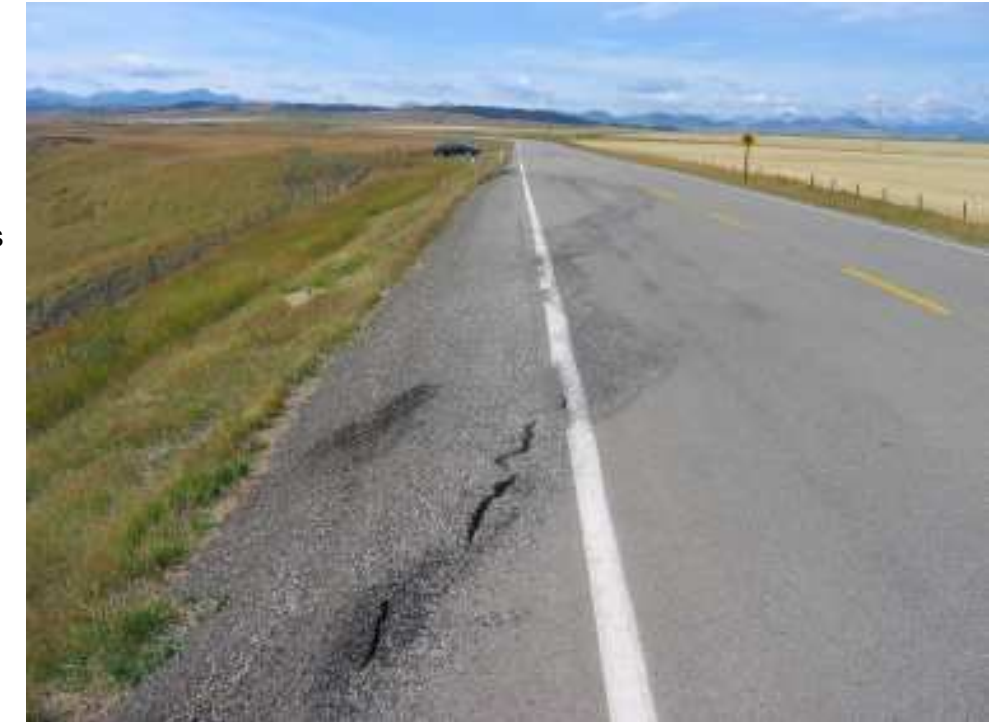
**Photo S24-2– Eastbound Lane Site –**

- Based on the location of the damage as well as the semi-circular pattern of the boundary of the cracking and settlement as seen during the September 2006 site inspection, it appears that the damage to the road surface at this site has been due to settlement of and/or shallow sliding/shearing in the embankment fill.

- The lack of a toe bulge or other signs of deformation in the fill embankment downslope of the damaged area on the road surface suggests that the settlement of the road surface is due to insufficiently compacted and/or compressible fill material underlying the road. Any such settlement would be expected to continue to something in the order of 5 to 10 years after construction and attenuate thereafter. The construction date for this segment of the highway is not known.

Same area as shown in Photo S24-1, with visible damage to the road surface

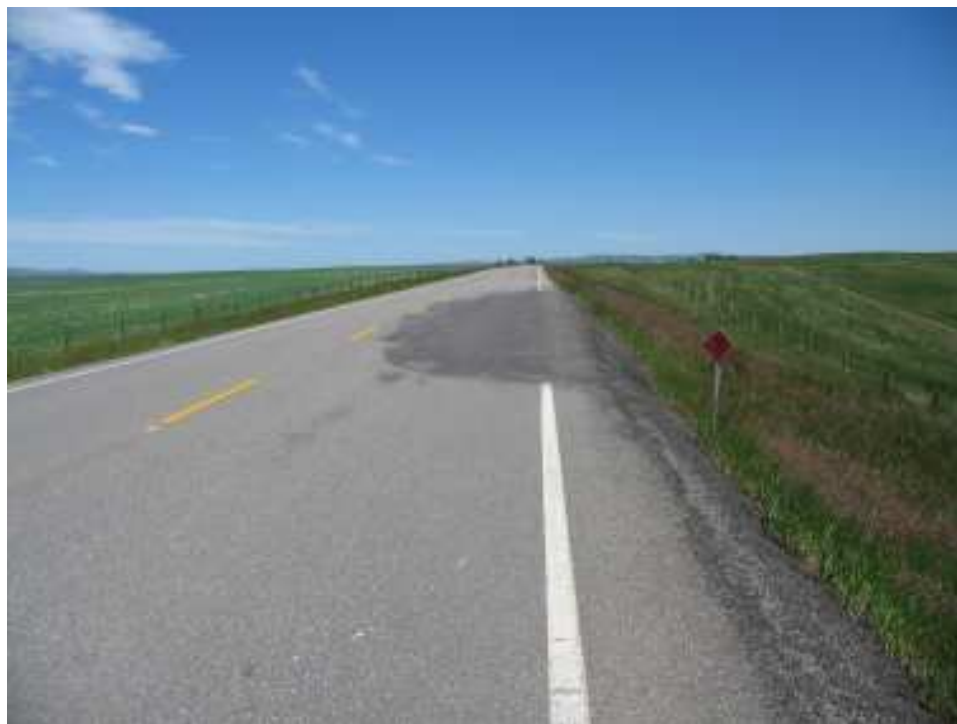
**Photo S24-3– Eastbound Lane Site –**

Facing east across the recently repaved settlement and cracking area at the Eastbound Lane site. The north slope of the Pincher Creek valley is to the right of this photo. Compare with Photo S24-4 which shows the damage in this area as it appeared in September 2006 before the recent paving.

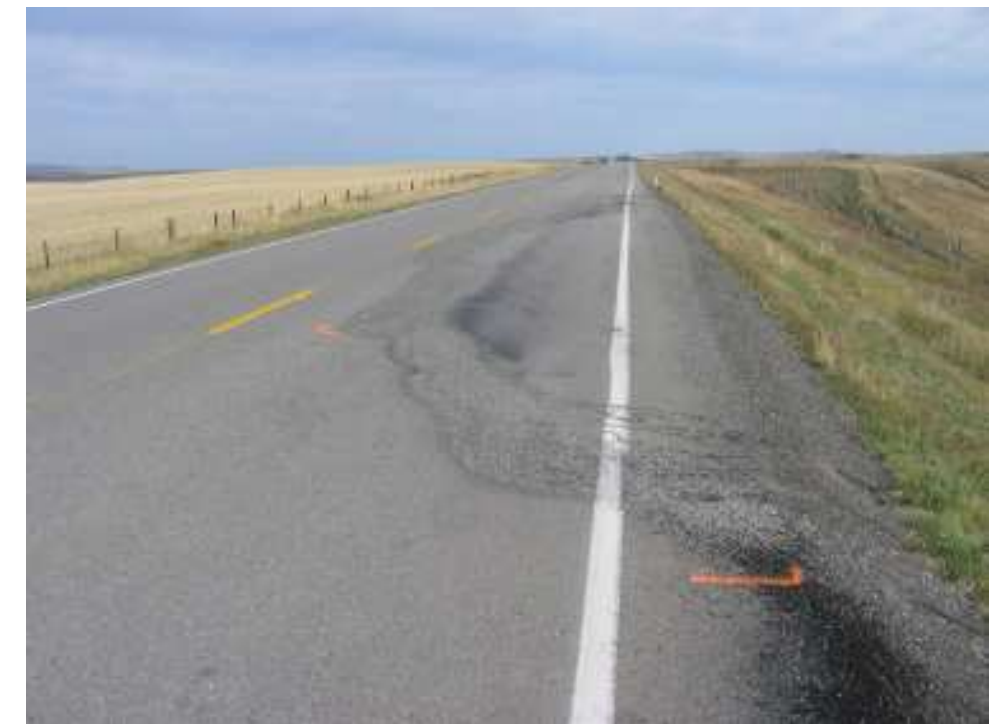
**Photo S24-4 – Eastbound Lane Site –**

Same area as shown in Photo S24-3, with visible damage to the road surface. The damaged segment of the highway appears to be limited to the area where the road was built atop a 3 to 4 m high fill embankment on the upper portion of the north valley slope.

It may be possible to make a longer-term repair of the cracking and settlement by using launched soil nails to strengthen the fill embankment and reduce the potential for future settlement and shallow slope movement in the embankment. Another option would be to remove the existing fill embankment along the damaged segment of the highway and reconstruct it with engineered and compacted backfill (possibly including geogrid reinforcement) that will not experience significant post-construction settlement. If AIT wishes to investigate either of these options, it is recommended that a series of probe holes be drilled at the site to confirm the composition and condition of the backfill and the underlying native soil. The information from these boreholes can be used to confirm or revise the assessment that the damage to the highway is due to settlement and deformation within the fill embankment and provide a basis to proceed with either of these repair options.

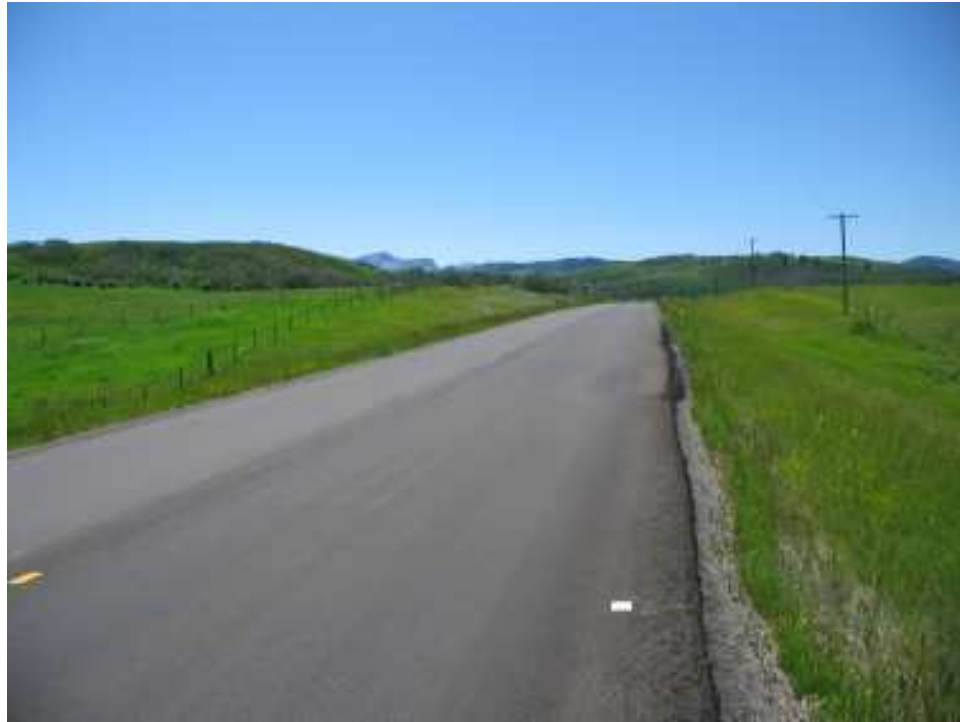
As for the Eastbound Lane site, the cracking and settlement area on the road surface at the Westbound Lane site had been repaved in the spring/early summer of 2007 and the cracking had not re-formed as of the time of the June 2007 site inspection. Therefore, it was not possible to make any detailed observations of the pattern and magnitude of damage to the road surface. Photos S24-5 to S24-8 in Appendix S24 show comparative views of the site from the September 2006 and June 2007 inspections.

**Photo S24-5 – Westbound Lane Site –September 2006**  
(upper left)  
Facing southwest across the recently repaved settlement and cracking area in the westbound lane. Compare with Photo S24-6 which shows the damage to this area as it appeared in September 2006 before the recent paving.

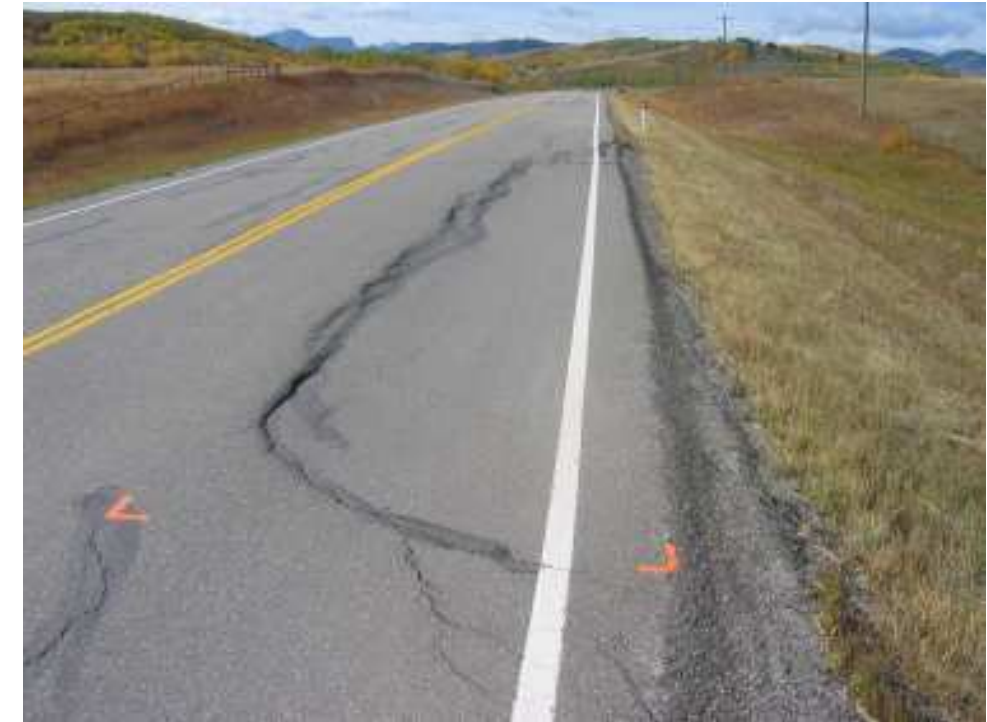
- The pattern of the settlement and cracking of the westbound lane could indicate a rotational slump failure in the northwest embankment slope. It is possible that the damage to the road is due to settlement of and/or shallow sliding in the embankment fill.
- The apparent deformation of the culvert at the base of the embankment raises the possibility that internal erosion of the embankment is occurring via a break in the culvert. This could have led to the development of voids within the embankment possibly resulted in settlement of the overlying road surface. This scenario is not considered to be the likely cause of the damage to the road surface because settlement due to internal embankment erosion near the culvert would likely occur directly above or close to the culvert location, whereas at this site the boundary of the visible cracking in the

**Photo S24-6 – Westbound Lane Site –September 2006**  
(upper right)  
Facing southwest across the settlement and cracking area in the westbound lane with visible damage as it appeared in September 2006.

AMEC recommends that any future cracking and settlement of the road surface be treated as a maintenance issue with regrading and patching of the road surface as necessary. In parallel to this, AMEC recommends the following path forward to clarify the Risk Level at this site and determine the best option for repairing the settlement and cracking of the road surface if required.

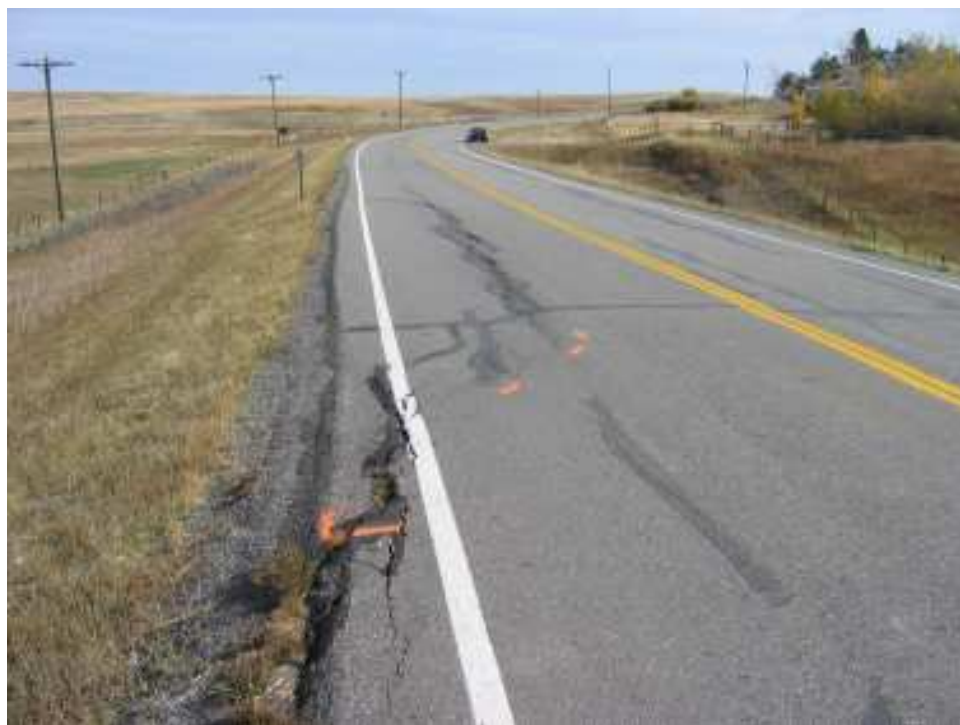
**Photo S24-7 – Westbound Lane Site –September 2006**  
(lower left)  
Facing northeast across the settlement and cracking area in the westbound lane, as it appeared in September 2006. The semi-circular pattern of the cracking is consistent with a rotational slump failure in the northwest embankment slope (left side of photo), however a corresponding toe bulge below the road was not observed. The linear cracks in the eastbound lane (right hand side of photo) are judged to be unrelated to the circular cracking pattern in the westbound lane.

1. Drill a series of boreholes in the road within the settlement and cracking area as well as adjacent areas including around the culvert. These boreholes can be used to determine the composition and condition of the fill material both within and adjacent to the damaged area as well as to check for voids within the embankment. This information will help to confirm the cause of the damage to the road surface and provide a basis to select and design repair measures.

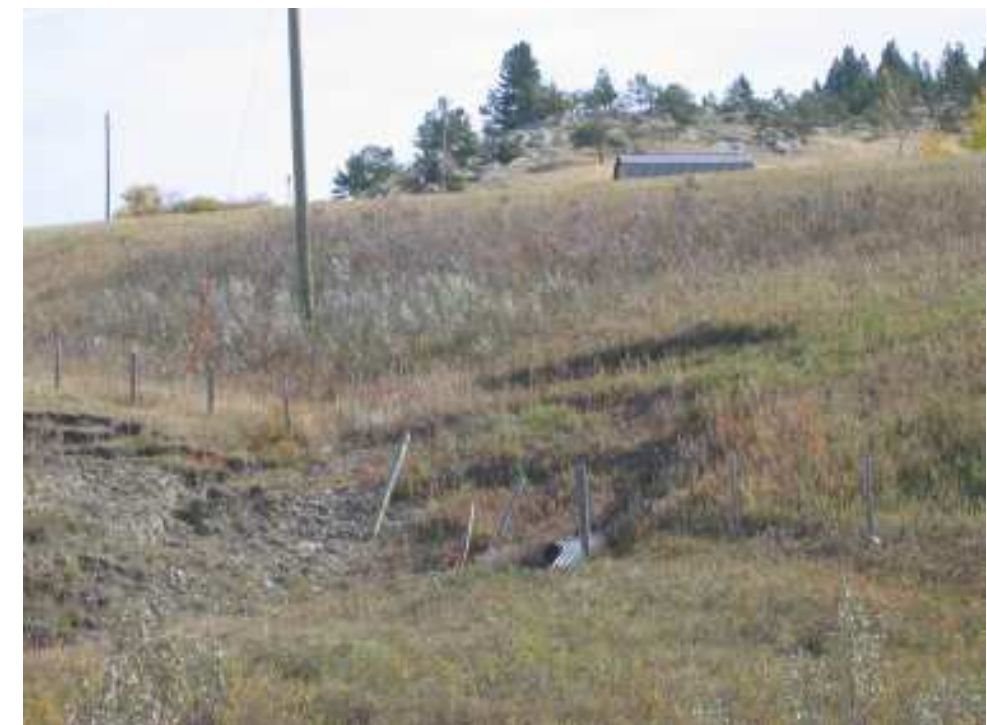
- There was no visible deformation or bulging of the northwest embankment slope below the damaged segment of the westbound lane.
- There was a slump failure at the toe of the northwest embankment slope around the culvert outlet. Photo S24-8 in Appendix S24 shows the slump failure and its position relative to the culvert outlet. The headscarp of the slump is approximately 5 m above the toe of the embankment slope. Aside from this slump, the embankment slopes appeared to be stable and there were no visible areas of seepage discharge at the time of the inspection.

The appearance of the west embankment slope and the slump around the culvert outlet at the toe of the west embankment slope had not changed significantly since the September 2006 site inspection.

**Photo S24-8 – Westbound Lane Site –September 2006**  
(lower right)  
Slump failure along the toe of the northwest embankment slope, near the culvert outlet.

If significant voids due to internal embankment erosion are encountered in the boreholes, then the existing culvert should be repaired/replaced and the eroded portion of the embankment reconstructed.
