1.0 Site Visit

CASTLE RIVER

B.F. 31131
(SW27-6-2-WS)

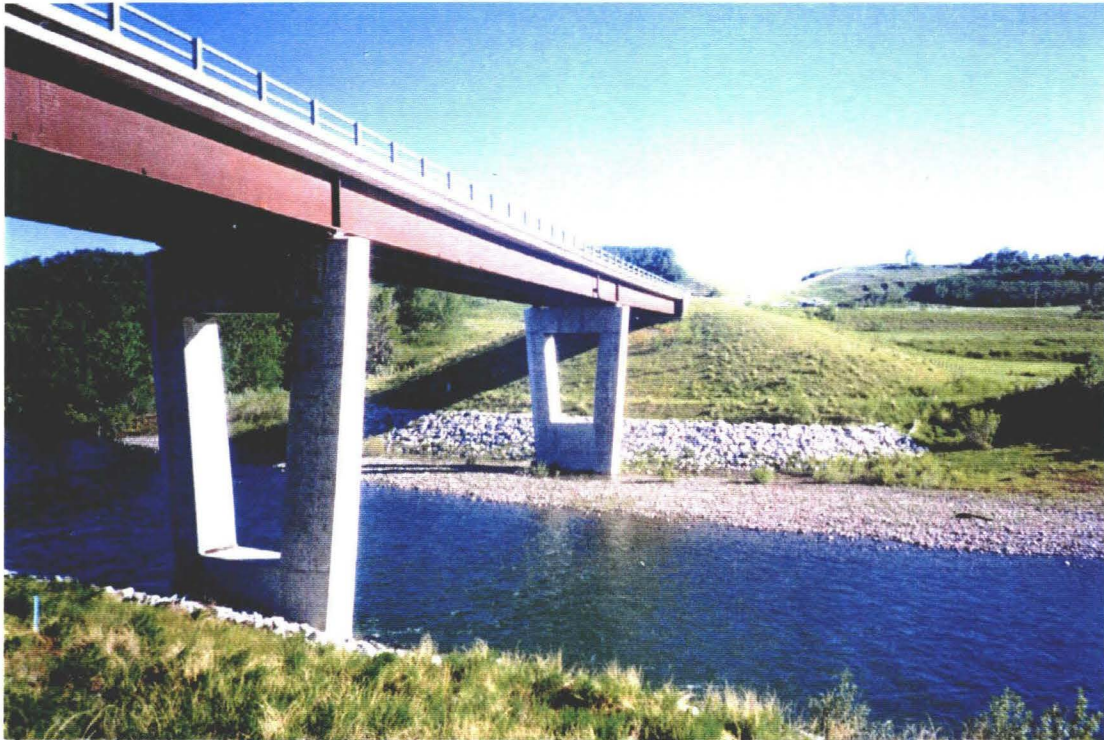
- No indications of instability were observed on any of the abutment slopes. Refer to Photos 1 and 2.
- Erosion protection measures appeared to be installed well and are performing effectively on the west side of the south abutment fill. Refer to Photo 3.

Photo 1 – Looking North at north abutment.

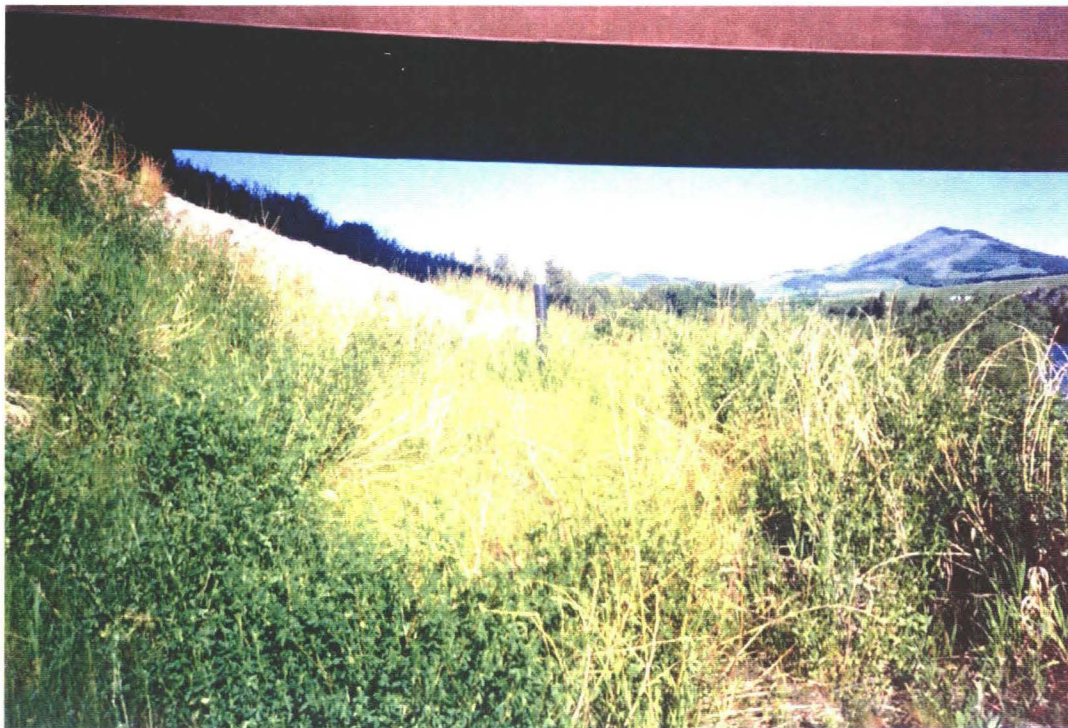
Photo 2 – Looking west at south abutment fill slope.

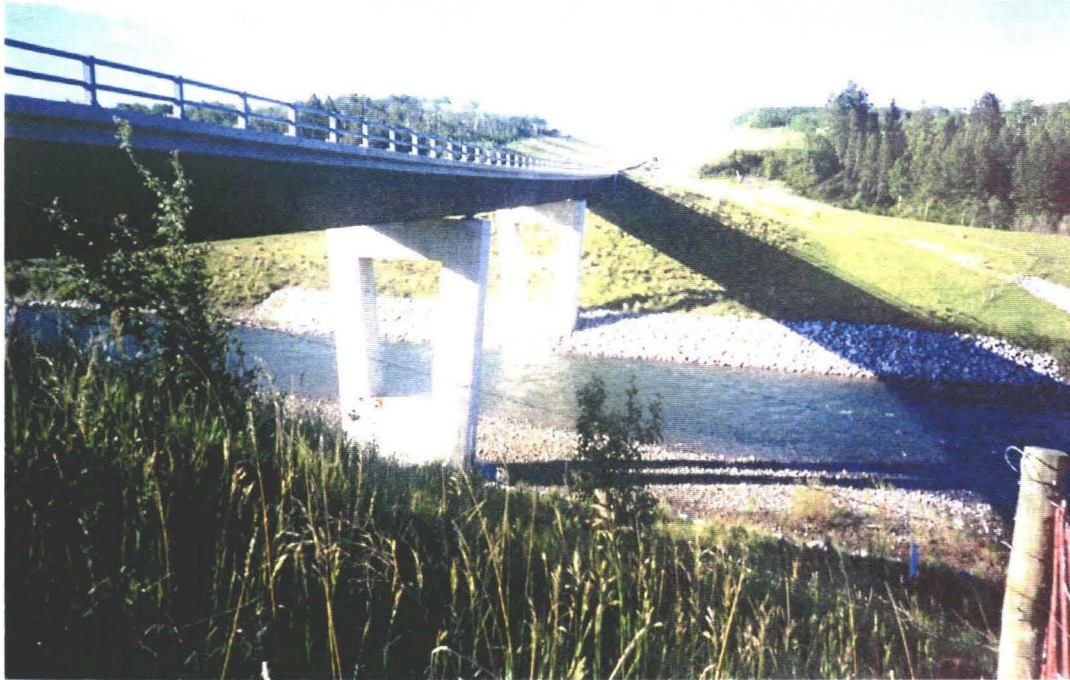
Photo 3 – Looking south at south abutment. Note erosion protection works in west ditch of the abutment fill.
