**SOUTHERN REGION GEOHAZARD ASSESSMENT
ANNUAL ASSESSMENT REPORT
2007**

November 2007

4.18 S21 – HIGHWAY 541 – HIGHWOOD BASE ROAD CREEK

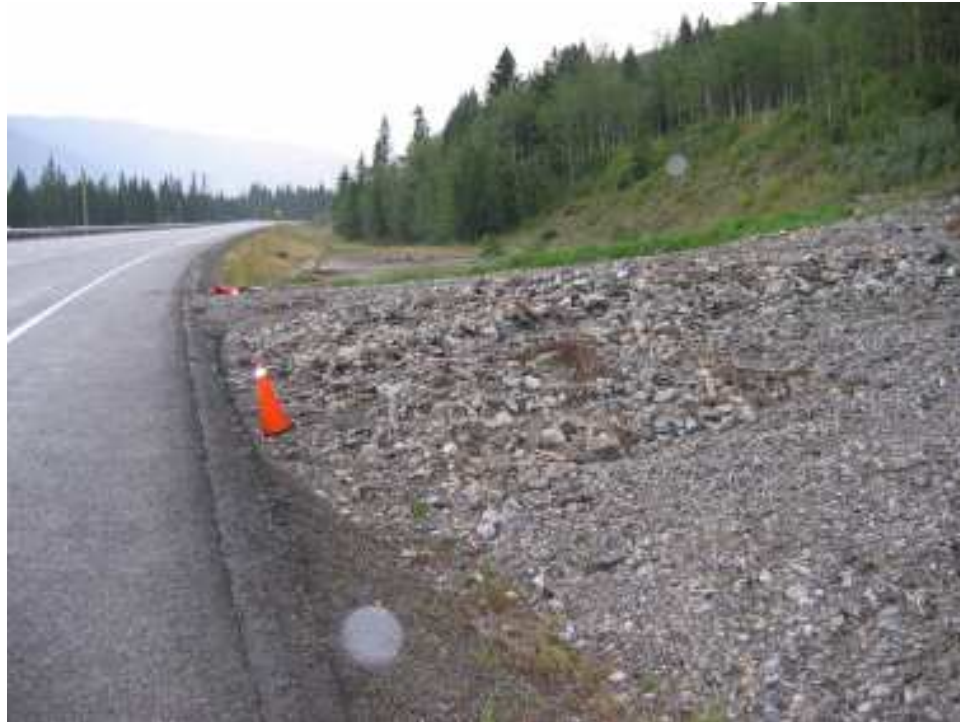
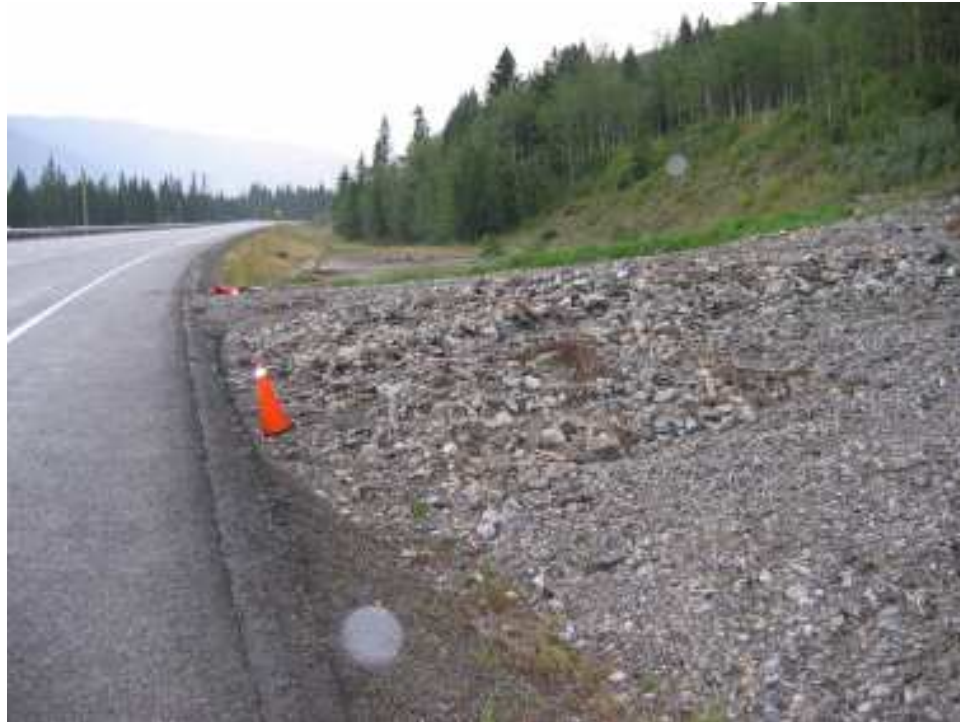
This site was initially inspected by AMEC in August 2004 when a significant accumulation of debris was noted along the north side of the highway (Photo S21-1 in Appendix S21). It appeared that this debris had overtopped the ditch at some time earlier in 2004 and flowed onto the westbound lane of the highway before being cleared by the maintenance contractor.

Photo S21-1 – August 2004 (upper left)
Facing west across debris filling the north ditch and burying the culvert inlet. It appears that the debris had previously buried the culvert inlet and also extended onto the westbound lane of the highway before being cleared by the maintenance contractor.

1. Further excavation of the accumulated debris along the creek channel upstream of the culvert inlet in order to increase the available volume of debris storage upstream of the culvert during future debris flow events. This will provide additional “buffer” capacity before future debris accumulations encroach onto the highway and therefore reduce the Consequence Factor for this site. This will also help to reduce the chance of future channel shifting away from the existing culvert due to a build-up of debris along the existing channel. The excavated debris could possibly be hauled away and dumped in the cleared area along the north side of the highway approximately 100 m westbound from the creek channel. One to two days of work by a track-mounted excavator and two trucks would likely be sufficient to complete this work.

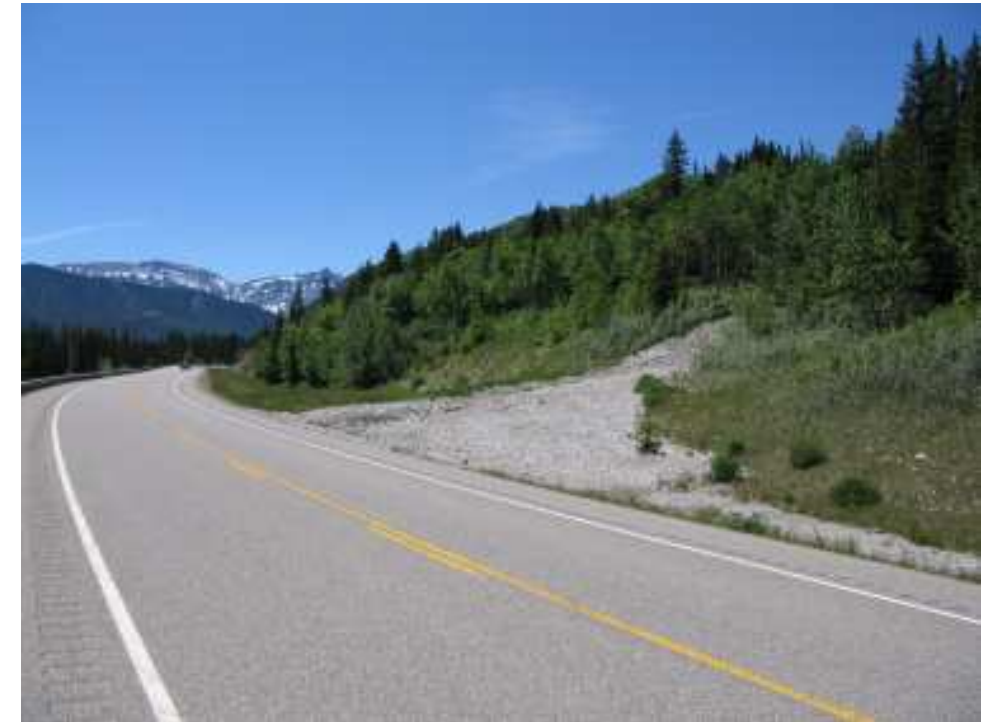
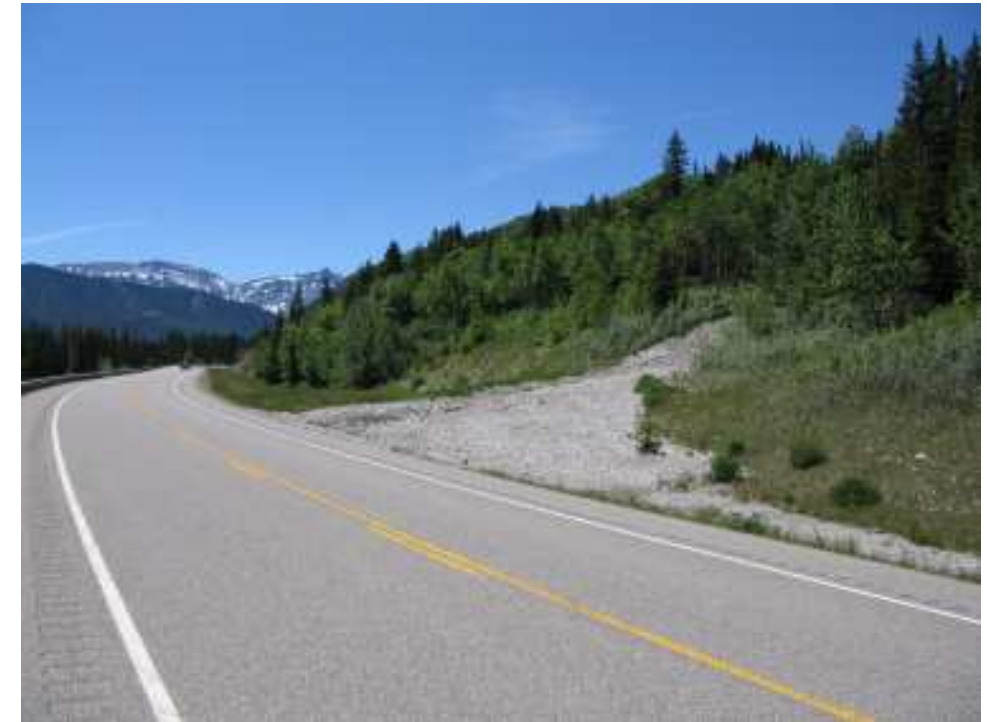
- The overall appearance of the site and the debris along the creek channel had not changed significantly since the 2005 inspections.
- The culvert was still blocked with roughly the same amount of debris as noted in the 2005 inspections. However, it appeared that the normal creek flows could percolate through the debris in the culvert without water impounding along the north side of the highway.

Photo S21-2 – June 2007 (upper left)
Facing westbound along the highway with the 2004 debris flow deposit visible on the upslope side of the road.

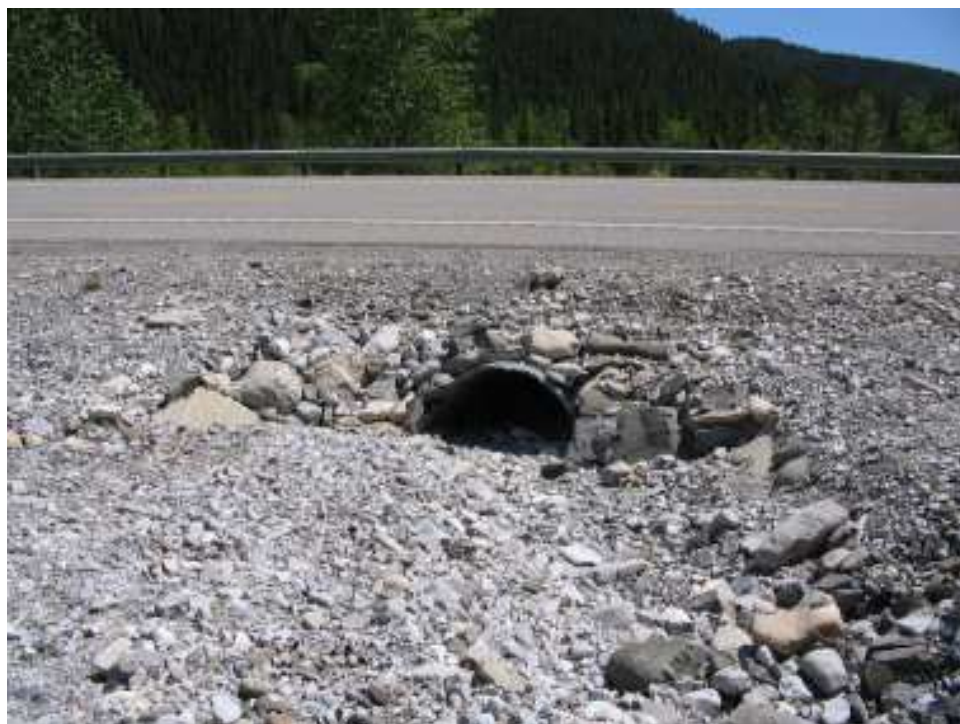
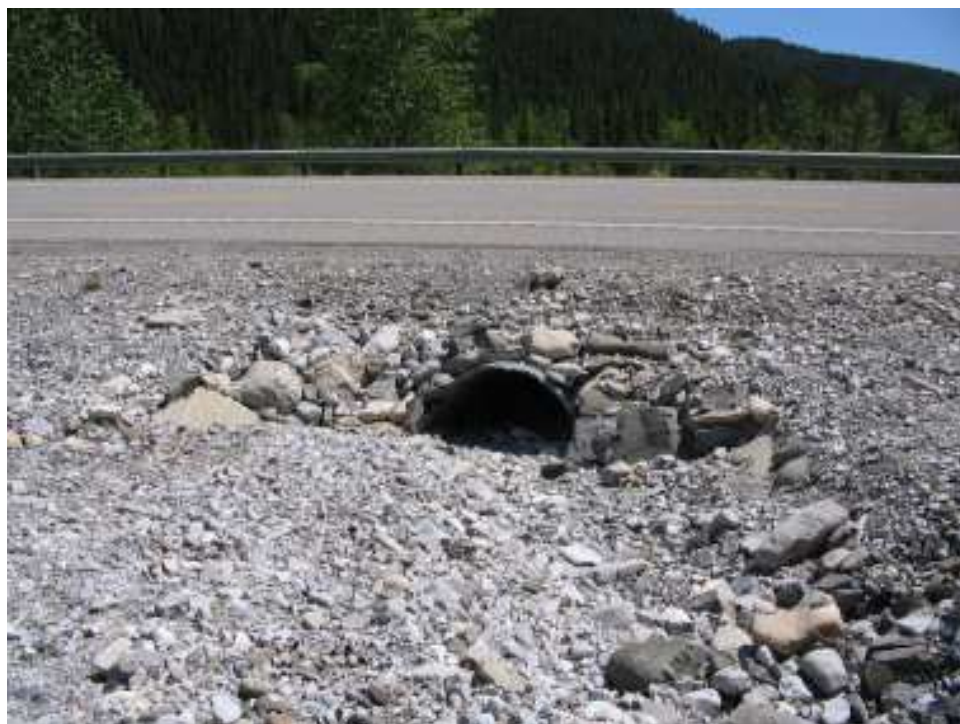
Photo S21-3 – June 2007 (upper right)
Facing downstream towards the inlet of the 1250 mm diameter culvert below the highway. The culvert inlet is in roughly the same condition as noted in the August 2005 inspection and is approximately 2/3 full of debris.

2. The debris within the culvert itself should also be cleaned out in order to restore the culvert’s flow capacity. It may be more practical to install a second culvert adjacent to the existing culvert in order to increase the drainage capacity at the creek channel.

The previous recommendation to install a “trash rack” grate across or slightly upstream of the inlet of the existing culvert (as well as the second culvert, if installed) in order to reduce the amount of debris that enters the culvert in the future could still be considered. However, the debris excavation recommended in point 1 above is likely a more practical way to manage the risk of debris flow deposition onto the highway.

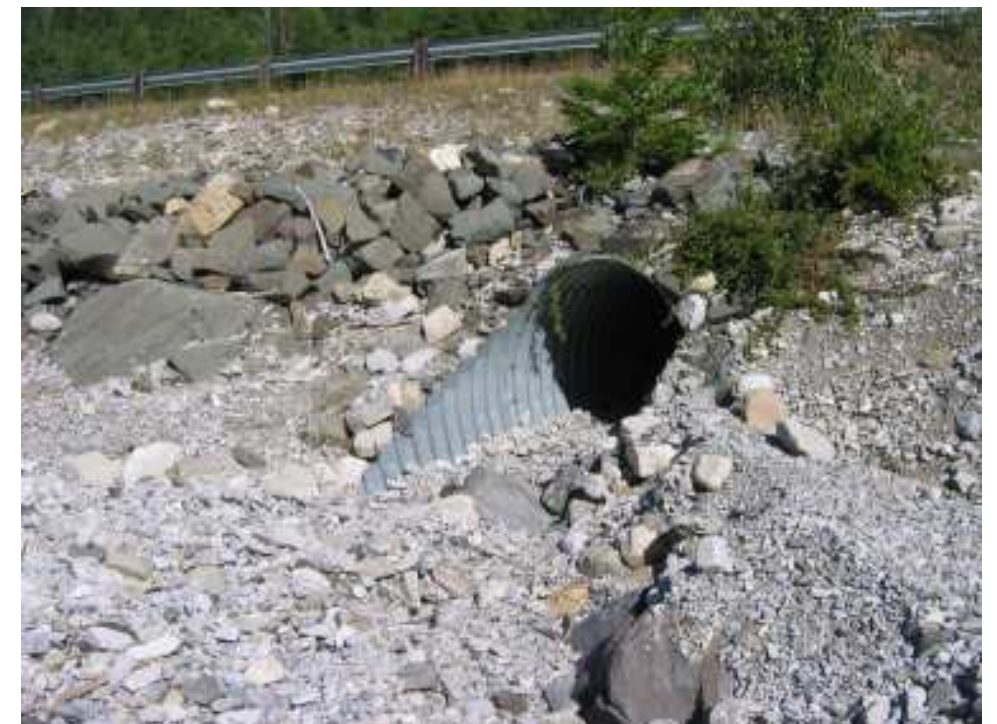
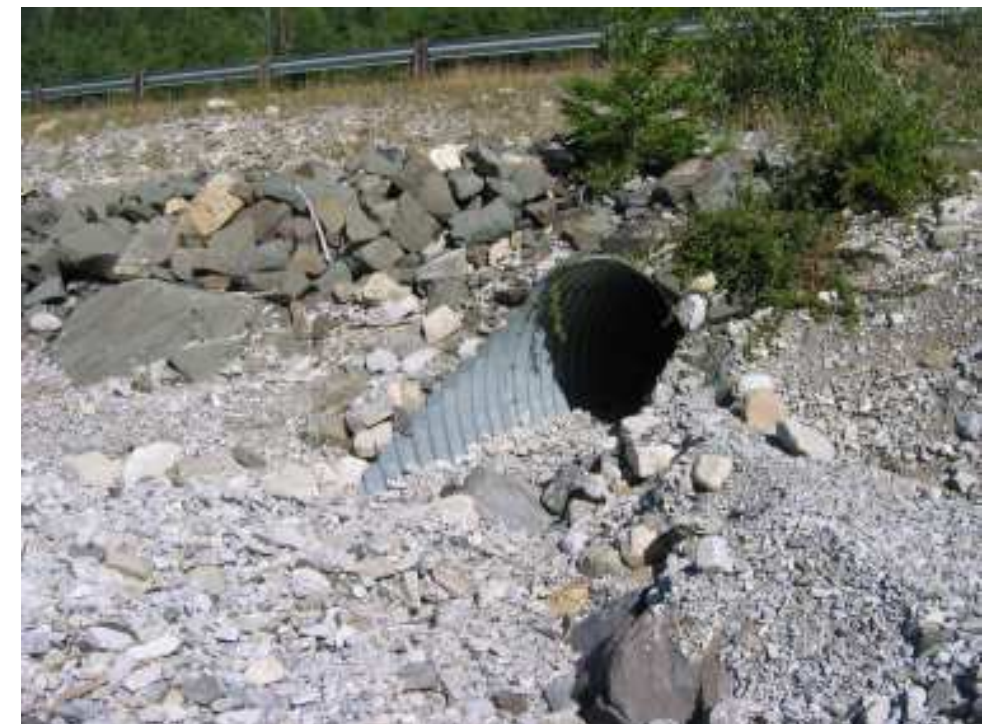
Photo S21-4 – August 2005 (lower left)
This photo from the August 2005 site inspection shows the outlet of the culvert approximately 1/4 full of debris. The culvert outlet was in essentially the same condition at the time of the June 2007 inspection.
