CG25277.B

**Re: Southern Region Geohazard Assessment Program
Site S21 – Highwood Base Road Creek, Highway 541:02
2008 Annual Inspection Report**

This letter documents the 2008 annual site inspection of Site S21 – Highwood Base Road Creek, on Highway 541:02 approximately 3 km east of the junction between Highways 40, 541 and 940 at Highwood House.

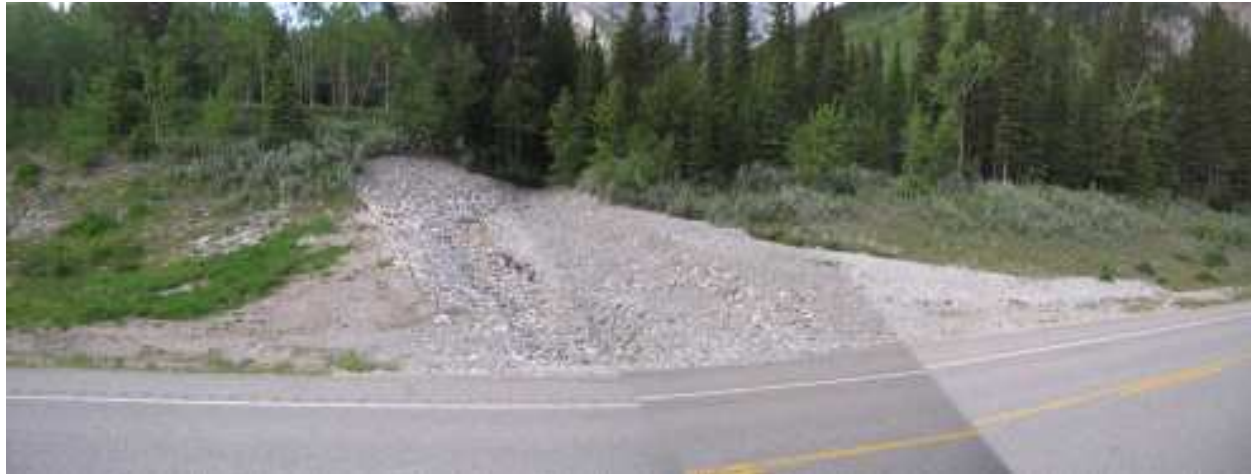
Photo S21-1 (top) – June 2008

- Portions of the accumulated debris along the channel between the highway and treeline as well as within the culvert itself had been excavated and removed at some time since the June 2007 site inspection, presumably by AT's maintenance contractor. Photos S21-1 and S21-2 show views of the debris around and upstream of the culvert inlet as it appeared in June 2008. Photo S21-3 shows the debris accumulation as it appeared during the previous site inspection in June 2007.
- A geotextile liner underlying the debris along the flow channel just upstream of the culvert inlet was partially exposed at the time of the June 2008 site inspection (Photo S21-5).
- The culvert pipe was roughly 1/6 full of debris at the time of the 2008 inspection, compared to roughly 2/3 full as noted during the 2005 to 2007 inspections.

Facing upstream along the creek channel from the highway. Note the well-defined debris fan extending out from the treeline, with the creek channel incised into it.

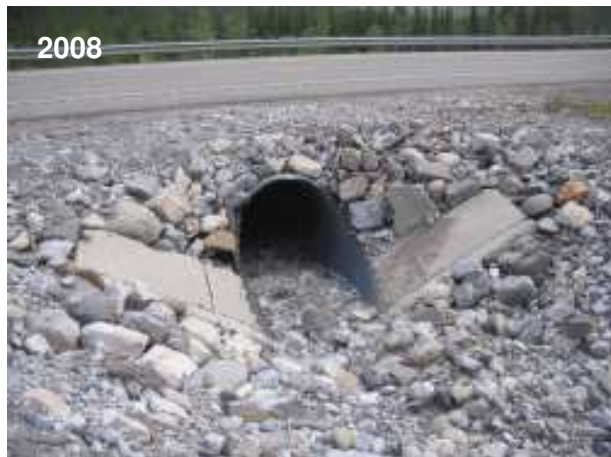
Photo S21-2 (middle) – June 2008

The removal of some of the debris around and upstream of the culvert inlet as well as within the culvert pipe itself has provided some additional "buffer" capacity before future debris accumulations fill and block the culvert. This has reduced the Consequence Factor and therefore the recommended Risk Level for this site (see below).

Facing downstream towards the culvert inlet. The debris around the culvert inlet and within the culvert has been cleaned out since the June 2007 site inspection (compare with Photo S21-3), however the culvert was approximately 1/6 full of debris in June 2008. It is not known if the culvert was cleaned out completely after the June 2007 inspection and the current debris has accumulated since that time, or if a portion of the debris in visible in Photo S21-3 from June 2007 was left behind after the clean-out.

- AT's maintenance contractor should continue to remove debris as necessary to maintain the volume of debris within the culvert pipe and along the channel upstream of the culvert similar to or less than the amount seen during the June 2008 inspection.

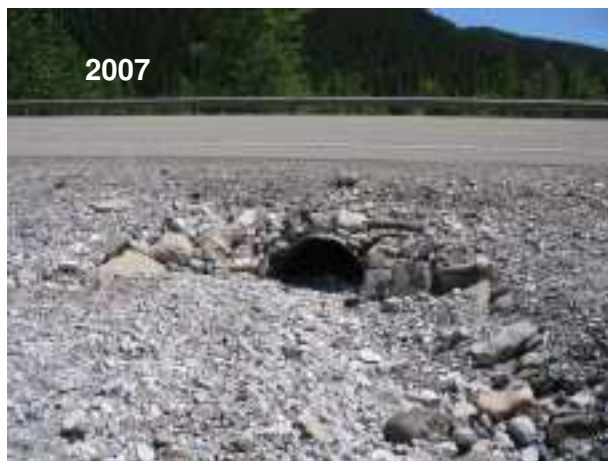
Photo S21-3 (bottom) – June 2007

Debris accumulation around the culvert inlet and within the culvert as seen during the June 2007 site inspection.

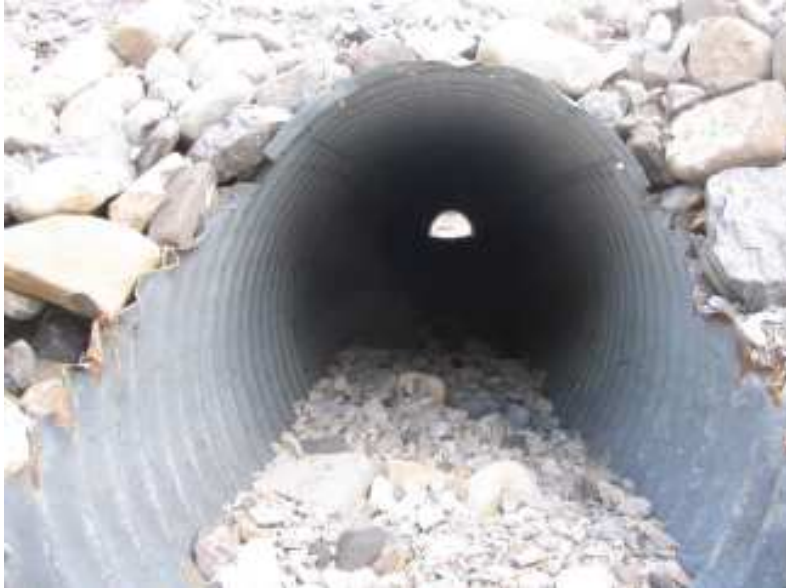
Photo S21-4 (top) – June 2008
Facing upstream from the culvert outlet,
with debris accumulation in the pipe.

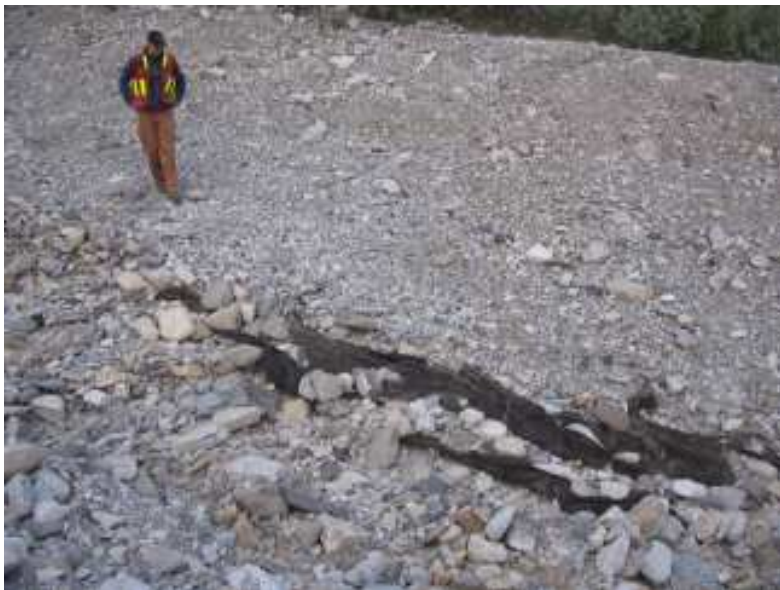
The purpose of the apparent geotextile liner below the debris along the channel for a short distance upstream of the culvert inlet is not clear. There does not appear to be a need to maintain a separation between the debris and the underlying material. Furthermore, the geotextile is vulnerable to damage during excavation and removal of the debris. In any case, the geotextile does not increase the hazard to the culvert and highway from the debris in the channel.

Photo S21-5 (bottom) – June 2008
Geotextile exposed along the channel
upstream of the culvert inlet.
