Site 39 – Eyrie Gap Cut Slope

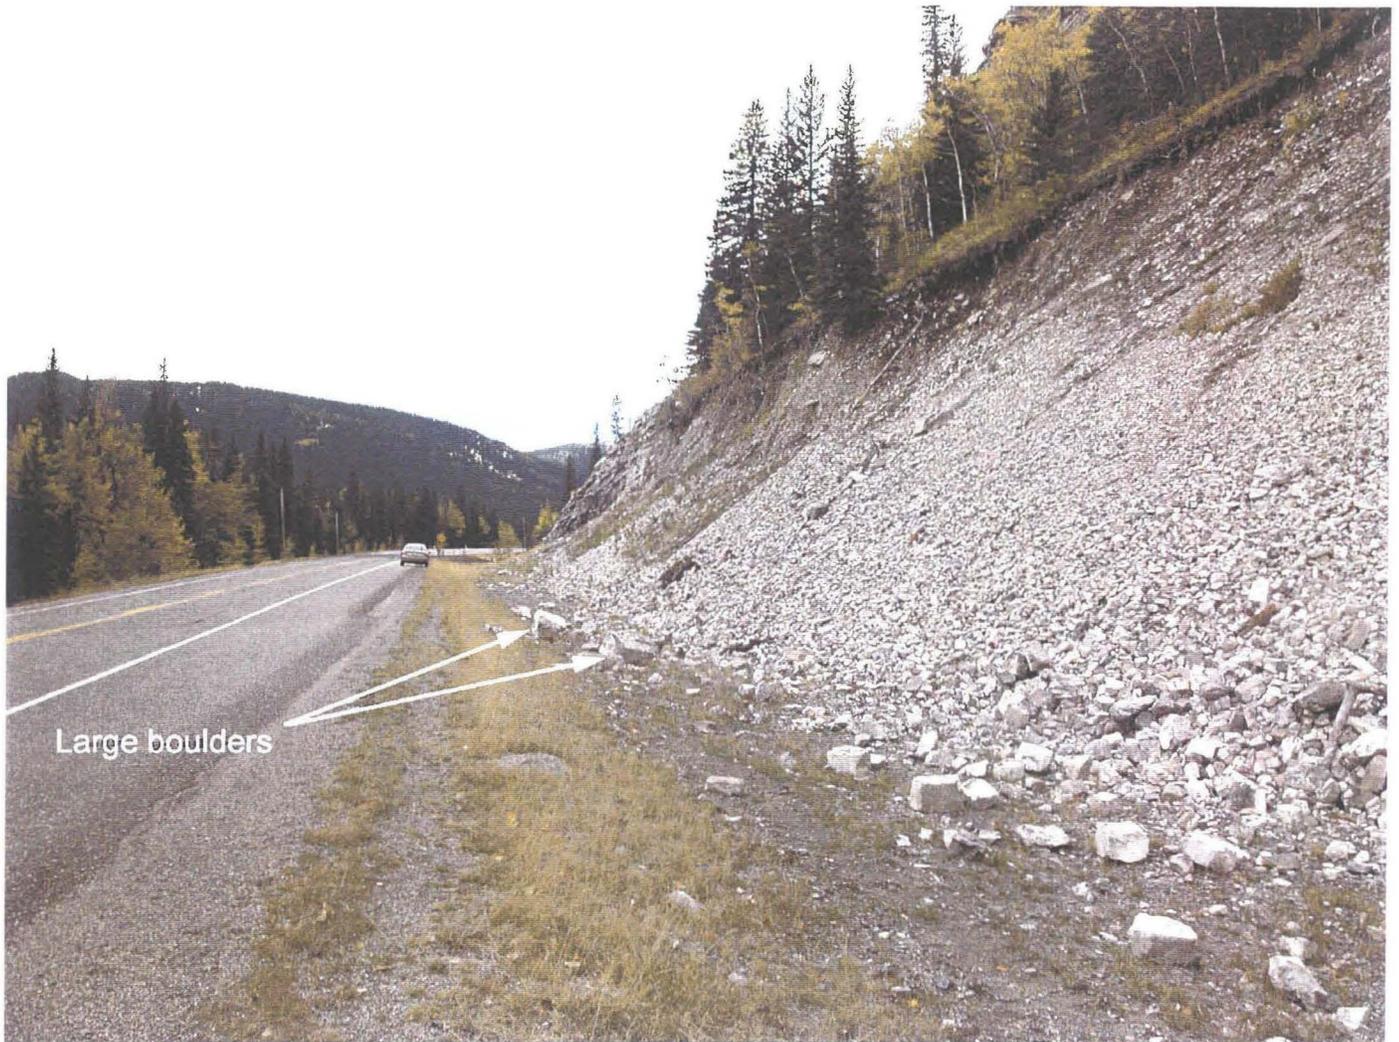
There were numerous cobble to small boulder size rocks in the ditch between the toe of the colluvium and the edge of the pavement at the time of the inspection in September 2005 however there were no rocks on the road or visible damage to the asphalt due to past rockfalls.

There were two large boulders (approximately 1.5 m maximum dimension) in the ditch and within 3 m of the edge of the pavement at the time of the inspection (Photo 1). No other boulders of comparable size were visible in the area and it is not clear if these boulders actually originated from the cut slope and, if so, how they were able to roll to a position so close to the edge of the pavement.

- Probability Factor of 13 based on the appearance of the debris that suggests that several rockfalls occur each year.
- Consequence Factor of 1 based on no visual evidence of past rockfalls reaching the paved surface of the road.

Photo 1 – Facing west along the ditch at the toe of the colluvium slope. Cobble to boulder sized rocks have rolled beyond the toe of the slope, however there were no rocks on the road or signs of rockfall damage to the pavement. Two large boulders (approximately 1.5 m maximum dimension) were noted within 3 m of the edge of the pavement. There were no other boulders of comparable size visible in the debris and it is not entirely clear if these boulders actually originated from the cut slope.

It is recommended that the rocks between the toe of the colluvium slope and the edge of the road be removed to increase the clear width along the highway and to prevent the Consequence Factor from rising as more debris accumulates. Future ditch cleaning should be done as required and treated as an ongoing maintenance requirement.
