Site 40 – East of Eyrle Gap Rock Cut II

This site consists of a soil and rock cut slope along the north side of the highway and approximately 4.5 km east of the junction between Highways 40, 541 and 940 at Highwood House.

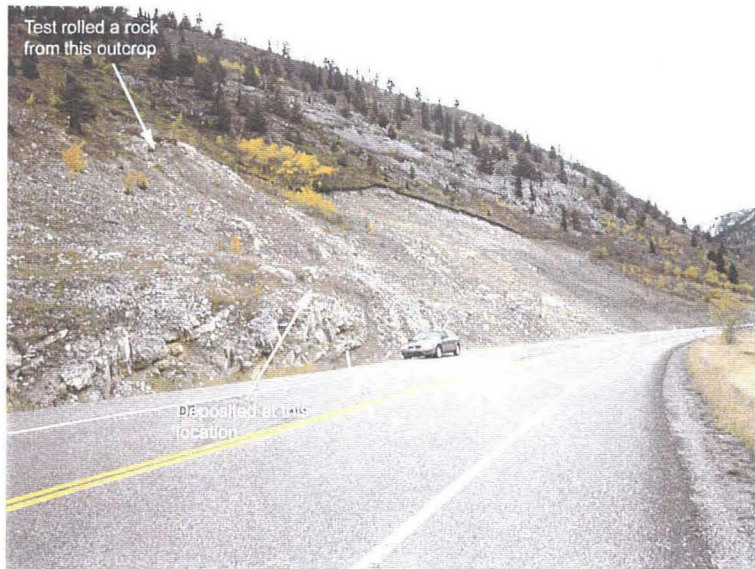
The upper portion of the cut slope transitions into the natural slope face. The crest of the cut is not well-defined but may roughly correspond to the vegetation line as shown in Photo 1. Assuming this to be the case, the total vertical height of the slope is approximately 20 m at an overall angle of approximately 40°. The lowermost quarter (approximately) of the slope exposes fractured bedrock and the upper portion of the cut slope exposes rocky soil. Photos 1 and 2 show the appearance of the cut slope.

Photo 1 (top) – Soil and rock cut slope above the highway. The majority of the rockfall debris was judged to be due to rocks rolling down the slope. A rock was rolled from the location marked in the upper left corner of the photo in order to check the effectiveness of the ditch for containing rolling rocks. The rock did not reach the ditch, and instead came to rest at the location marked.

1. The accumulated debris from the ditch should be cleaned out to restore its full capacity.
2. The site should be inspected by a geotechnical engineer in conjunction with other recommended site inspections along the Highway 40/541 corridor during 2006 in order to estimate the rate of debris accumulation in the ditch after it had been cleaned (and therefore re-set to full capacity) and determine if additional measures could cost effectively reduce the Risk Level at this site.

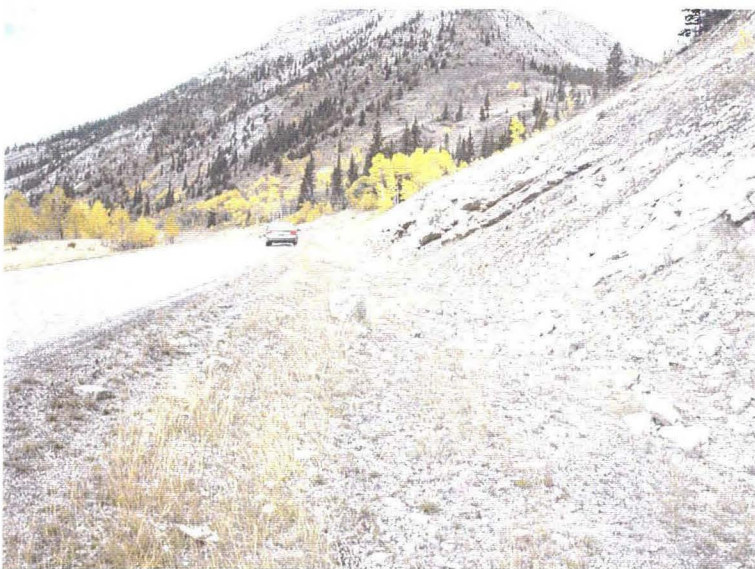
At the time of the inspection in September 2005 there was an accumulation of rockfall debris in the ditch, including an approximately 0.6 m diameter boulder that was 2 m from the edge of the pavement. There were also numerous cobble sized rocks on the sideslope of the ditch and within 1 m of the edge of the road. Three large boulders were noted in the grassed area on the opposite (downslope) side of the road. It does not appear that the boulders rolled across the road but perhaps they were cleared off the road and left on the downslope side.

Photo 2 (middle) – Facing west along the ditch. Note the distribution of rockfall debris within the ditch, including boulder-sized rocks within 2 m of the edge of the pavement.

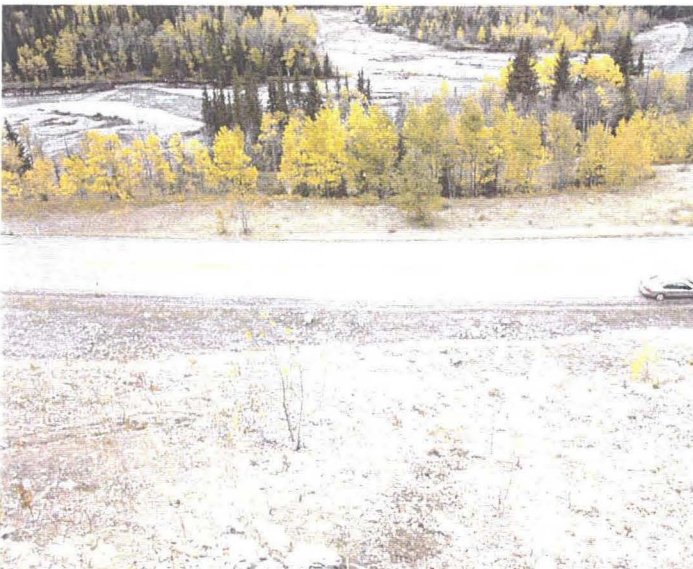
Photo 3 shows a view facing downslope from near the crest of the cut slope and shows the distribution of rockfall debris in the ditch. In order to roughly check the effectiveness of the ditch for containing rocks that roll down from near the crest of the cut slope, a small boulder was rolled from this location (marked on Photo 1). However, the boulder did not reach the ditch and instead came to rest at the crest of the approximately 3 m high, near-vertical rock cut at the base of the slope. Notwithstanding this rough check, the debris in the ditch indicates that some rocks do roll into the ditch and come to within 1 m of the edge of the road.

Photo 3 (bottom) – Facing downslope from the upper portion of the cut slope. The distribution of rockfall debris in the ditch is visible, with some rocks within 1 m of the edge of the road.
