SITE NUMBER AND NAME: S070-II and -III Eyrie Gap and Fir Creek Geohazard Sites		HIGHWAY & KM: 541:02, km 4.488 to km 4.794	PREVIOUS INSPECTION DATE: October 22, 2021	INSPECTION DATE: May 17, 2022
LEGAL DESCRIPTION:	NAD 83 COORDINATES: UTM Northing Easting		RISK ASSESMENT:	
S070-II: NW-35-16-05 M5	11	5585241 671123	PF: 10	CF: 1 TOTAL: 10
S070-III: NW-35-16-05 M5	11	5585007 671335	PF: 11	CF: 1 TOTAL: 11
AVERAGE ANNUAL DAILY TRAFFIC: 844 (west) & 770 (east) (Reference No. 50100258)			CONTRACTOR MAINTENANCE AREA (CMA): 27

PROJECT SOUTHERN REGION GEOHAZARD RISK MANAGEMENT PROGRAM		
TITLE Site Plan S070-2, -3 - Eyrie Gap and Fir Creek Geohazard Sites Hwy 541:02, km 4.794-4.488		
SCALE 1:5,000	PROJECT No. A05116A03	FIG No. 1

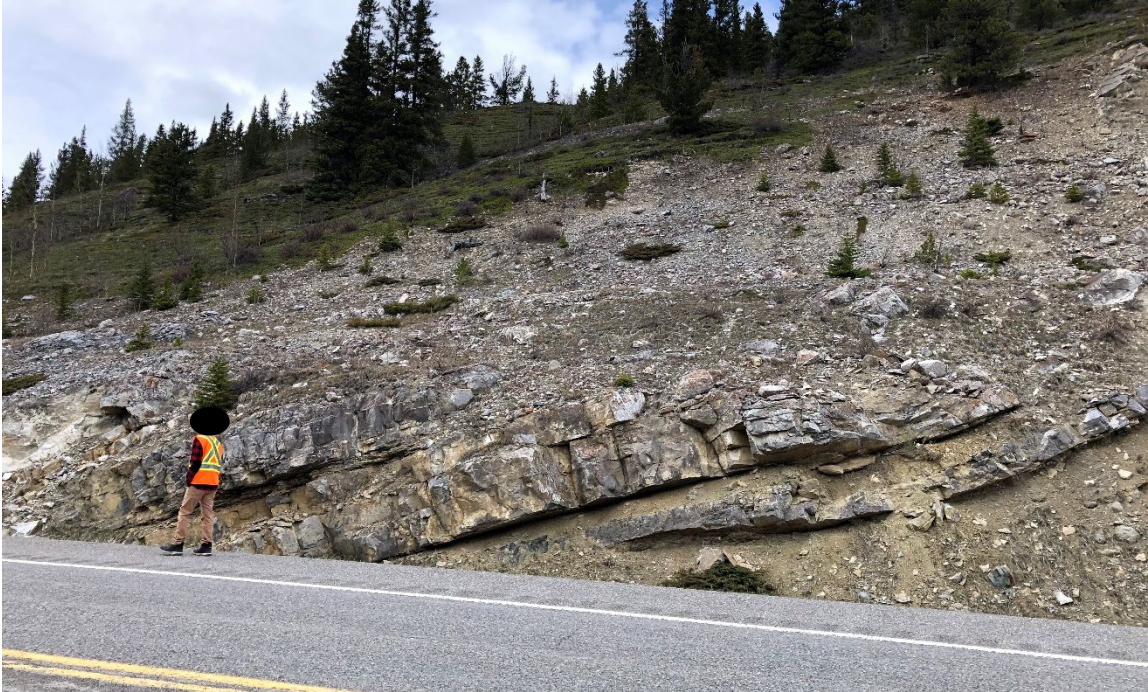
Photo 1 Northern portion of back slope at S070-II on adjacent to the highway. Photo taken May 16, 2022, facing northwest.

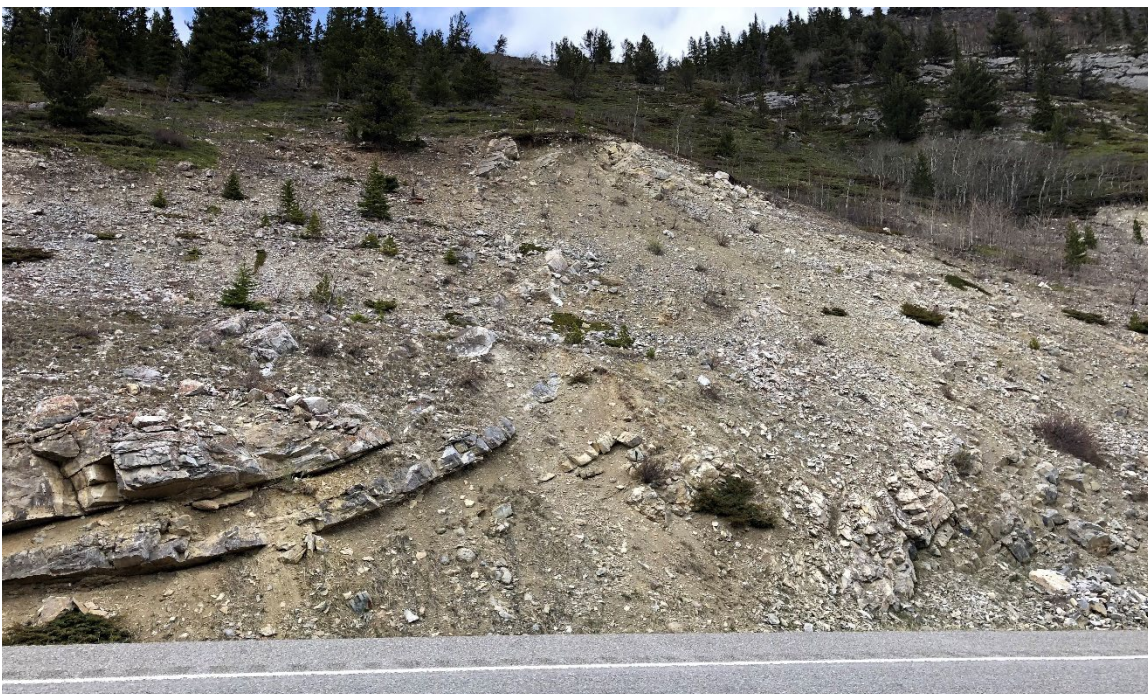
Photo 2 Central portion of back slope at S070-II adjacent to the highway. Photo taken May 16, 2022, facing northeast.

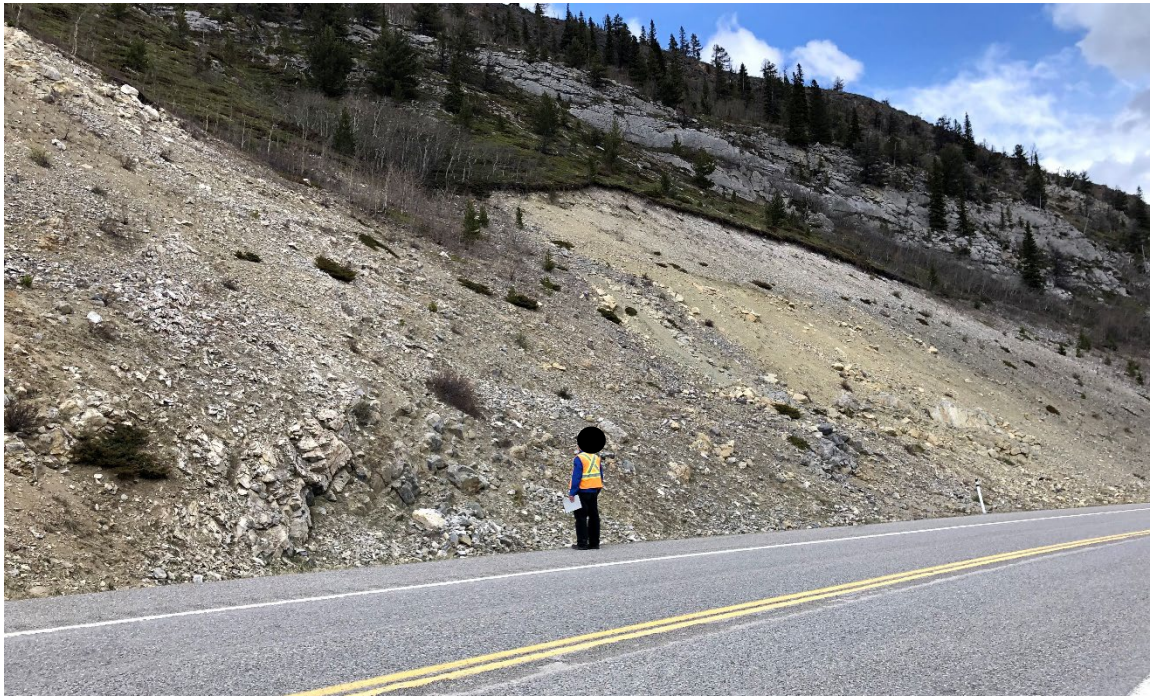
Photo 3 Southern portion of back slope at S070-II adjacent to the highway. Photo taken May 16, 2022, facing east.

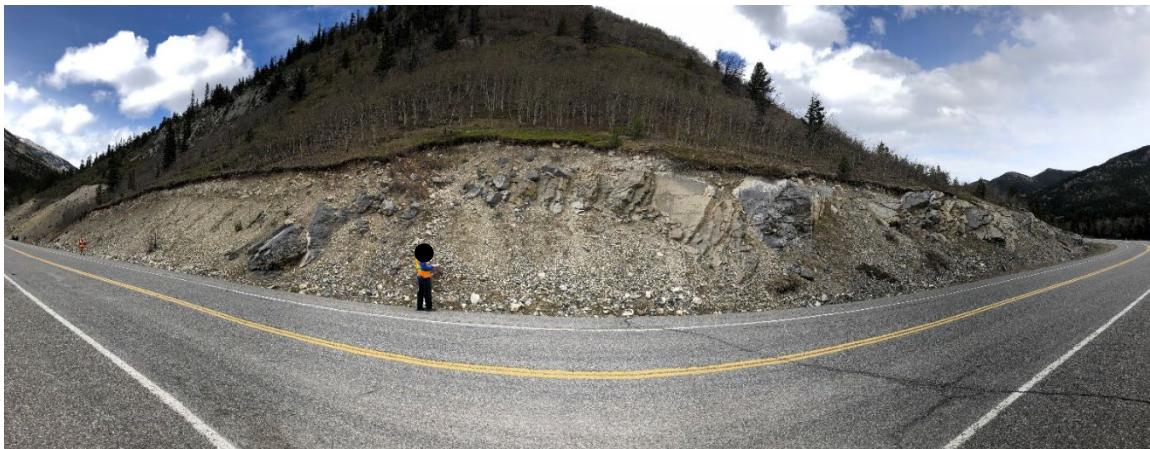
Photo 4 Back slope at S070-II on north side of the highway. Panoramic photo taken May 16, 2022, facing northeast.

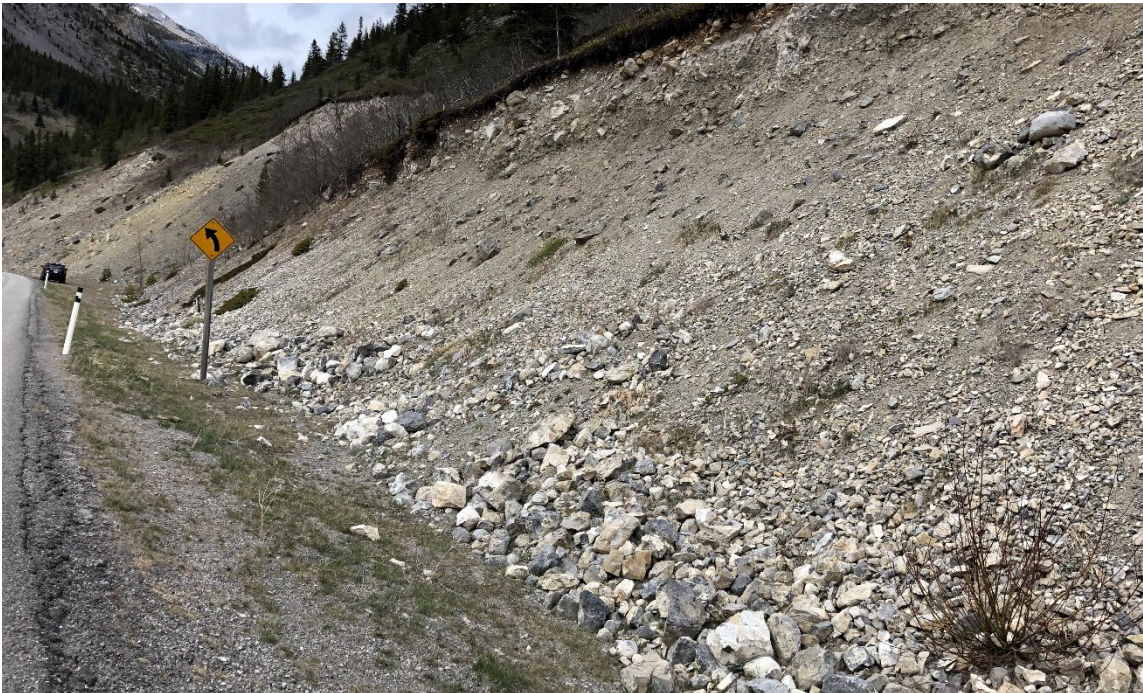
- Bedrock and soil mantled back slope north of the highway is approximately 6 m high, including a 1.5 m near vertical section at the brow. The bedrock bedding planes are dipping obliquely towards the highway (Photos 5 through 7). Upslope of the rock slope, approximately 30 m of high ground is present, well vegetated with grass and trees. Bedrock outcrops are present near the brow of the slope. Erosion at the crest of the slope has created overhanging vegetation mats.

- Rockfalls are active and fresh rockfall debris up to 1.45 m x 0.65 m x 0.70 m was observed in the ditch during the 2022 inspection. Rockfall debris is primarily subrounded to angular. At the time of the 2022 site visit, granular material had accumulated in the ditch and should be cleared out (Photo 5).

- The ditch is approximately 0.7 m deep and provides good catchment for rockfall debris (Photo 5 and 6).
- The site is located on the right-hand side of a pullout where a creek was realigned due to a previous washout.

Photo 5 Rockfall debris at the toe of the slope at the S070-III site. Photo taken May 16, 2022, facing northwest.

- The sites should be regular inspected by AT's MCI and inspected as part of the Southern Region GRMP Section B inspections.
- The ditches at S070-II and -III should be regularly cleaned out to maintain rockfall capacity.

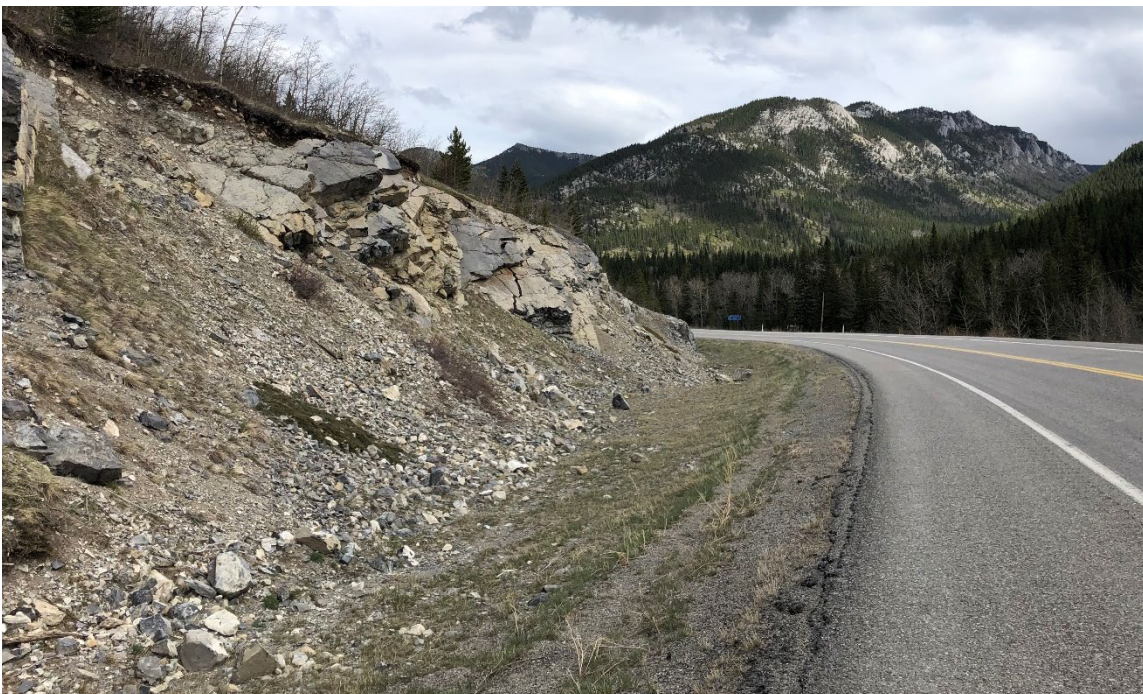
Photo 6 Northbound ditch along S070-III. Photo taken May 16, 2022, facing southeast.

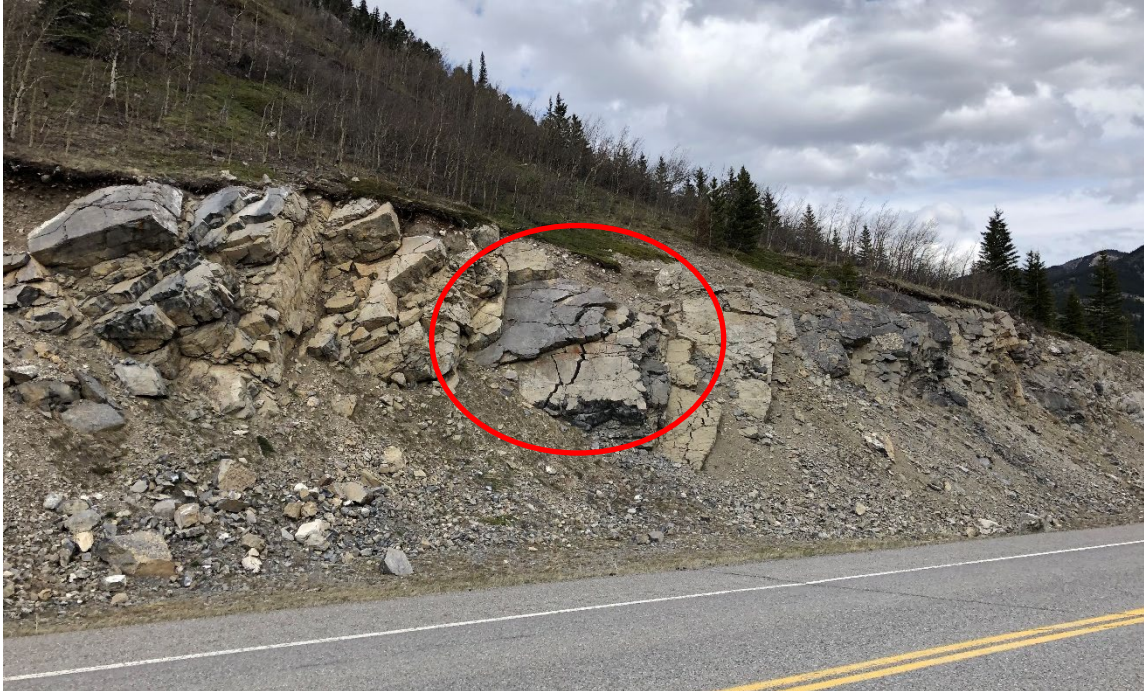
Photo 7 **Bedrock fracturing at S070-III (indicated by red circle) leading to future rockfall blocks. Photo taken May 16, 2022, facing northeast.**
