## Site 41 – East of Eyrie Gap Rock Cut I

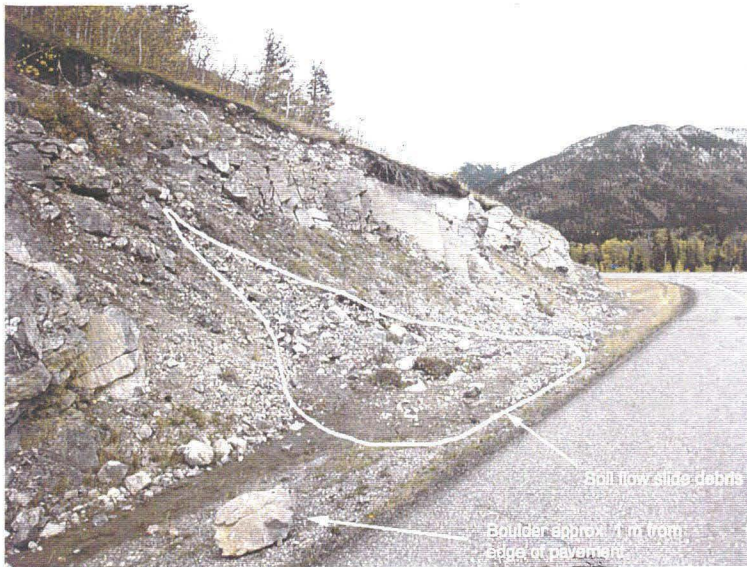
At the time of the inspection there was abundant cobble to boulder sized rockfall debris in the ditch and one boulder was approximately 1 m from the edge of the pavement (Photo 1). There were no rocks on the road or visible asphalt damage due to previous rockfalls at the time of the inspection. There was also debris from a flowslide of the upper (soil) portion of the cut slope blocking the ditch at one location (Photos 1 and 2).

- Probability Factor of 13 based on observations of debris from several rockfalls judged to have occurred in the past year along with the soil flow slide.
- Consequence Factor of 2 based on the possibility for rocks to be deposited along the upslope edge of the road surface due to the volume of rockfall debris currently accumulated within the ditch.

**Photo 1** (top) – Rock and soil cut slope along the northeast side of the highway. The overall cut slope angle is about 45°. The bedding dip in the rock is approximately 45° in an unfavorable orientation relative to the highway alignment. Note the rockfall debris in the ditch, including a boulder approximately 1 m from the edge of the pavement.

A flow slide has also occurred in the soil exposed in the upper portion of the cut slope and deposited debris into the ditch.

It is recommended that the accumulated rock and soil debris be cleaned from the ditch in order to restore the full capacity of the ditch and reduce the Consequence Factor to 1

and the Risk Level to 13. Also, the debris should be cleaned from the ditch as necessary in the future and this should be treated as an ongoing maintenance issue.

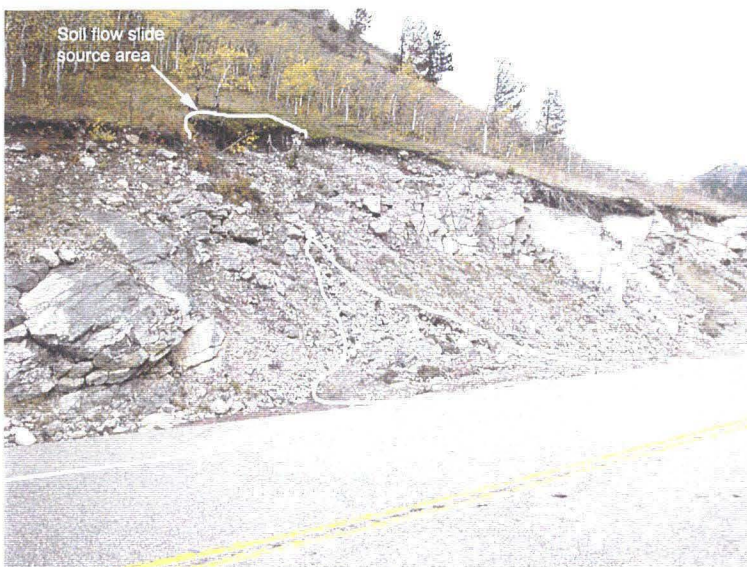
**Photo 2** (middle) – Flow slide debris from upper portion of cut slope that has blocked the ditch.

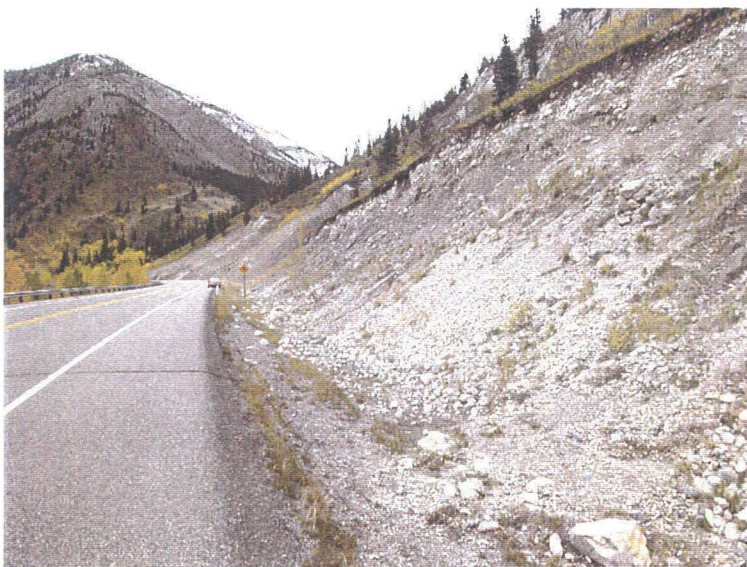
The northwestern end of the site transitions into a cut slope entirely in soil and an apron of soil debris has built up in the ditch and reduced the effective width of the ditch by about 50% (Photo 3). The exposed soil in the upper portion of the cut slope in this area includes cobble sized rocks, some of which have been released during erosion of the soil, rolled across the apron of accumulated soil in the ditch and been deposited on the sideslope of the ditch adjacent to the road.

**Photo 3** (bottom) – The northwest end of the cut slope. An apron of soil debris has built up in the ditch and reduced the effective width of the ditch by about 50%.
