Site 42 – West of Fir Creek Rock Cut

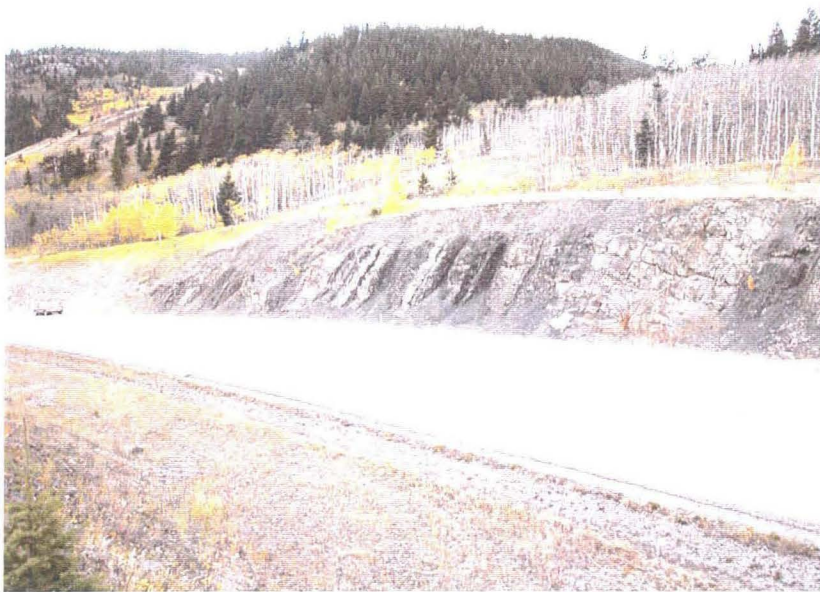
The rock exposed in the cut consisted of bedded shale, coal and conglomerate rock with bedding strike roughly perpendicular to the highway and steeply dipping down to the west. Therefore, from a slope stability perspective the bedding is oriented favorably with respect to the highway.

The width of the ditch was approximately 4 m and the depth of the ditch was approximately 1.5 m. Photo 1 shows an overall view of the cut slope. This ditch exceeds the sizing criteria shown on Figure B1 in Appendix B.

Photo 1 (top) – Facing north across Highway 541 towards the West of Fir Creek Rock Cut site. The exposed rock at this site is generating ongoing minor rockfalls of gravel to cobble sized debris. The existing ditch appears to be sufficient to prevent debris from landing on the road.

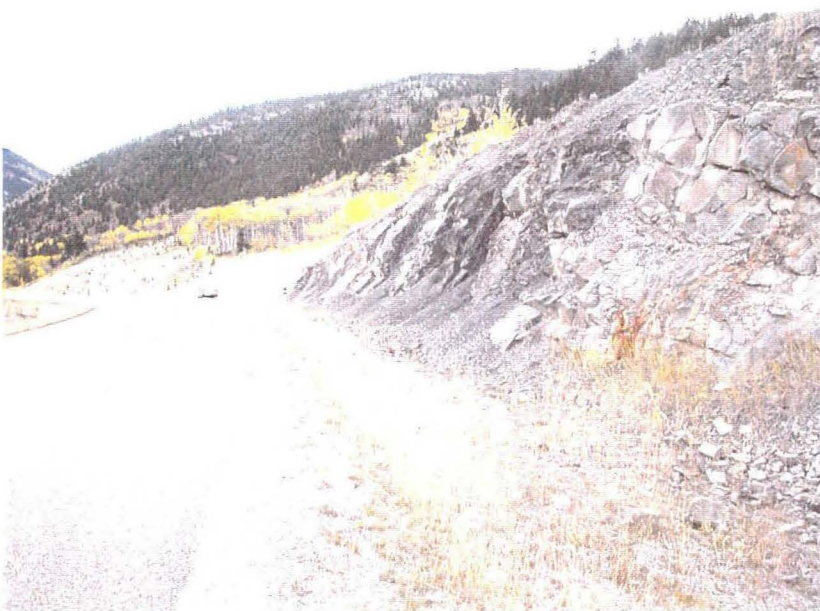
There were minor accumulations of rockfall debris along the toe of the cut slope at the time of the inspection (Photo 2). The debris was typically gravel to cobble sized. The rockfalls are due to ongoing weathering of the exposed rock in the cut slope. There were no signs of rockfall debris being deposited close to the road.

- Probability Factor of 13 based on observations of debris from several rockfalls judged to have occurred in the past year.
- Consequence Factor of 1 based on no visual evidence of past rockfalls reaching the paved surface of the road.

Therefore, the recommended Risk Level for this site is 13.

Photo 2 (bottom) – Facing west across the West of Fir Creek Rock Cut site. The accumulated rockfall debris along the toe of the slope should be cleaned in order to restore the full capacity of the ditch and maintain the low Consequence Factor for this site.

As a proactive measure, it is recommended that the accumulated rockfall debris be cleaned out from the ditch at this site in order to keep the Consequence Factor at 1. In the future, ditch cleaning at this site should be treated as an ongoing maintenance item.
