### **Site 43 – Fir Creek Crossing**

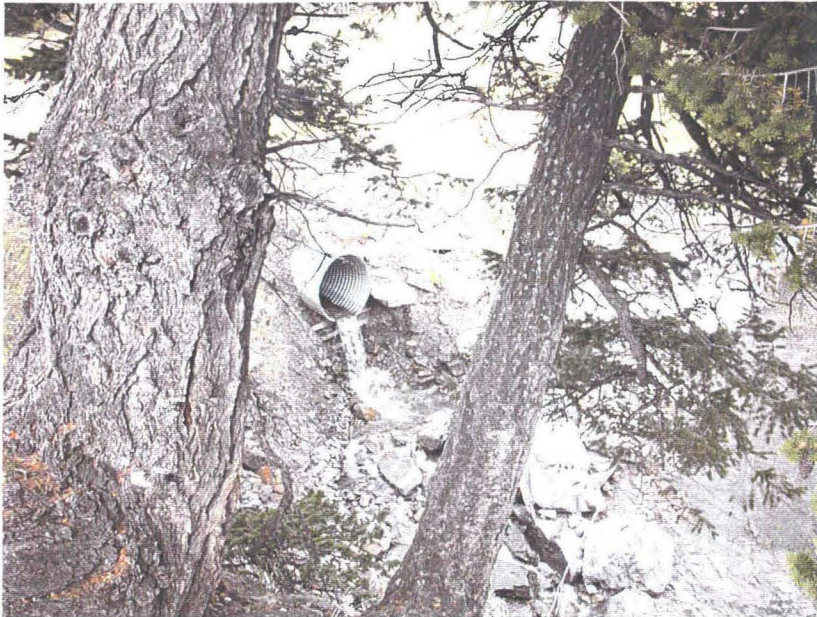
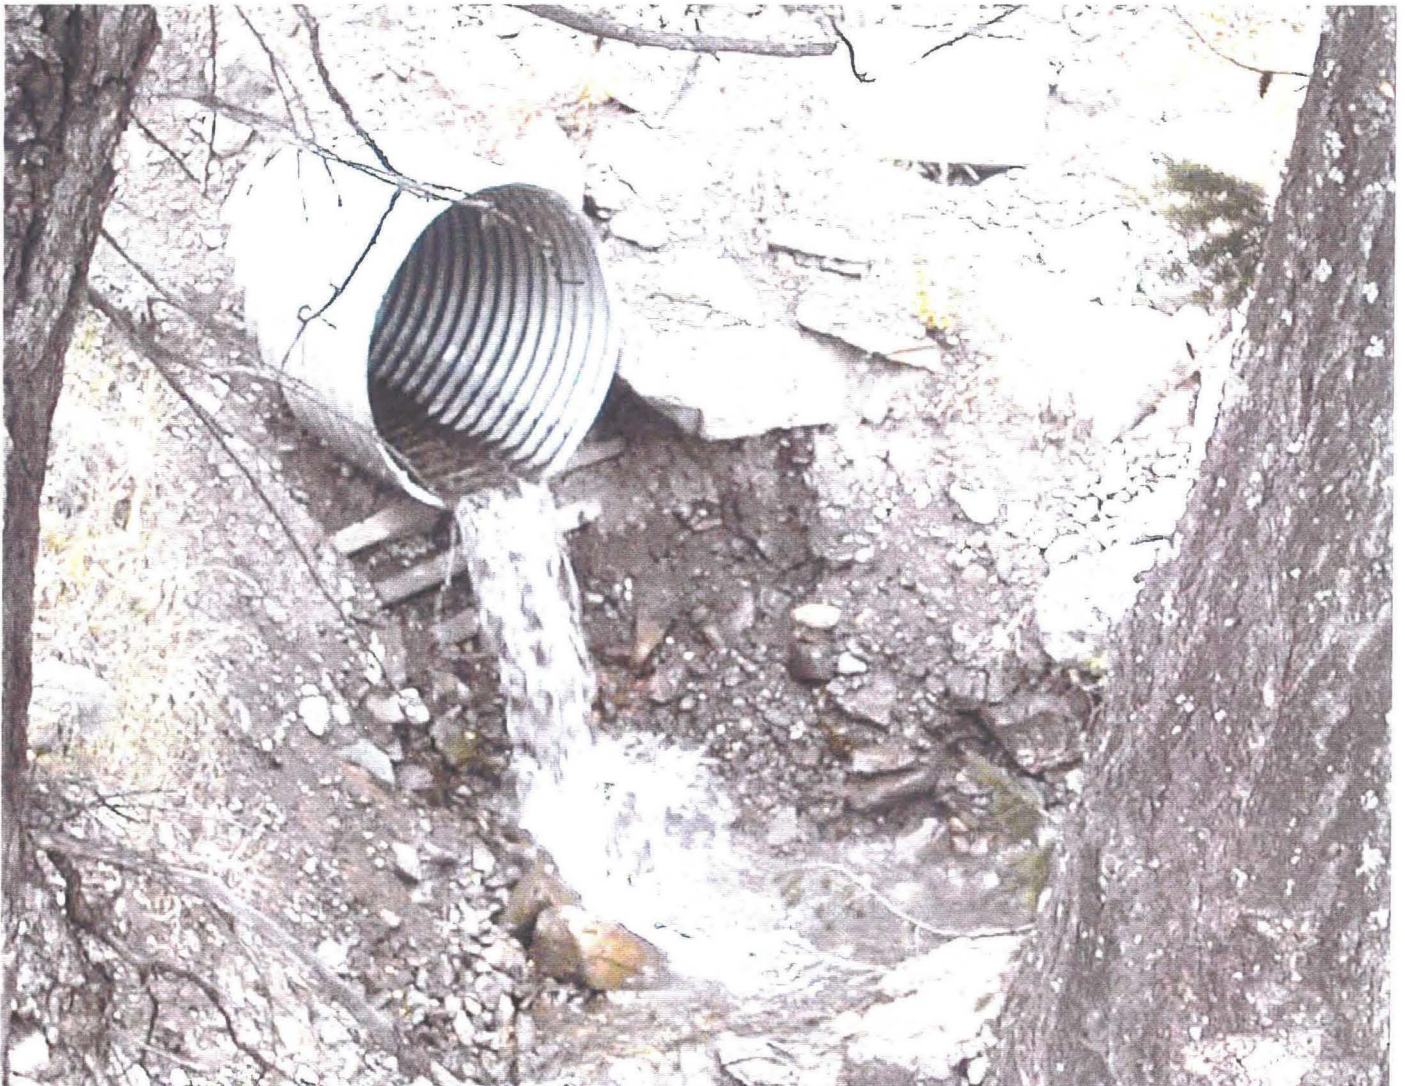
The culvert was open and clear of debris at the time of the inspection. There were no issues noted around the culvert inlet. Some erosion of the toe of the embankment fill was noted around the culvert outlet, as illustrated in Photos 1 and 1A. It did not appear that this erosion has destabilized the fill embankment to date.

- Probability Factor of 2 to reflect the very low to low probability of fill embankment instability developing under the current conditions.
- Consequence Factor of 1 to indicate that this is a maintenance issue with no immediate impact to the road.

Therefore, the recommended Risk Level for this site is 2.

**Photo 1** (upper left) and **Photo 1A** (enlarged view, below) – Culvert outlet at the Fir Creek crossing along Highway 541, as seen from southwest of the crossing. The exposed soils around the outlet have been eroded by culvert flow splashing down from the elevated outlet. This does not create a hazard to the stability of the road at present, however additional armoring should be placed to prevent further erosion.

As a proactive measure, it is recommended that additional rip-rap be placed around the culvert outlet to minimize further erosion of the exposed soils below the outlet.
