August 28, 2009

CG25309.B

**Re: Southern Region Geohazard Assessment Program
Highway 541:02, East Of Fir Creek Rock Cut Site
June 2009 Inspection Report**

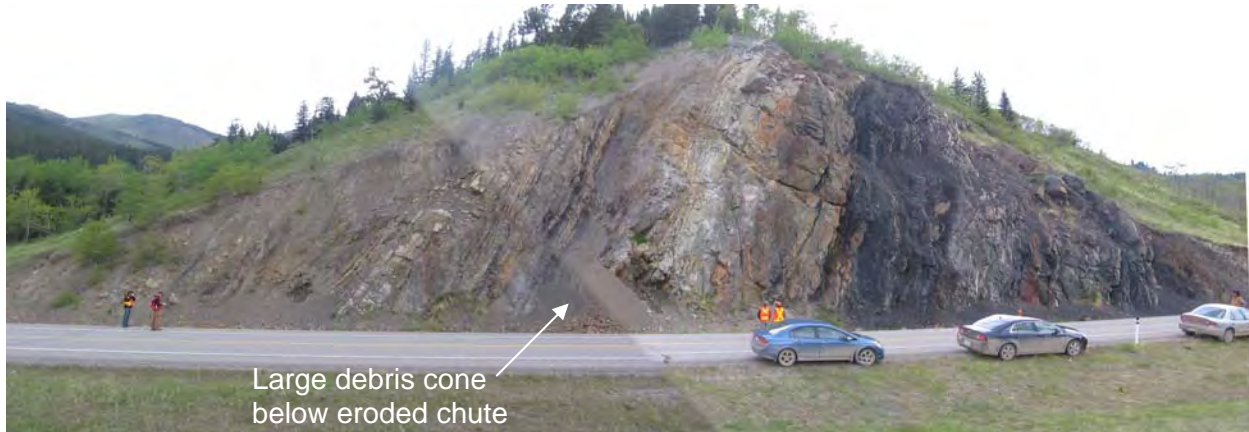
Photo 1 (top) – June 2009

- Overall, there was little to no change in the appearance of the cut slope since the 2005 inspection. The distribution and accumulation of rockfall debris along the ditch was similar to that noted in 2005, including a large debris cone below a chute eroded along a weak bed exposed in the cut slope. Photo 1 shows a general view of the cut slope with the location of the large debris cone highlighted. Photo 2 shows a closer view of the eroded chute and debris cone.

- When compared with the photos from the 2005 inspection, the June 2009 debris cone appeared to be slightly larger than in 2005. However, it is not known how much time was required for the June 2009 debris cone to accumulate, how many times since 2005 the rockfall debris from the ditch had been cleaned out, or what volume of rockfall debris had been removed since 2005.

Facing across the highway towards the cut slope. Overall, little to no change in the cut slope appearance since the 2005 inspection. The talus cone of accumulated rockfall debris below the central portion of the cut slope was slightly larger than observed during 2005. It is not known how many times the rockfall debris in the ditch was cleaned out between the 2005 and 2009 inspections, nor how long it has taken for the debris cone visible in June 2009 to accumulate.

The accumulated rockfall debris should be cleaned out from the ditch in order to restore the ditch to near-maximum capacity, and in future years the debris should be cleaned out as required in order to maintain the ditch reasonably close to full capacity. The rate of rockfall debris accumulation at this site is not clear based on the 2005 and 2009 inspections only, therefore the optimum frequency and timing for ditch cleaning is not known but is likely in the order of once every one to two years.

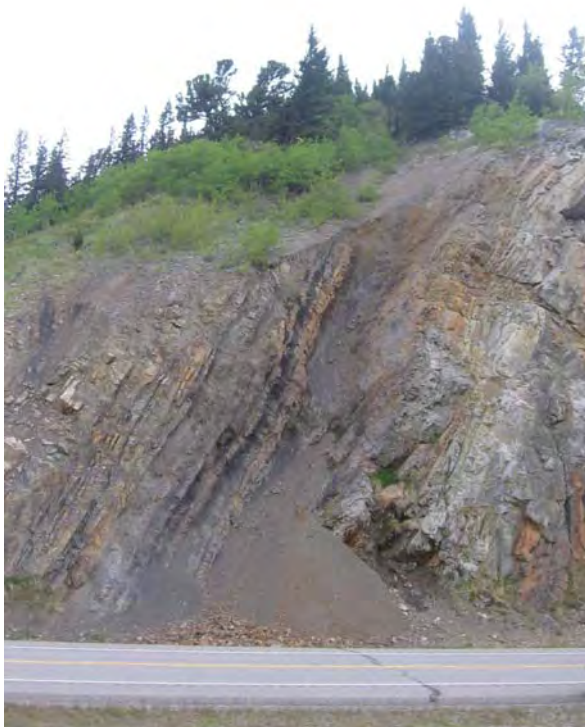
Photo 2 (bottom) – June 2009

Closer view of the debris cone below the eroded chute in the central portion of the cut slope.

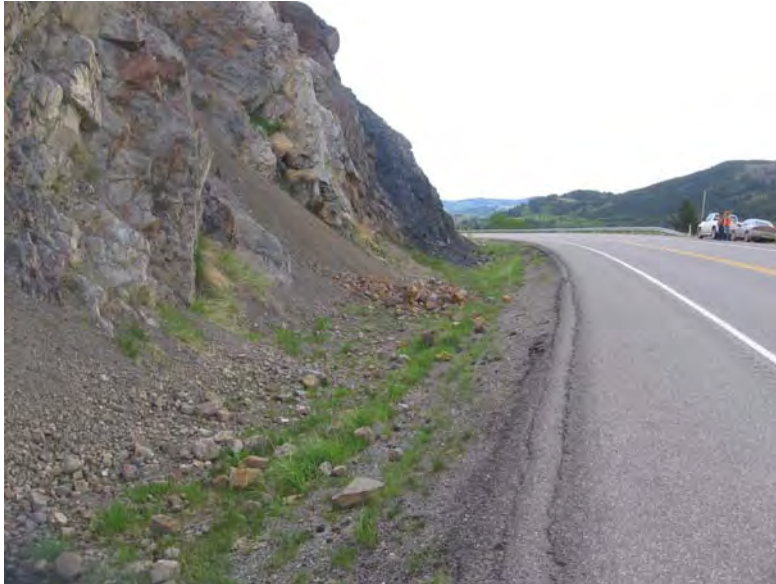
- Aside from the debris cone, there was gravel to cobble sized rockfall debris scattered throughout the ditch and up to the north edge of the pavement (see Photo 3).

Photo 3 (top) – June 2009
Facing eastbound along the north ditch, showing the accumulation of rockfall debris along the ditch.

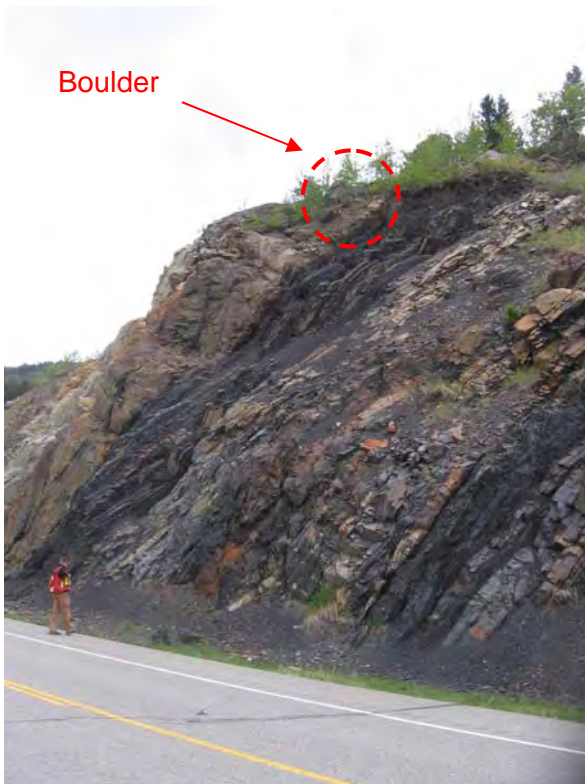
- A boulder was present near the crest of the cut slope as shown in Photo 4. It appeared that if this boulder was essentially perched on the slope, and if it were to come loose in the future it could roll onto the highway and/or impact the ditch and break up, with debris spilling onto the highway. Such a rockfall is not necessarily imminent, but illustrates the potential hazard at this site.

The ongoing rockfall appears to pose relatively little risk to the highway, given that there was limited to no evidence of debris spilling onto the highway despite the ditch being relatively undersized. However, there remains a hazard of some rockfall debris, and possibly boulder-sized rocks such as the one shown in Photo 4, reaching the highway in the future.

Photo 4 (bottom) – June 2009
Another view of the cut slope. Note the boulder perched near the crest of the slope. If this boulder eventually comes loose from the slope it may roll onto the highway and/or break up upon impacting the ditch with debris spilling onto the highway.
