| SITE NUMBER AND NAME: S070-6 Eyrie Gap and Fir Creek Geohazard Site | | HIGHWAY & KM: 541:02 7.023 | PREVIOUS INSPECTION DATE: October 22, 2021 (Call-Out) | INSPECTION DATE: May 17, 2022 |

| PRIMARY SITE ISSUE: Near-vertical cut slope up to 20 m in height on the north side (westbound lane) of the highway with near vertical bedding planes and a strike roughly perpendicular to the highway. | |

| PROJECT SOUTHERN REGION GEOHAZARD RISK MANAGEMENT PROGRAM | | |

Inspection Photographs

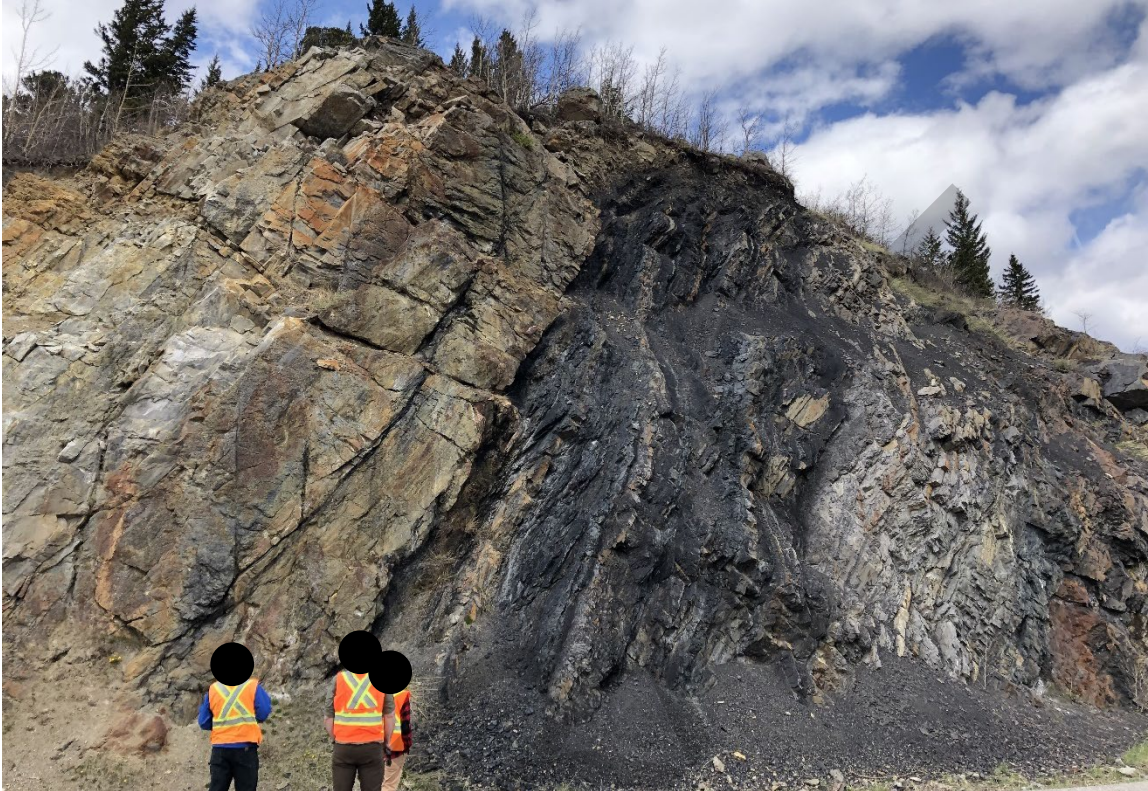
| The bedrock at the site consists of bedded coal, shale, and conglomerate. The central position of the back slope is massively bedded, potentially limestone, and approximately 20 m in height. (Photo 1 and 4). |
| Material is eroding and weathering along the bedding planes and has formed an erosion fan consisting of sand and gravel sized particles in the central portion of the slope. (Photos 1 through 4). |

Photo 1 Bedrock cutting on the north side of the highway estimated as up to 20 m high.
Photo taken May 16, 2022, facing north.

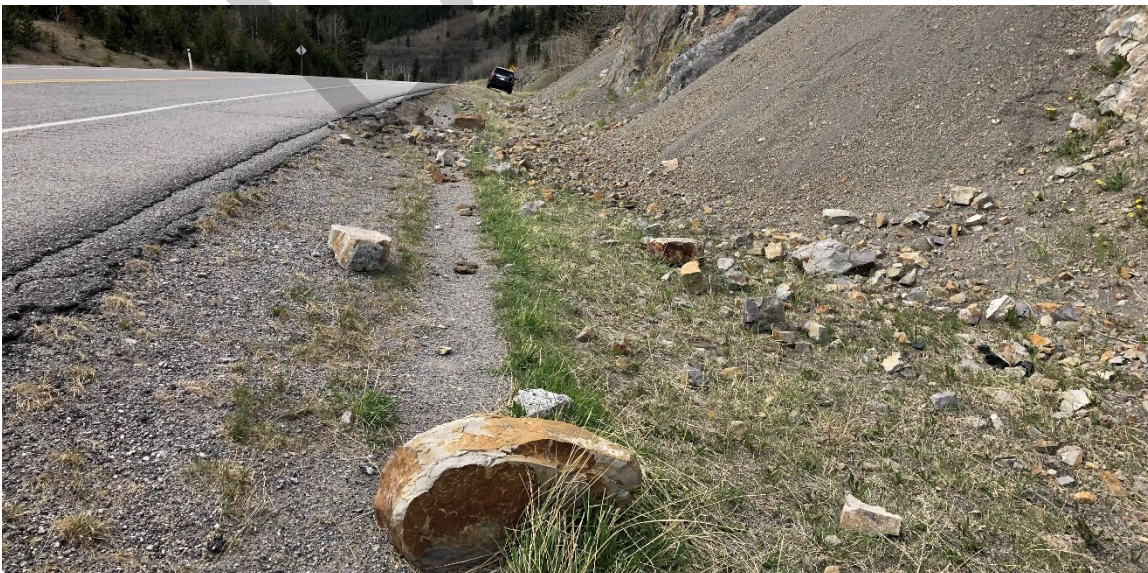
| Rockfalls are active and unweathered rockfall debris (up to 0.7 m x 0.3 m x 0.35 m) was noted in the north (westbound) ditch. The site is active with small rockfalls observed during the 2022 inspection (Photo 2 and 3). |

Photo 2 Rockfall material in the ditch and debris fan on the lower portion of the back slope.
Photo taken May 16, 2022, facing west.

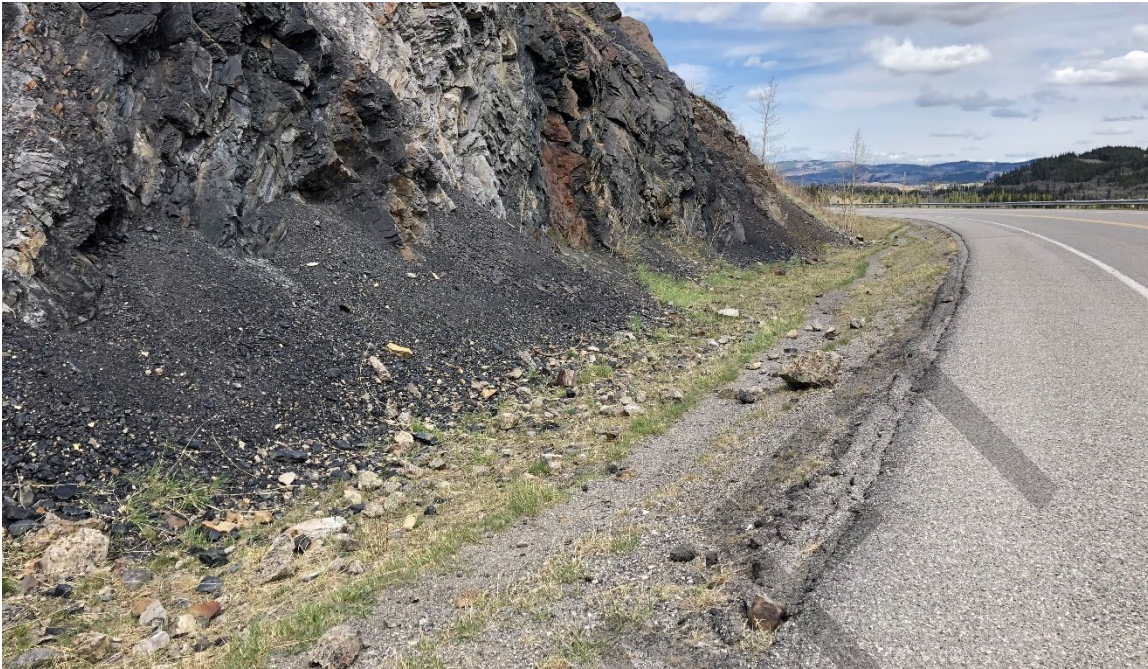
Photo 3 Rockfall material in the ditch and mini debris fans on the lower portion of the back slope. Photo taken May 16, 2022, facing east.

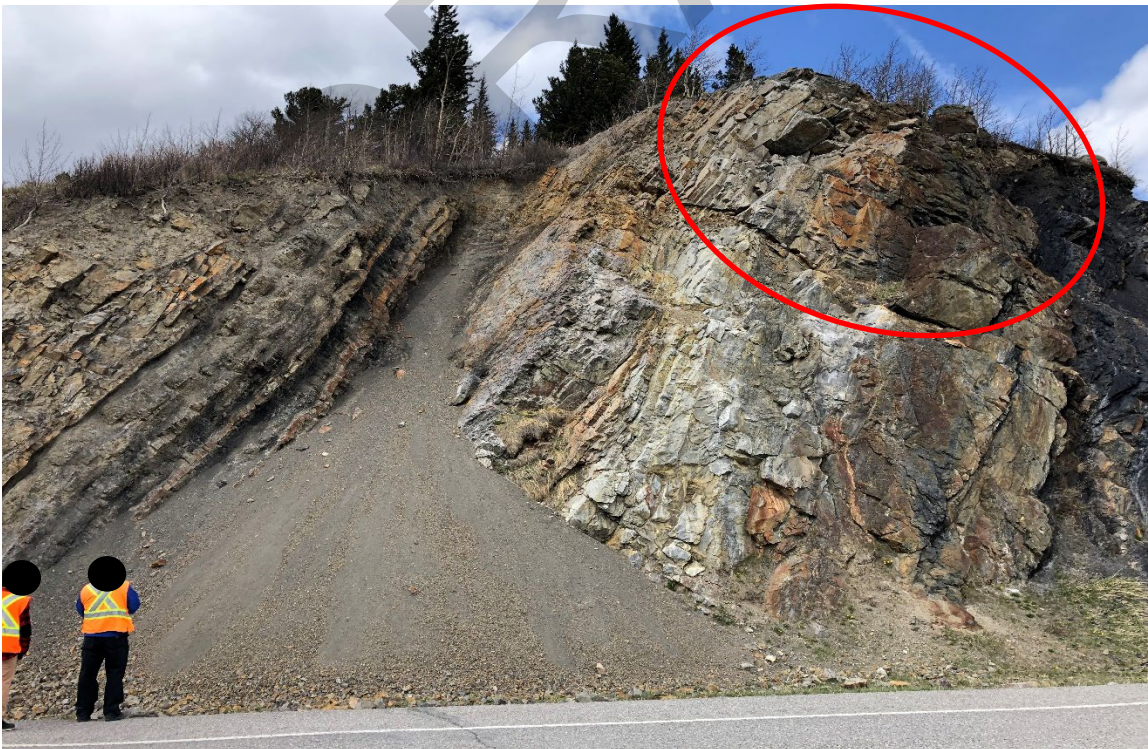
| A large block adjacent to the debris fan is at risk of detaching and falling into the north (westbound) ditch and rebounding into the highway (Photo 4). |

Photo 4 Large debris fan in central portion of the slope. Block adjacent to debris fan (indicated by red circle) is at risk of detaching. Photo taken May 16, 2022, facing north.

- The site should be regularly inspected by AT's MCI and during the Southern Region GRMP Section B inspections.
- Excavation of rockfall catchment ditches adjacent to the highway and spot bolting of blocks which appear unstable or pose a wedge failure risk. A trajectory model could be used to determine the size of lock block wall required to contain the rockfalls.
- The large block of material shown in Photo 4 should be assessed for stability and if needed, anchored to limit deformation/dilation and toppling.
- A lock block wall or HTCBC could be considered but the impact in wildlife movement and road safety would need to be evaluated.
