Site 45 – Highwood River Recreation Area Rock Cut

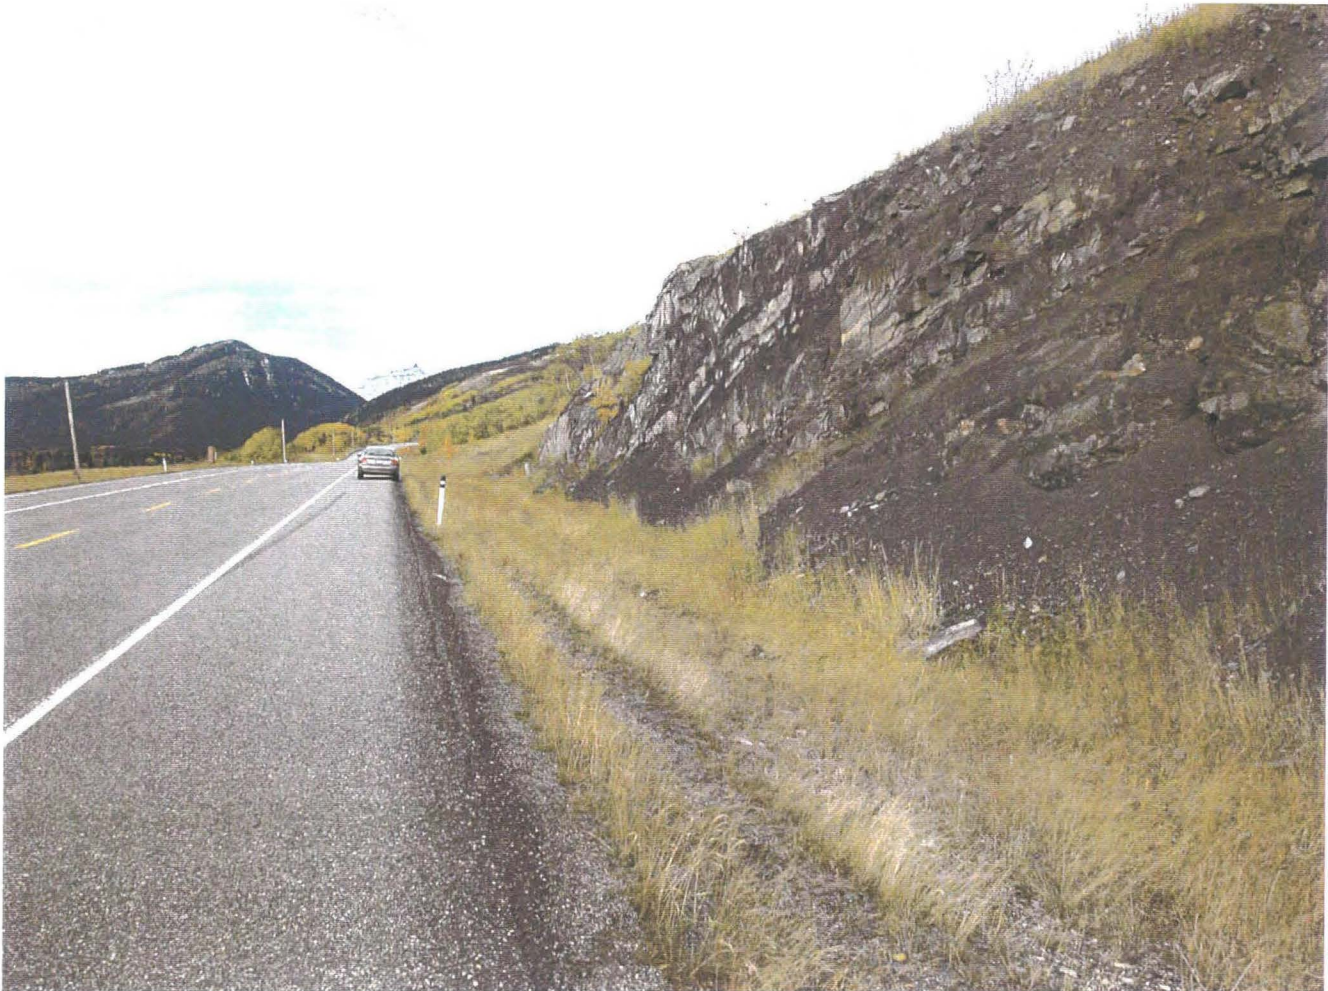
This site consists of a rock cut along the north side of the highway and just west of the parking area for the Highwood River Recreation Area. The maximum height of the near-vertical rock cut is approximately 8 to 10 m and it exposes bedded shale and coal (Photo 1). The dip of the bedding is down towards the west and roughly parallel to the highway. Therefore, from a slope stability perspective, the bedding of the rock is oriented favorably with respect to the highway.

At the time of the inspection in September 2005, rockfall debris consisting of gravel to boulder sized particles was present in the central portion of the ditch and there was an apron of accumulated debris along the toe of the cut slope. No rockfall debris was noted between the central portion of the ditch and the edge of the pavement. The pavement did not show any signs of damage from previous rockfalls.

The width and depth of the ditch are typically 7 and 1.25 m, respectively. The existing ditch exceeds the minimum width specified by the ditch sizing criteria shown on Figure B1 in Appendix B, however it does not meet the minimum depth criteria for the maximum height of the cut slope. However, the existing ditch is judged to be sufficiently large based on the extra width along with the lack of evidence of rockfalls reaching the road.

- Probability Factor of 13 based on observations of debris from several rockfalls judged to have occurred in the past year.
- Consequence Factor of 1 based on no visual evidence of past rockfalls reaching the paved surface of the road.

Therefore, the recommended Risk Level for this site is 13.

Photo 1 – Facing west along Highway 541 at the Highwood River Recreation Area Rock Cut site. Rockfall debris from the cut slope has accumulated along the toe of the slope. There were no signs of rockfall damage to the road surface and the existing ditch appears to be of sufficient size to contain the rockfall debris provided that it is cleaned out as necessary.

As a proactive measure, it is recommended that the rockfall debris be cleaned out from the ditch at this site in order to keep the Consequence Factor from rising due to future debris accumulation. The cleaning of rockfall debris from the ditch at this site should be treated as an ongoing maintenance item.
