Site 46 – Eden Valley Rock Cut

This site consists of a rock cut slope along the northwest side of the highway and approximately 9 km east of the Highwood River Recreation Area.

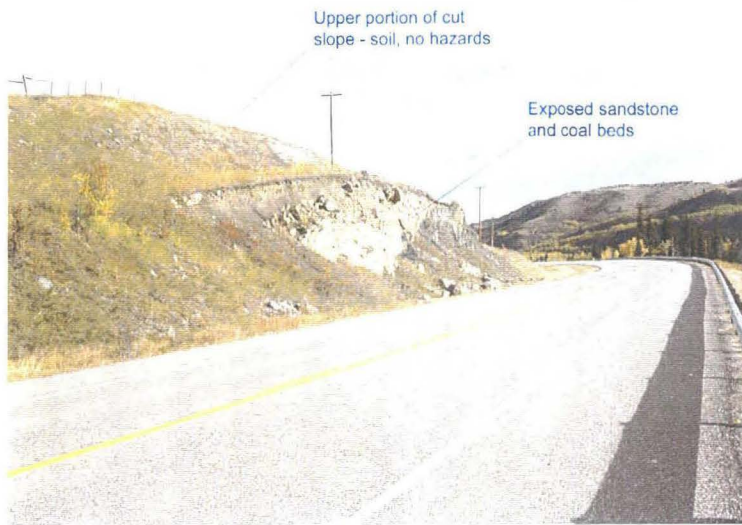
The lower portion of the cut slope at this site exposes beds of sandstone and coal with a strike approximately perpendicular to the highway and bedding dip down to the west. The maximum height of the near-vertical rock cut is approximately 9 m. The upper portion of the cut slope above the rock cut consists of a grass-covered soil slope with no obvious hazards to the highway.

Photo 1 (top) – Facing northeast along Highway 541 at the Eden Valley Rock Cut site. The lower portion of the cut slope is near-vertical and exposes bedded sandstone and coal with active rock falls. The upper portion of the cut slope is laid back at a gentler angle with no hazards.

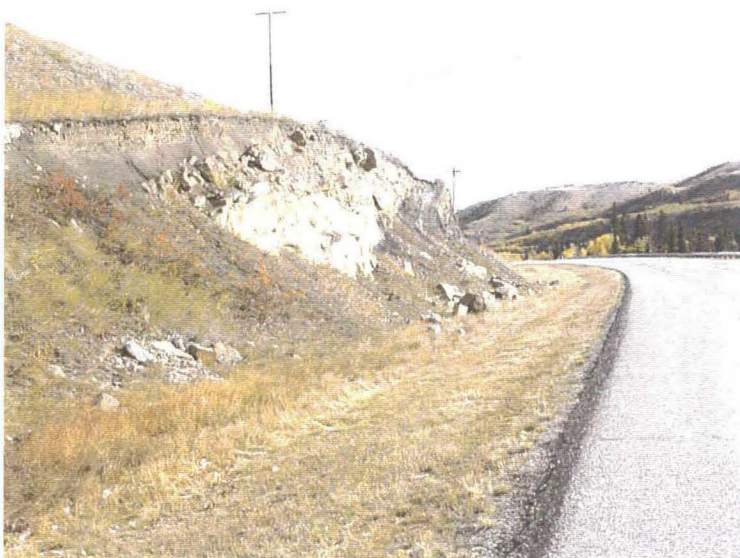
The ditch contained many boulder-sized pieces of weathered sandstone that had fallen from the rock cut. There were no rocks on the paved surface of the road at the time of the inspection and no damage to the pavement from previous rockfalls was noted. There was an apron of rockfall debris along the base of the rock cut at the east end of the site at the time of the inspection in September 2005. The debris generally consisted of gravel sized coal particles that had fallen from the cut slope and accumulated in the ditch with a slope angle of approximately 34°. The accumulation of debris had reduced the effective ditch width and some boulder-sized pieces of sandstone that had fallen out from the top of the rock cut had rolled down the colluvium apron and landed closer to the paved surface than they would otherwise.

The width and depth of the ditch along the toe of the cut slope were approximately 9.75 and 0.9 m, respectively. For the maximum rock cut height of 9 m, the existing ditch has roughly double the minimum width specified under the ditch sizing criteria shown on Figure B1 in Appendix B however it does not meet the minimum depth criteria. Based on the lack of rockfall debris reaching the road, the existing ditch is judged to be sufficiently sized due to the extra width.

Photo 2 (middle) – Closer view of the rock cut slope with the accumulation of rockfall debris in the ditch. There were no rocks on the road at the time of the inspection and no visible damage to the pavement from past rockfall.

It is recommended that the accumulated rockfall debris be cleaned from the ditch in order to keep the Consequence Factor from rising due to further debris accumulation. In the future, cleaning rockfall debris from the ditch should be treated as an ongoing maintenance issue.

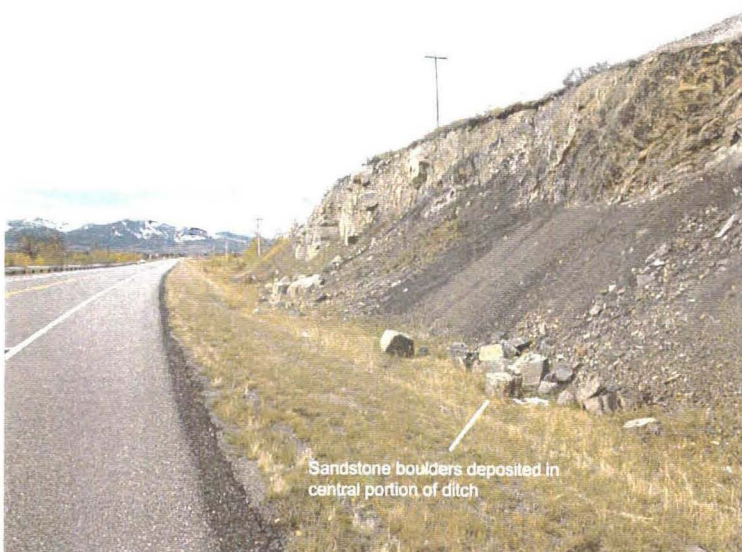
- Probability Factor of 13 based on observations of debris from several rockfalls judged to have occurred in the past year.
- Consequence Factor of 1 based on no visual evidence of past rockfalls reaching the paved surface of the road.

Therefore, the recommended Risk Level for this site is 13.

Photo 3 (bottom) – Facing southwest across the rock cut slope. The sandstone boulders in the central portion of the ditch have fallen from the upper portion of the cut and onto the apron of accumulated debris, then rolled down to be deposited in the central portion of the ditch. The hazard of such rocks landing on the paved surface is still low, however the accumulated rockfall debris should be cleaned out to restore the full capacity of the ditch.
