S13 – Highway 546 Sheep River Site

APPENDIX S13
Highway 546 – Sheep River Site

PROJECT: SOUTHERN REGION LANDSLIDE MONITORING

TITLE: SCHEMATIC SITE PLAN
HIGHWAY 546: SHEEP RIVER SITE

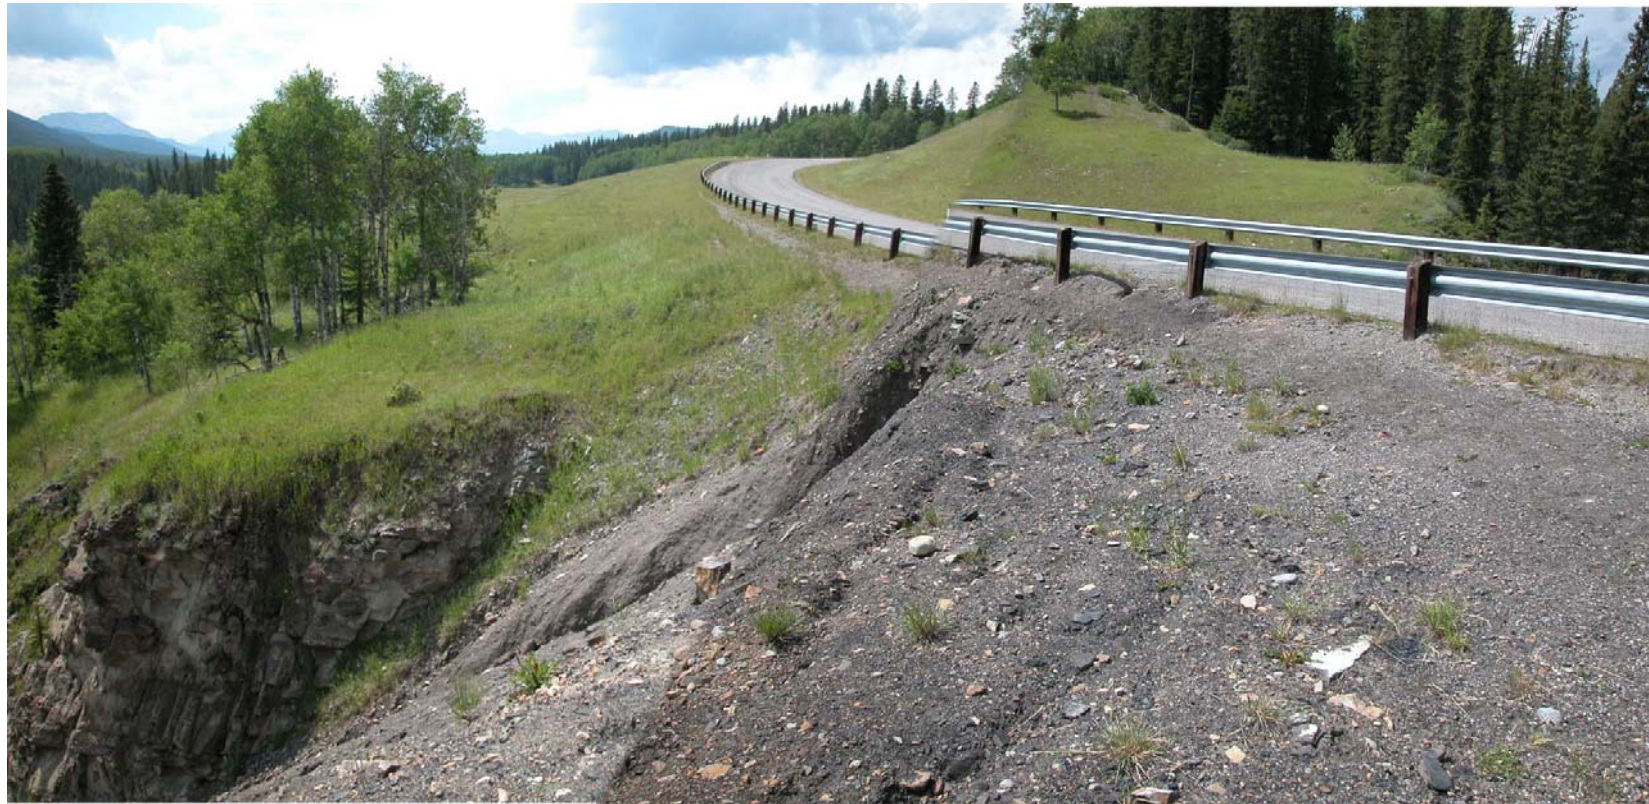
- Significant gully erosion is visible on the downstream face of a large fill embankment across a deep creek gully (Photos 1, 2, 4 and 6). The gully erosion on the embankment face has retrogressed approximately 1 m past the guardrail and into an approximately 2 m length of the road surface (Photos 2 and 3).

- The gully erosion appears to be due to runoff from the paved road surface flowing off the south edge of the road and onto the unvegetated, steep fill slope face.

Photo 1 (top)
Facing northwest across the Highway 546 – Sheep River Site. Gully erosion on the downstream fill slope face is visible.

Runoff from the road surface should be prevented from flowing onto the fill slopes in an uncontrolled manner. AMEC recommends the following to achieve this (see Figure 2-S13 for schematic illustration):

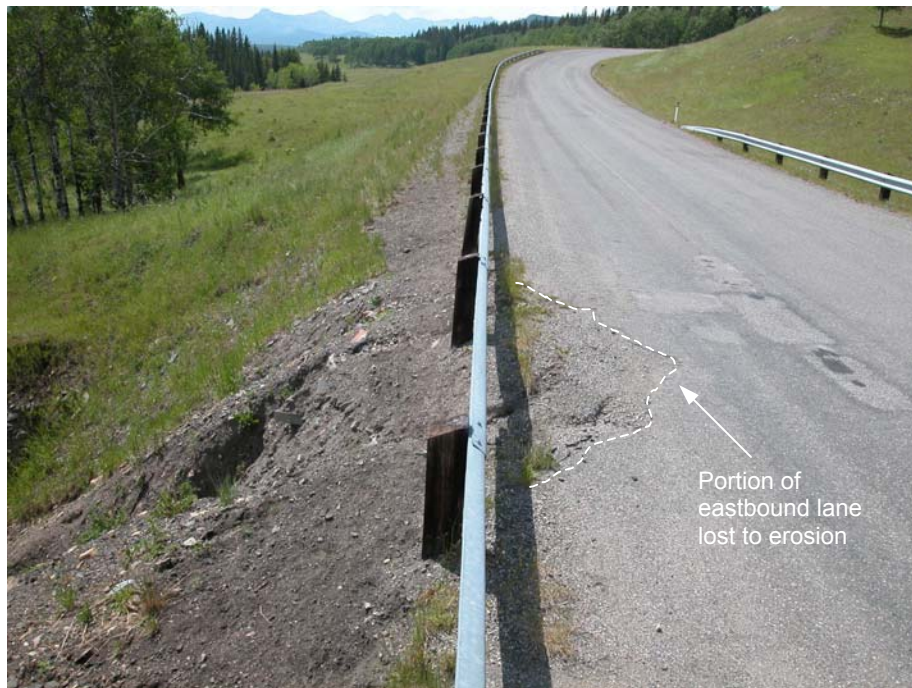
- One of the guardrail posts was being undermined by the gully erosion, and two others were close to becoming undermined (Photos 2, 3, 4 and 5). However, the guardrail alignment has not been damaged so far.

Photo 2 (lower left)
Facing west along the south guardrail. The gully erosion in the fill slope below the guardrail is visible, along with some erosion and settlement of the pavement surface along the south edge of the road.

- Backfill and asphalt patch the eroded/undermined area on the south edge of the road.
- Construct a small berm of asphalt along the south edge of the road.
- Leave two gaps in the asphalt berm to allow runoff to leave the road surface.
- Flumes (half culverts) or even whole culverts should be installed at the gaps in the berm to carry the runoff down to the toe of the embankment slope, so that runoff does not flow on the steep slope face at all. It will be very important to have a good contact between the inlet of the flume/culvert and the gap in the asphalt berm, or else the runoff will simply be concentrated onto the slope face immediately around the inlet.

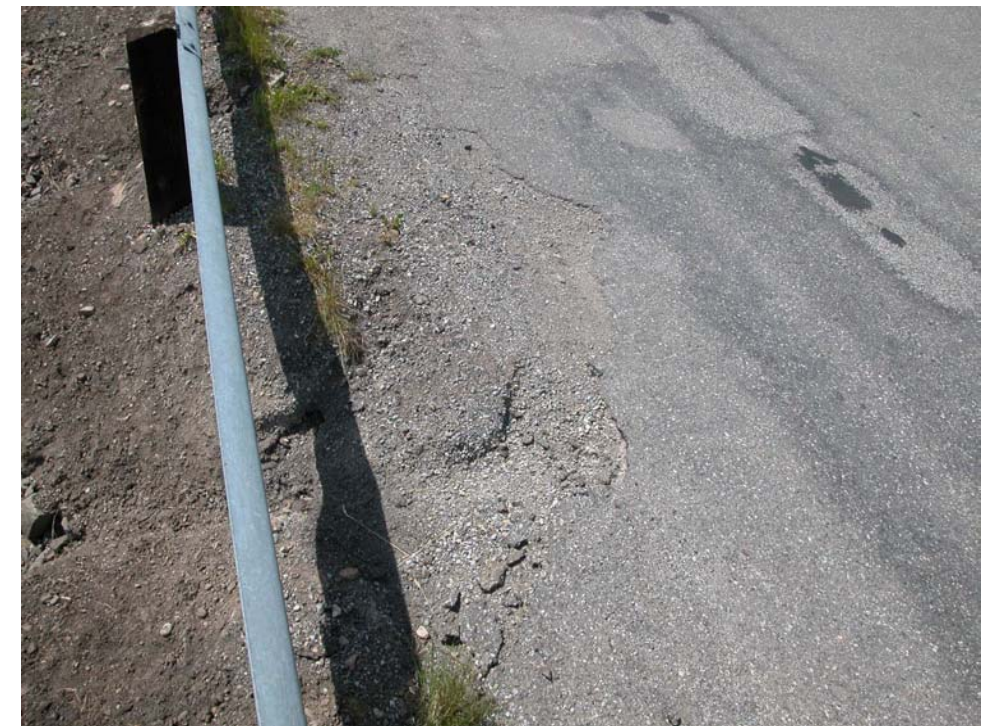
Photo 3 (lower right)
Closer view of the gully erosion extending into the pavement surface along the south edge of the road.

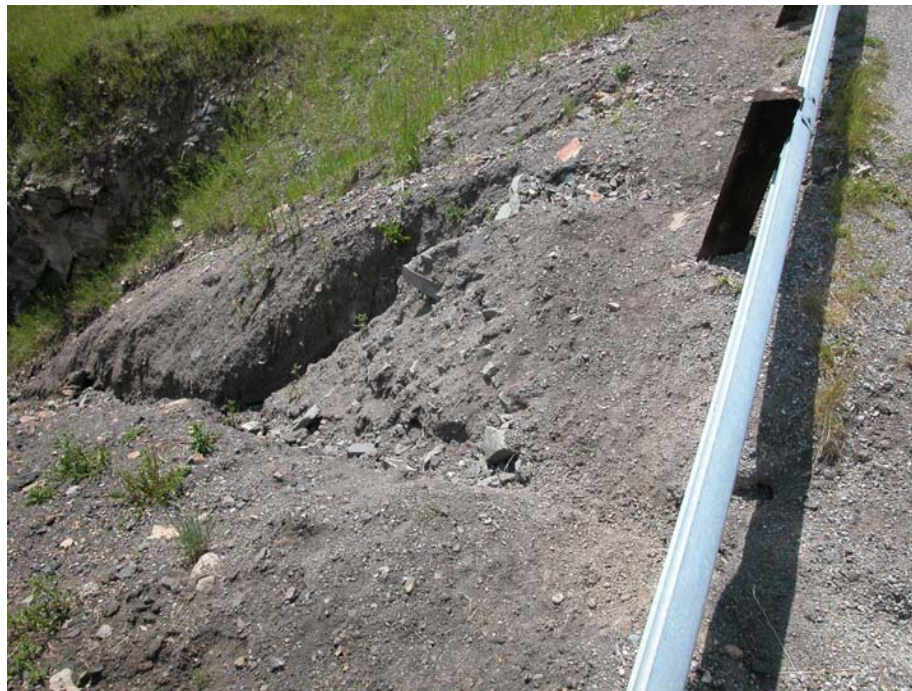
Photo 4 (upper left)
Another view of the gully erosion immediately south of the guardrail, showing the proximity of the steep drop-off to the road.

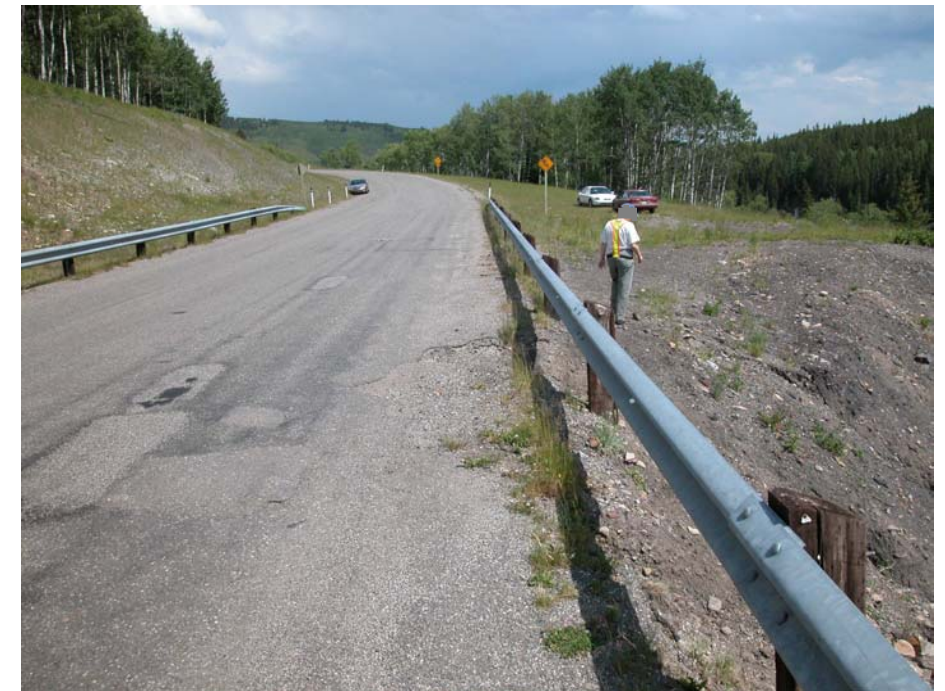
Photo 5 (upper right)
View facing east along the south guardrail. Note the proximity of the steep fill slopes to the edge of the road.

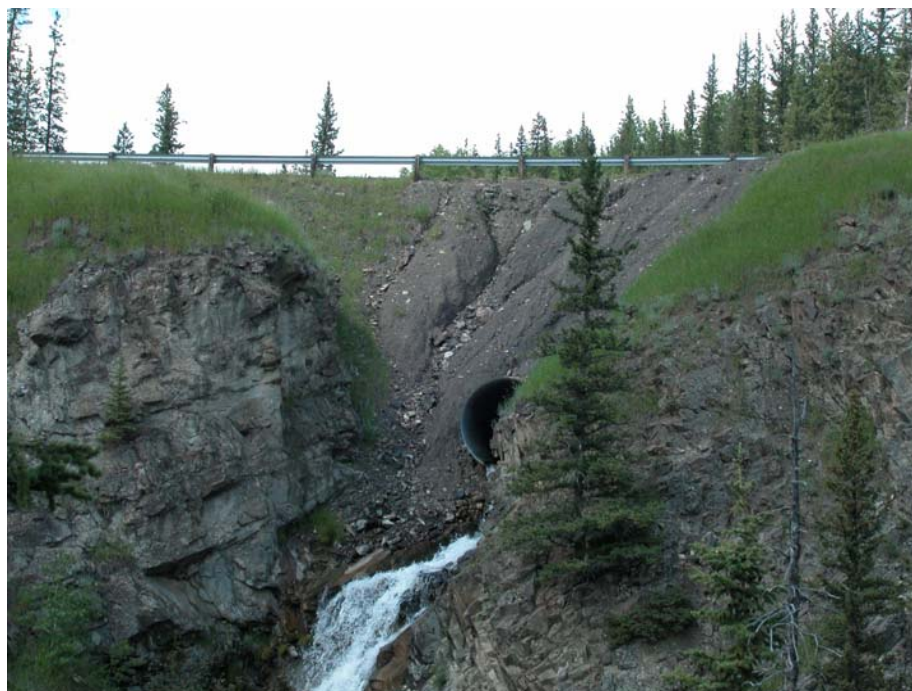
Photo 6 (lower left)
Facing north from downslope of the road. The height of the fill embankment above the culvert is visible, along with the pronounced gully erosion of the fill material adjacent to the south guardrail.

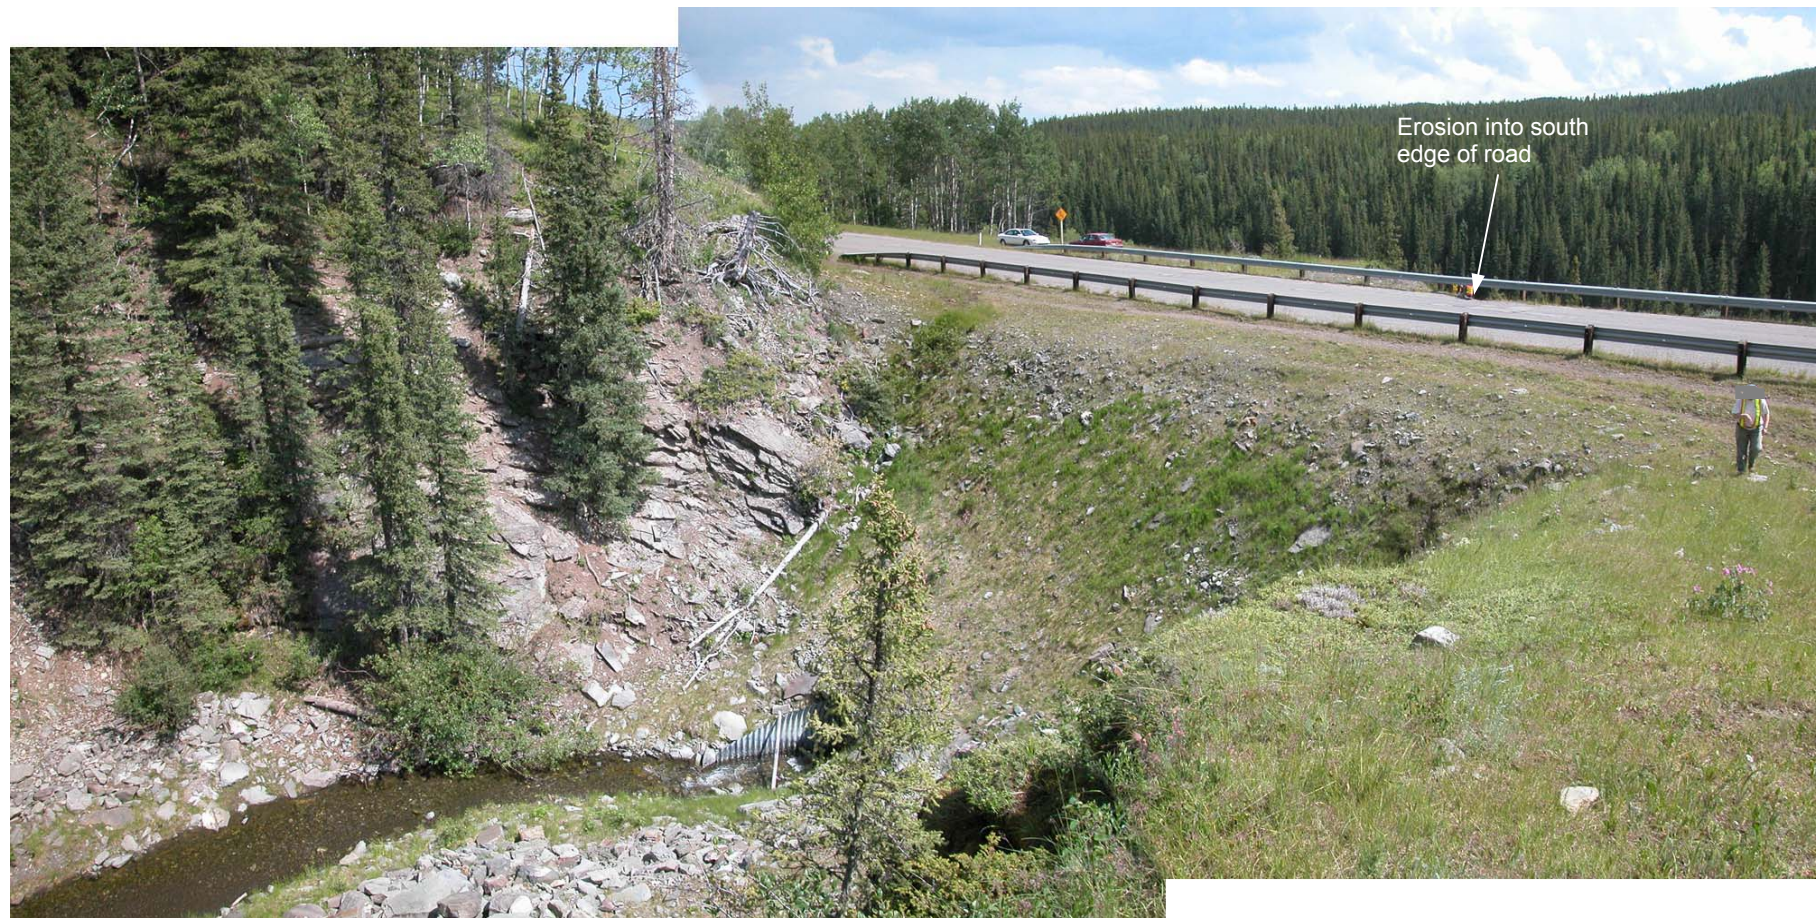
- A minor gully is developing on the west side of the upstream face of the embankment fill (Photos 7, 8). The catchment area that feeds drainage into this gully is relatively small. The gully appears to be well armored by large, angular cobbles from the fill embankment and local native ground.

Photo 7 (top)
 General view of the creek to the north of the highway. The culvert inlet is visible in the center, bottom of the photo. The point on the south guardrail shown in Photos 3 and 4 is as shown.

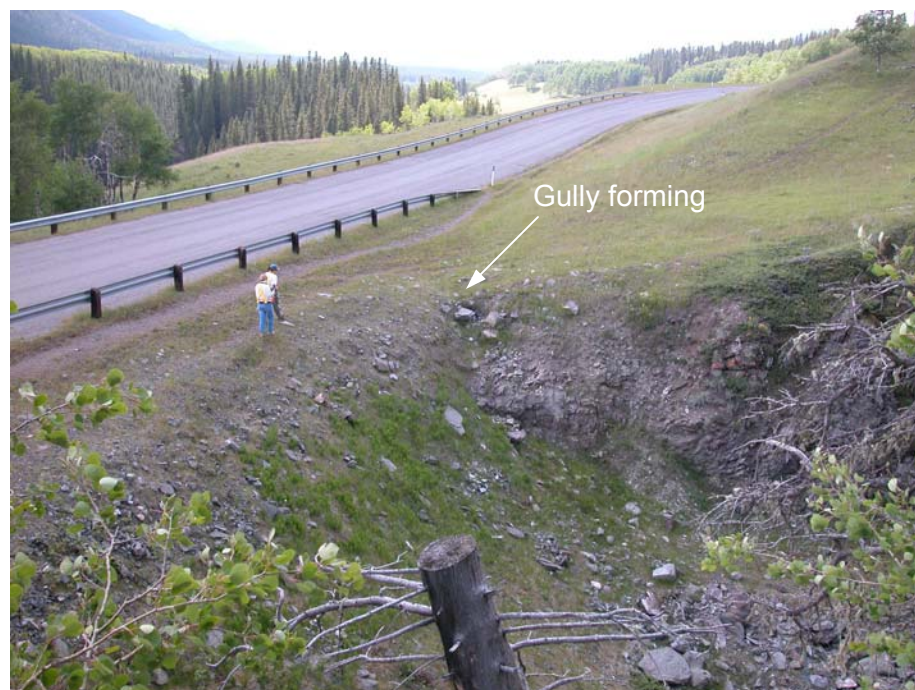
Photo 8 (bottom)
 Facing northwest across the north side of the highway/creek crossing. A minor gully is developing along the west margin of the fill embankment. This gully appeared to be well-armored by natural rock material, however it illustrates how uncontrolled runoff can erode into this fill material.
