S13 – SHEEP RIVER SITE

Alberta Transportation
Southern Region Geohazard Assessment
Annual Assessment Report
June 2004

PROJECT: SOUTHERN REGION GEOHAZARD ASSESSMENT

TITLE: SCHEMATIC SITE PLAN
HIGHWAY 546: SHEEP RIVER SITE

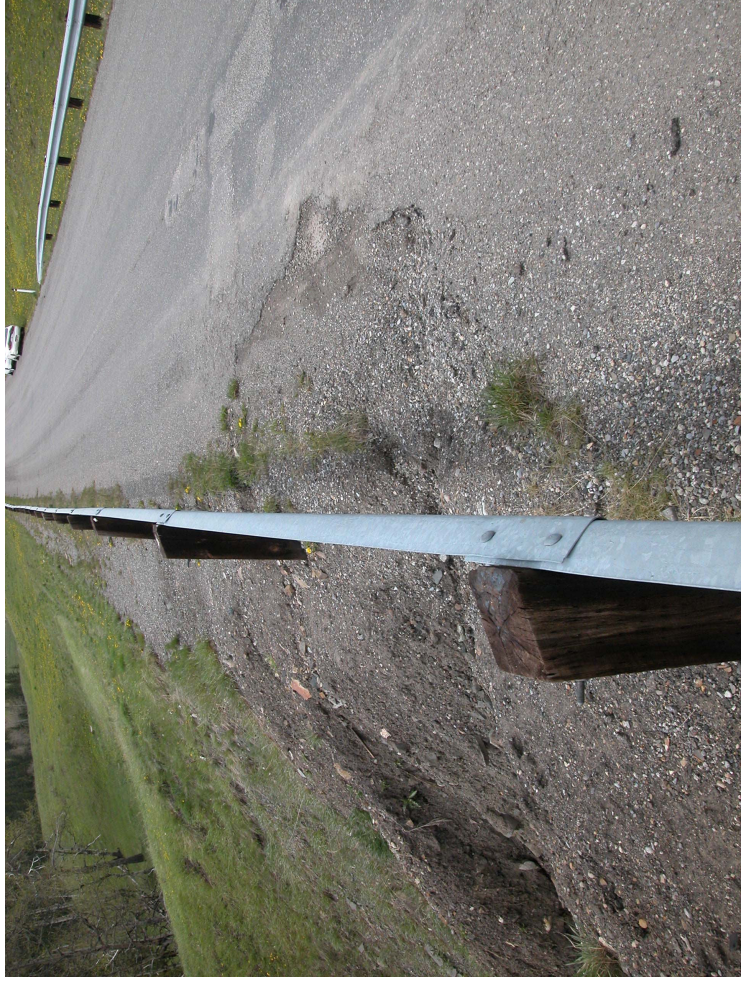
The rate of gully erosion into the eastbound lane was not estimated during the 2003 assessment because no previous assessments had been performed at this site and therefore there was no basis for comparison with previous years. Based on the visual observations from the 2004 assessment, the rate of gully erosion into the road surface is relatively slow and is

roughly estimated to have been less than 5 cm since the July 2003 assessment. Portions of the guardrail have been undermined but the guardrail itself has not been deflected to date. As noted in the 2003 assessment, the road surface is relatively wide at this location and it appears that the portion of the eastbound lane that has been lost to erosion to date is not within the traffic path. However any vehicles that pass close to the south guardrail are at risk of hitting the eroded and slightly undermined area. It is possible that the erosion into the southbound lane could be left unrepaired for several years without significant risk to the eastbound lane, however it would be preferable to repair the current damage, restore the full support to the guardrail posts and prevent it from happening again.

Photo S13-1 (upper left) – May 2004 – gully erosion retreating into the south edge of the road surface. There has been a slight retrogression (estimated less than 5 cm) of the erosion further back into the road since the July 2003 inspection. Compare with Photo S13-2.

- Backfill and asphalt patch the eroded/undermined area on the south edge of the road.
- Construct a small berm of asphalt along the south edge of the road.
- Leave two gaps in the asphalt berm to allow runoff to leave the road surface.
- Flumes (half culverts) or even whole culverts should be installed at the gaps in the asphalt berm to carry the runoff down to the toe of the embankment slope, so that runoff does not flow on the steep slope face at all. It will be very important to have a good contact between the inlet of the flume/culvert and the gap in the asphalt berm, or else the runoff will simply be concentrated onto the slope face immediately around the inlet.

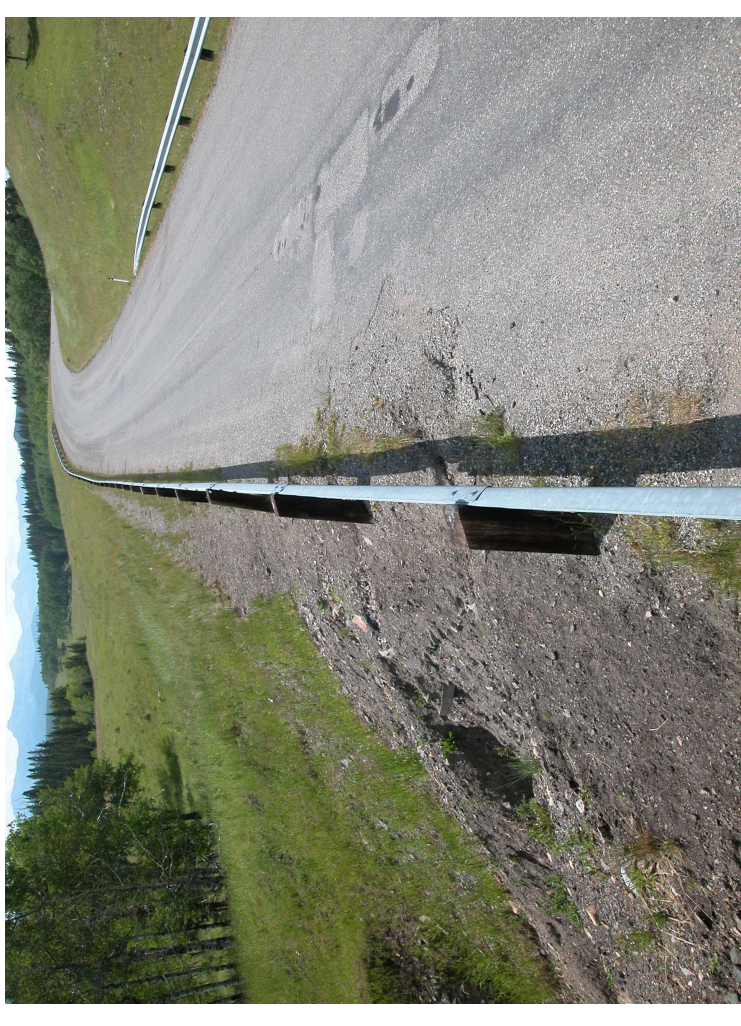
Photo S13-2 (upper right) – July 2003 – same area as shown in Photo S13-1, as seen during the July 2003 inspection.
