4.6 S7 – MILLARVILLE

The Millarville site is located on Secondary Highway 549:02, approximately 12 km west of Millarville and approximately 1.5 km west of the junction with Secondary Highway 762. This site has been inspected by AIT and consultant personnel since 2000 under the Southern Region GRMP.

PROJECT: SOUTHERN REGION GEOHAZARD ASSESSMENT

TITLE: INSTRUMENTATION SITE PLAN
SH 549 - WEST OF MILLARVILLE

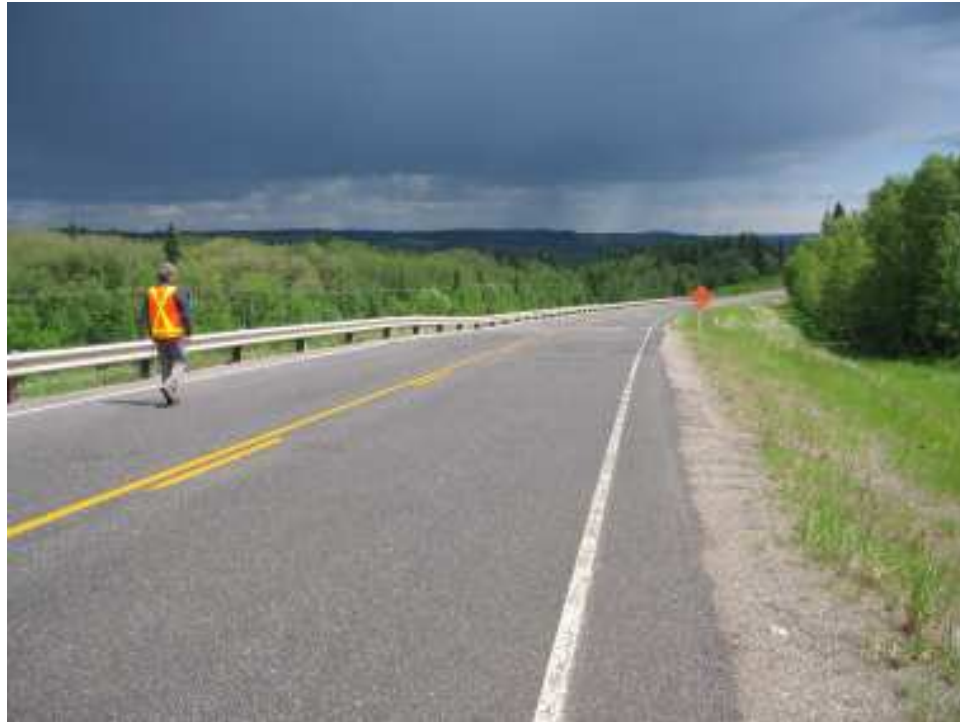
- A well-defined diagonal crack across the entire width of the highway was noted around Sta. 5+280 to 5+290 (approximately) and as shown on Photos S7-1 to S7-4. At the time of the inspection, the area to the east of the crack was downdropped approximately 30 to 50 mm relative to the west side. The orientation of the crack and the vertical displacement around it suggests that it forms the west/southwest flank of a landslide across the highway alignment. Cracking with a similar orientation but without such pronounced vertical displacement was noted in this area as well as further eastbound (around Sta. 5+320) in the 2005 and 2006 inspections. It appears that the specific

Photo S7-1 – June 2007 (upper left)
Facing east across the area where a pronounced diagonal crack and downdrop of the road surface was observed around Sta. 5+280/5+290 in the 2007 inspection. This area is approximately 120 m west of where the shear keys were installed in 2004 to mitigate landslide damage to the road surface. The crack position is marked with the orange “Sharp Shoulders” sign on the south side of the road and the vertical displacement across the crack is visible in the guardrail profile.

SI's should be installed around the diagonal cracking and vertical downdrop area around Sta. 5+280 and 5+290 in order to check for active landslide movement creating a risk to the highway. Based on the previous borehole drilling in this area, it is expected that clay and clay till soils underlie the highway and any landslide movement may be driven by high groundwater pressures. Therefore, **piezometers should also be installed** to check the piezometric conditions in this area.

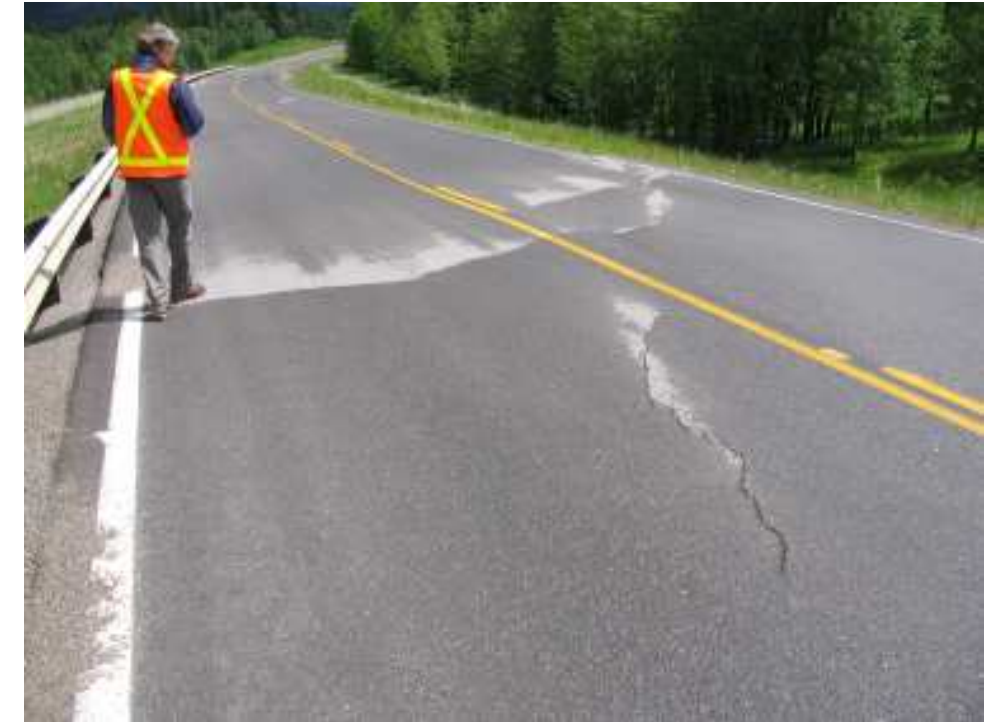
Photo S7-2 – June 2007 (upper right)
Closer view, facing east, of the diagonal crack and downdrop area around Sta. 5+280 and 5+290. This location was marked with a “Sharp Shoulders” sign at the time of the inspection.

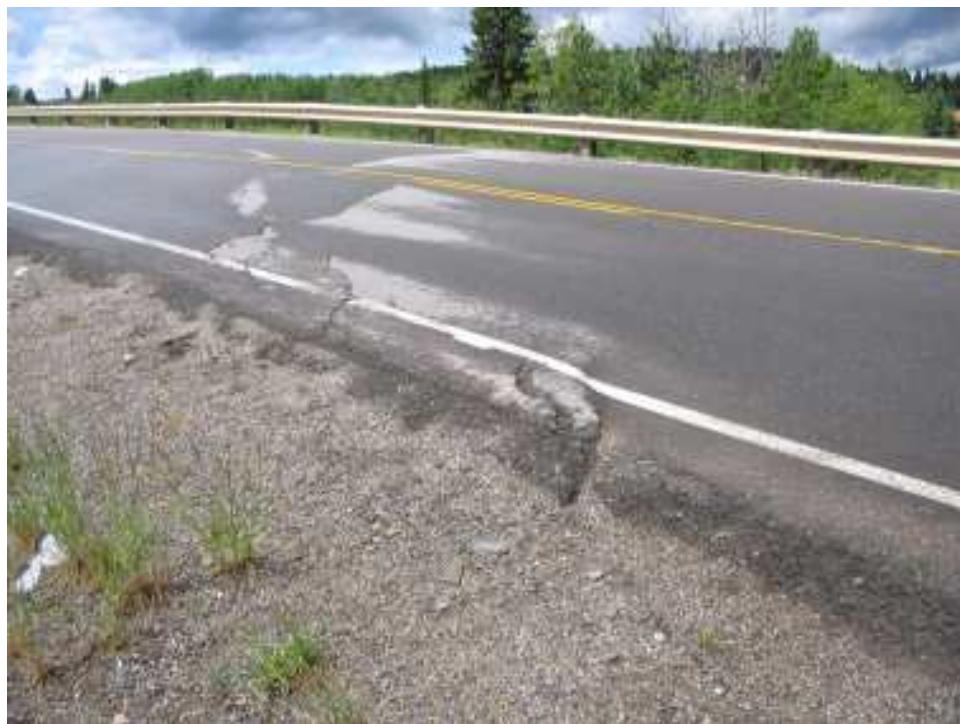
Photo S7-3 – June 2007 (lower left)
Facing northwest across the diagonal crack and downdrop area around Sta. 5+280/5+290. At the time of the inspection, the road surface to the east of the crack (right hand side of photo) was downdropped approximately 30 to 50 mm relative to the west side.

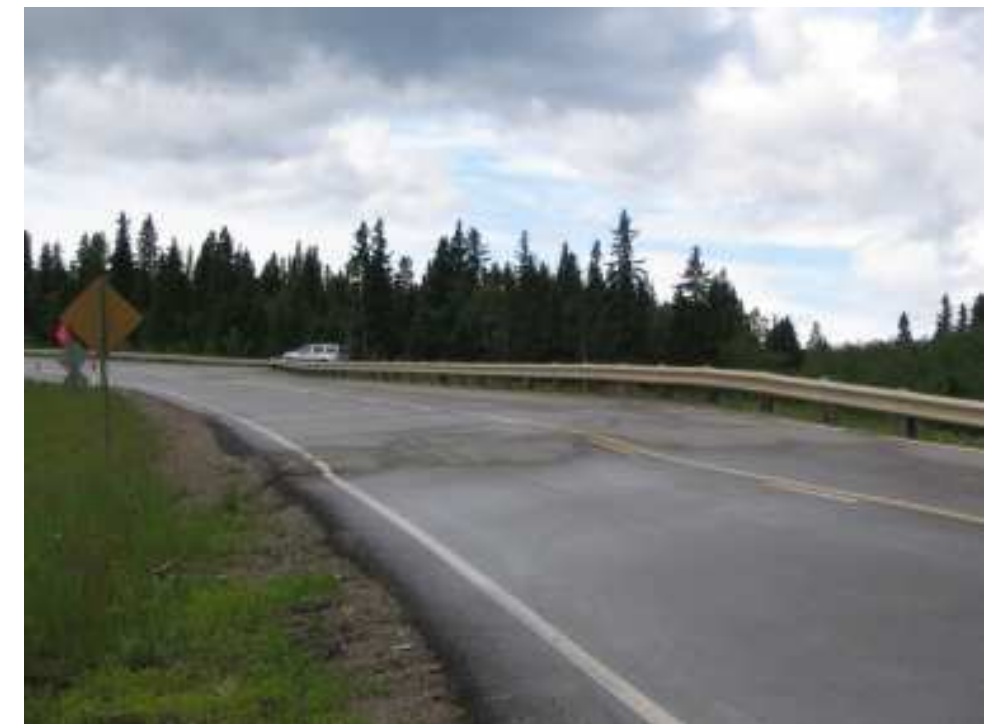
Photo S7-4 – June 2007 (lower right)
Facing west across the diagonal crack and downdrop area around Sta. 5+280/5+290. The vertical displacement across the crack is clearly visible.

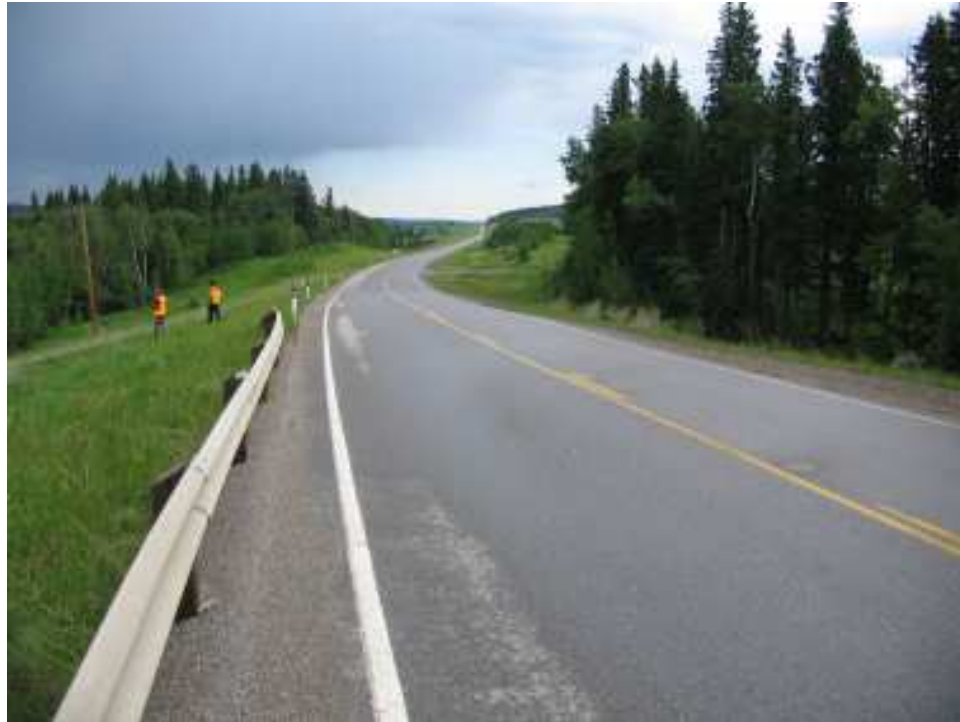
- A single crack was noted in the segment of the road through the area where the shear keys were constructed in the fall of 2004 (between approximately Sta. 5+400 and 5+460). No vertical displacement was noted across this crack. Photo S7-6 shows the crack. Otherwise, the road surface in this area was intact and in good condition with no visible signs of landslide damage from after the 2004 repairs. Photos S7-5 and S7-6 show this area.

Photo S7-5 – June 2007 (upper left)
Facing east across the segment of the highway where the shear keys were installed in 2004 (approximately Sta. 5+400/5+460) in order to prevent further landslide damage to the highway. Aside from one crack in the road surface (shown in Photo S7-6), there has been no further damage to the road surface since the repair.

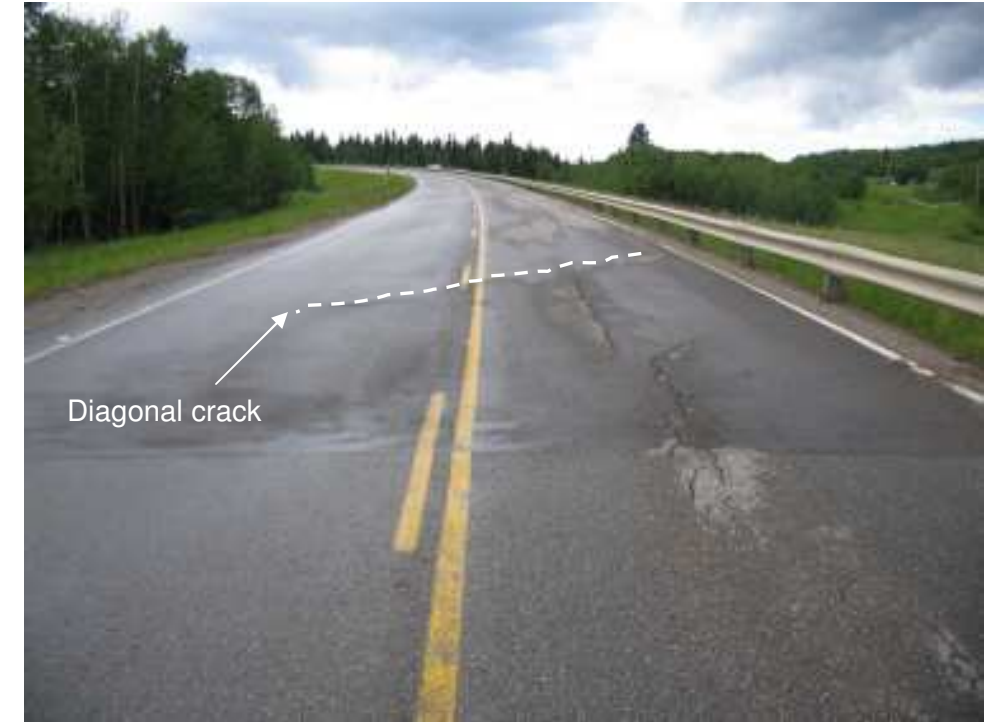
Photo S7-6 – June 2007 (upper right)
Facing west across the segment of the highway where the shear keys were installed in 2004. The diagonal crack visible in the middle background (highlighted in the photo) has developed since the repair, but otherwise no further damage to the road surface. There was negligible vertical displacement across the crack at the time of the inspection.
