September 29, 2008

CG25277.B

**Re: Southern Region Geohazard Assessment Program  
Site S7 – Millarville, Highway 549:02  
2008 Annual Inspection Report**

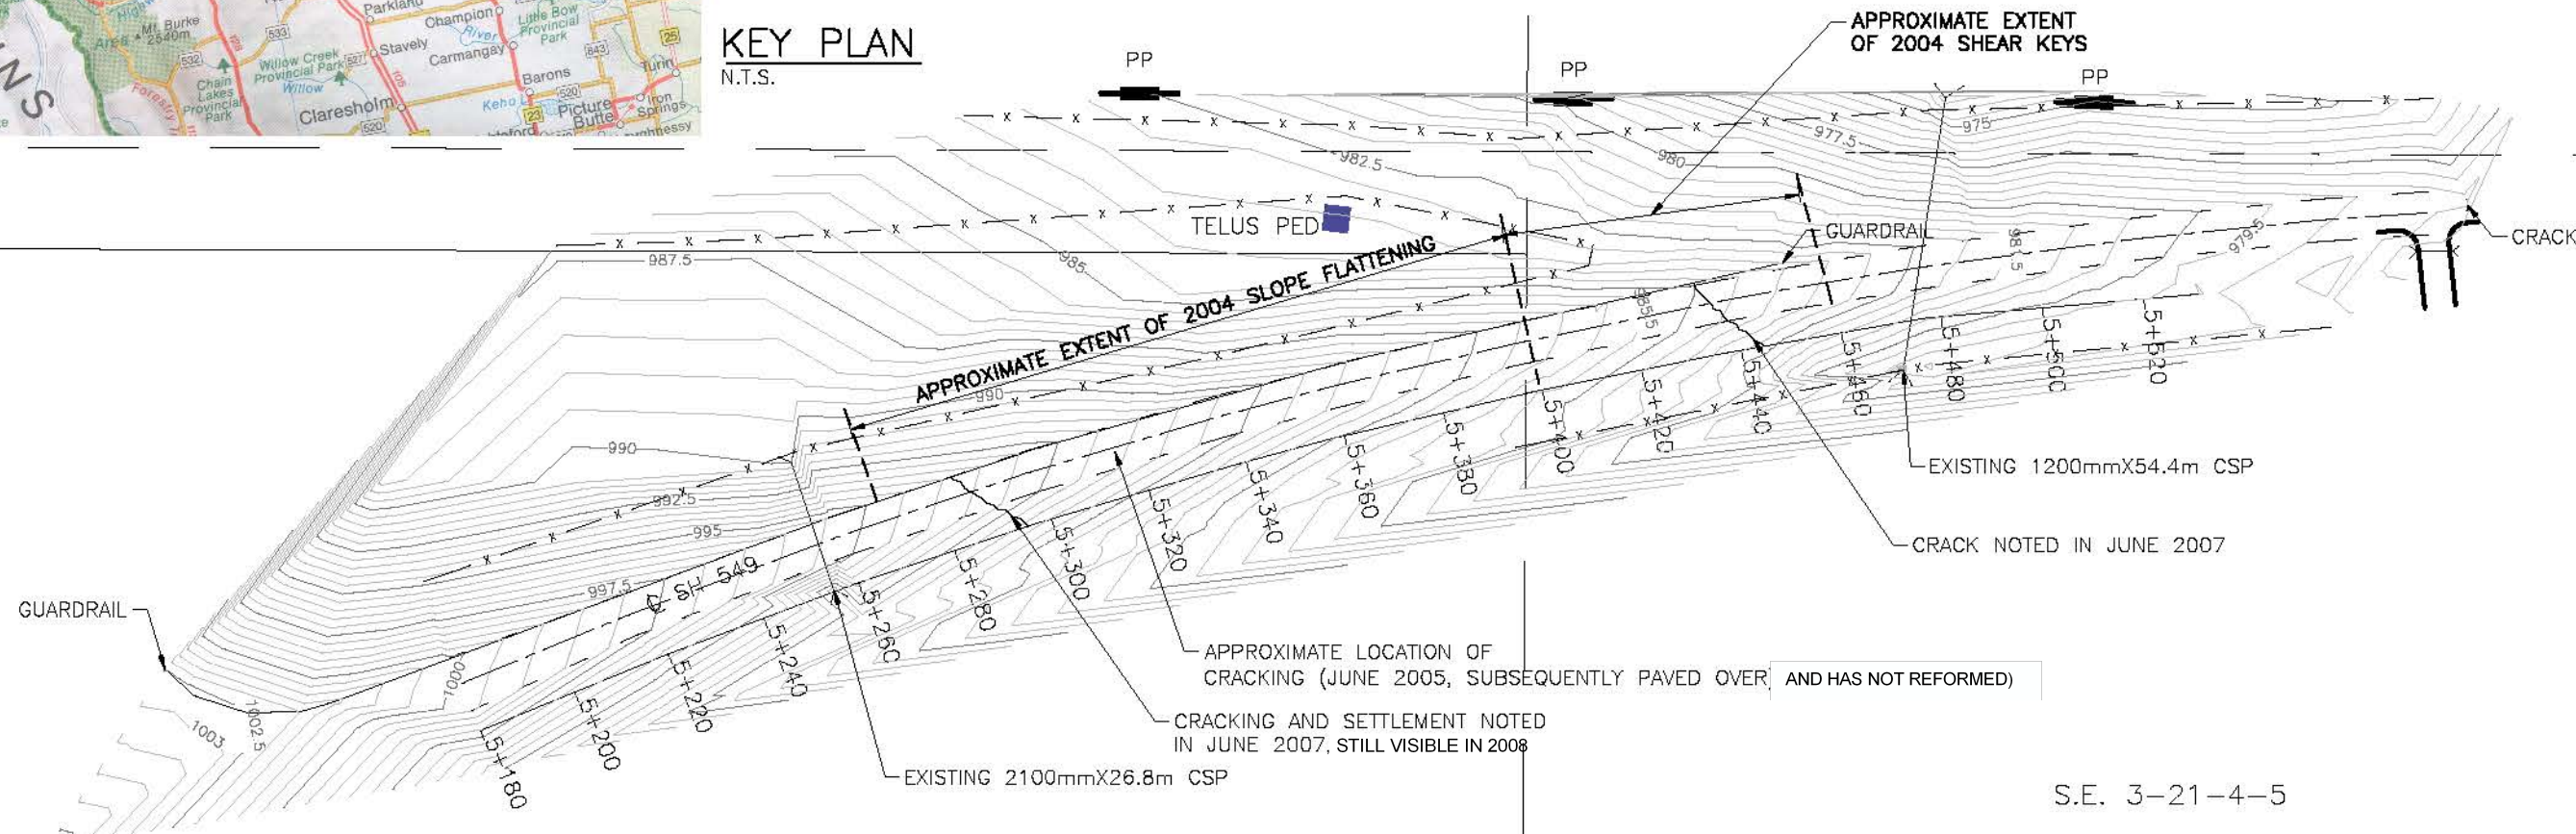
PROJECT: SOUTHERN REGION GEOHAZARD ASSESSMENT			
		TITLE: SITE PLAN S7-SH 549 - WEST OF MILLARVILLE			
CLIENT:			DATE: AUGUST 2008	JOB No.: CG25277.B	CAD FILE:
			FIGURE No.:	REV.	
			FIGURE S7-1	A

- The cracking areas around Sta. 5+280/5+290 and 5+440 (see attached site plan) that were noted west of the 2004 shear key construction area in the 2005 to 2007 annual inspections were still visible through minor patches and overlays since the 2007 inspection. However, the magnitude of the cracking and adjacent settlement was significantly less than noted during the 2007 inspection. Photos S7-1 to S7-3 show views of the cracking area as seen during the June 2008 inspection.
- Otherwise, no significant changes in the site appearance since the 2007 inspection.

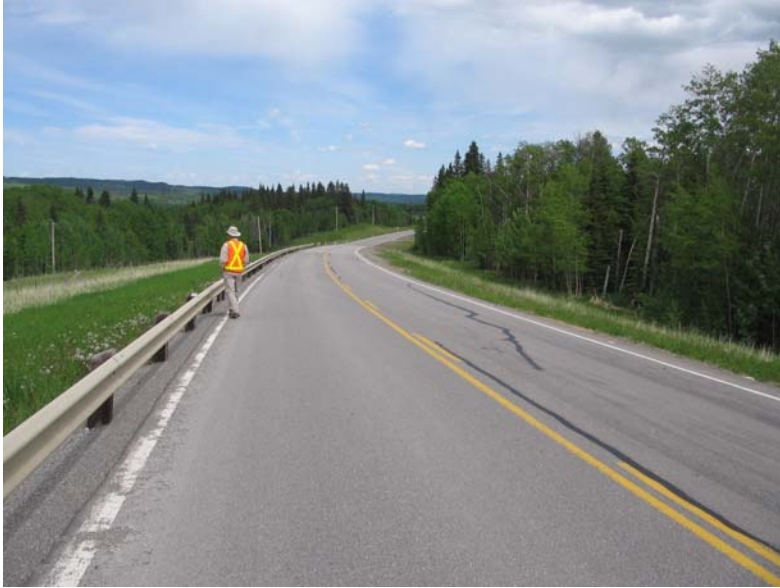
**Photo S7-1 – June 2008 (top)**

The post-2004 cracking areas that have been noted west of the shear key repairs from 2005 onwards continue to be visible, but with less significant damage to the road surface in the most recent inspections. It appears that this cracking can continue to be treated as a maintenance issue.

Facing eastbound across the cracking area around Sta. 5+280/5+290. The previous cracks are still visible, but appear to have remained sealed since 2005/2006.

- AT's maintenance contractor personnel should continue to patch or crack-seal the cracking areas as required in the future, as part of the normal maintenance for the highway.

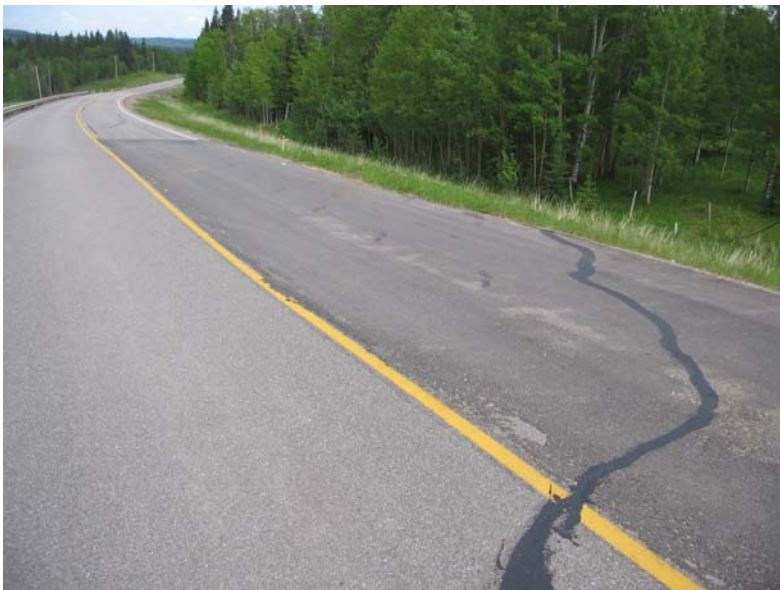
**Photo S7-2 – June 2008 (bottom)**

Another view facing eastbound, closer to the cracking area around Sta. 5+280/5+290. Minor additional cracking has occurred since the 2007 inspection, but previously-sealed cracks have not re-opened.

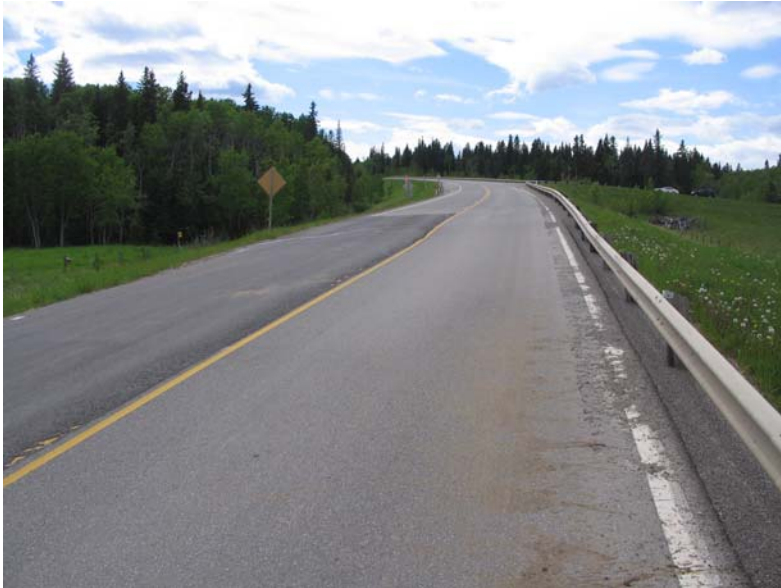
**Photo S7-3 – June 2008 (top)**

Facing westbound across the cracking area around Sta. 5+280/5+290. No significant additional cracking since the 2007 inspection.
