CG25309.B

**Re: Southern Region Geohazard Assessment Program
Highway 742:02 Avalanche Areas
2009 Annual Inspection Report**

This letter documents the 2009 annual site inspection of the avalanche areas along Highway 742:02, southbound of Canmore, AB.

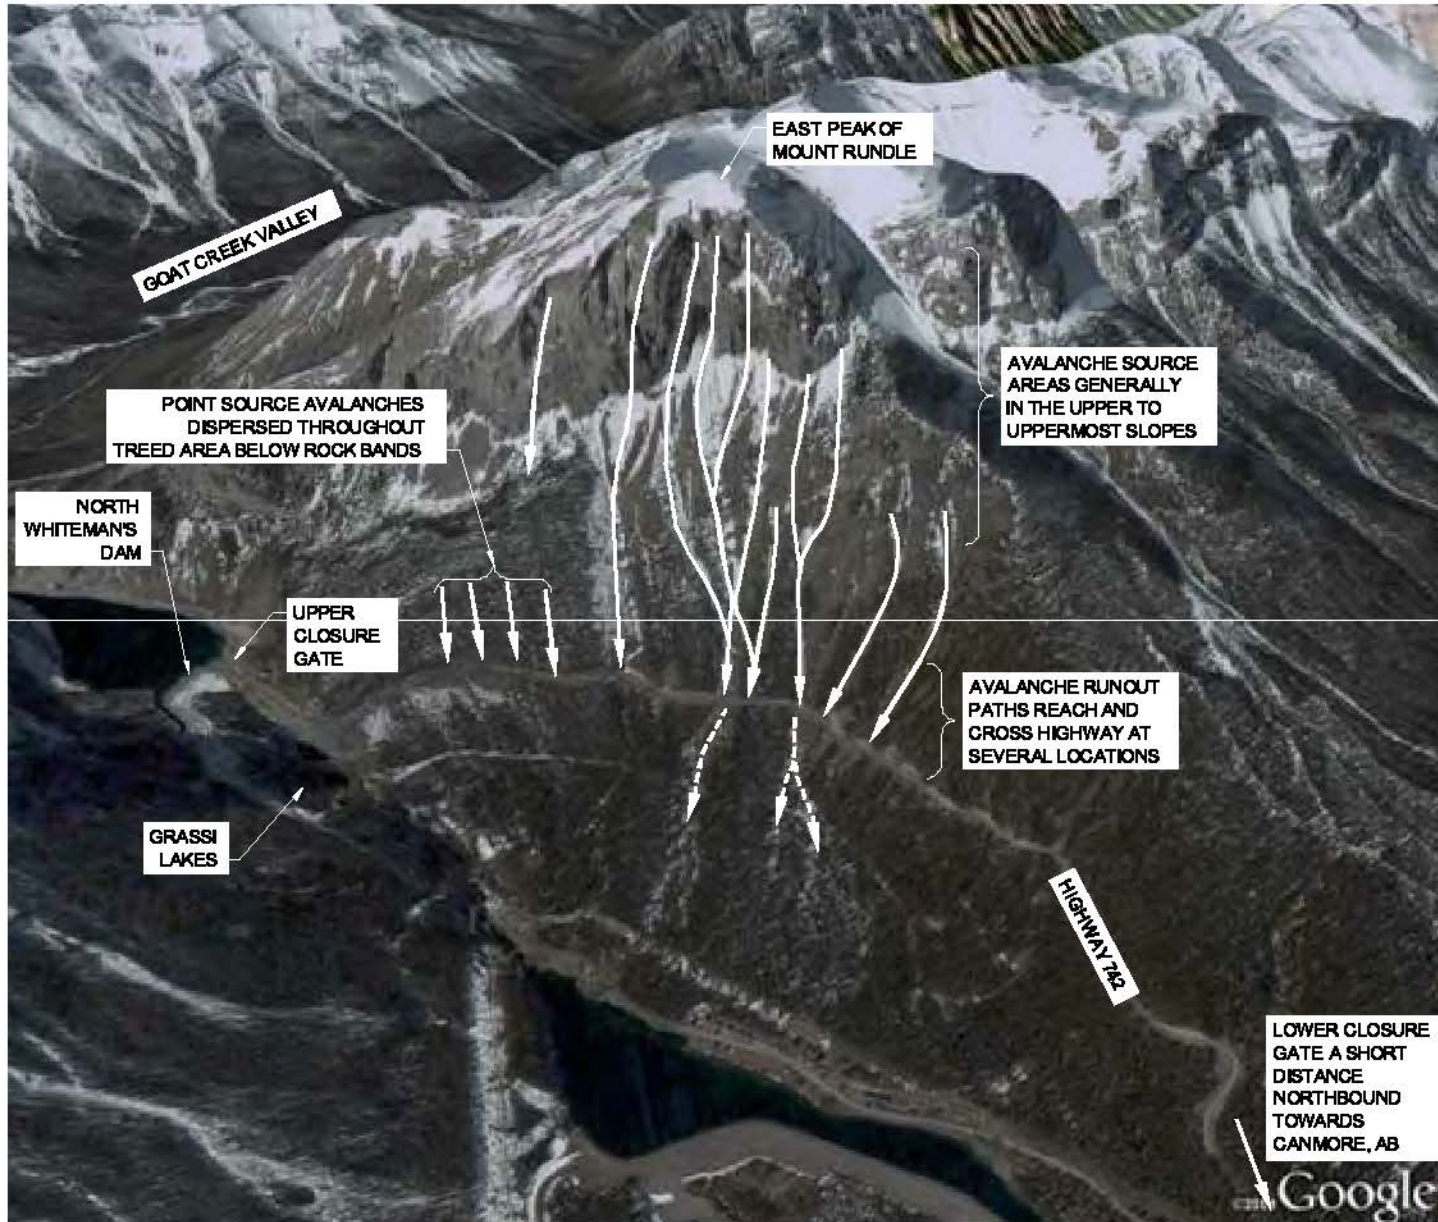
PROJECT: SOUTHERN REGION GEOHAZARD ASSESSMENT				
	TITLE: "EAST END OF RUNDLE" AVALANCHE AREA OBLIQUE VIEW SHOWING AVALANCHE PATHS				
CLIENT:			DATE: JUNE 2009	JOB No.: CG25309.B	CAD FILE: 25309N15.dwg
				FIGURE No.: FIGURE 2	REV. A

- There is an avalanche hazard along the highway from the steep slopes on the east end of Mount Rundle. Of note, this area was also the site of the February 1991 incident where a vehicle parked within the signed avalanche hazard area was swept from the highway by a naturally occurring avalanche (please refer to the April 2009 Highway 742 corridor geohazard review report for further details).

- The approximate location of the avalanche source zones and runout paths above the highway are shown on Figure 2, attached.
- The Parks Division personnel assess the avalanche hazard in this area based on visual reviews of the snowpack conditions on the slopes above the highway, supplemented with temperature and wind data from a weather station near the summit of the east end of Mount Rundle that is operated by the Parks Division. It was noted that this weather station does not have the capability to measure snowfall, but that the addition of a precipitation/snowfall gauge to the existing weather station would almost certainly not provide representative data for the avalanche source areas that are subject to highly localized wind-borne snow accumulation.

The heli-bombing avalanche control work is judged to be the most suitable option for this site. It is also considered to be by far the most cost-effective, given that the ballpark cost per season has been in the order of \$13,000 per year or less from 2001 to 2009 (not including the associated cost for the maintenance contractor to plow the highway after avalanches are triggered).

1. **It is recommended that the Parks Division continue with the monitoring of avalanche conditions and avalanche control work as required for these three areas.** The use of other avalanche control measures to supplement or replace the heli-bombing avalanche control work is not recommended. As described in the "Assessment" section, the other possible avalanche control measures are assessed to be less practical and/or less cost-effective than continuing with the heli-bombing by the Parks Division as required, provided that AT can accept the consequence of temporary closures of the highway through the "East End Of Rundle" area pending heli-bombing and snow clearing from the road.

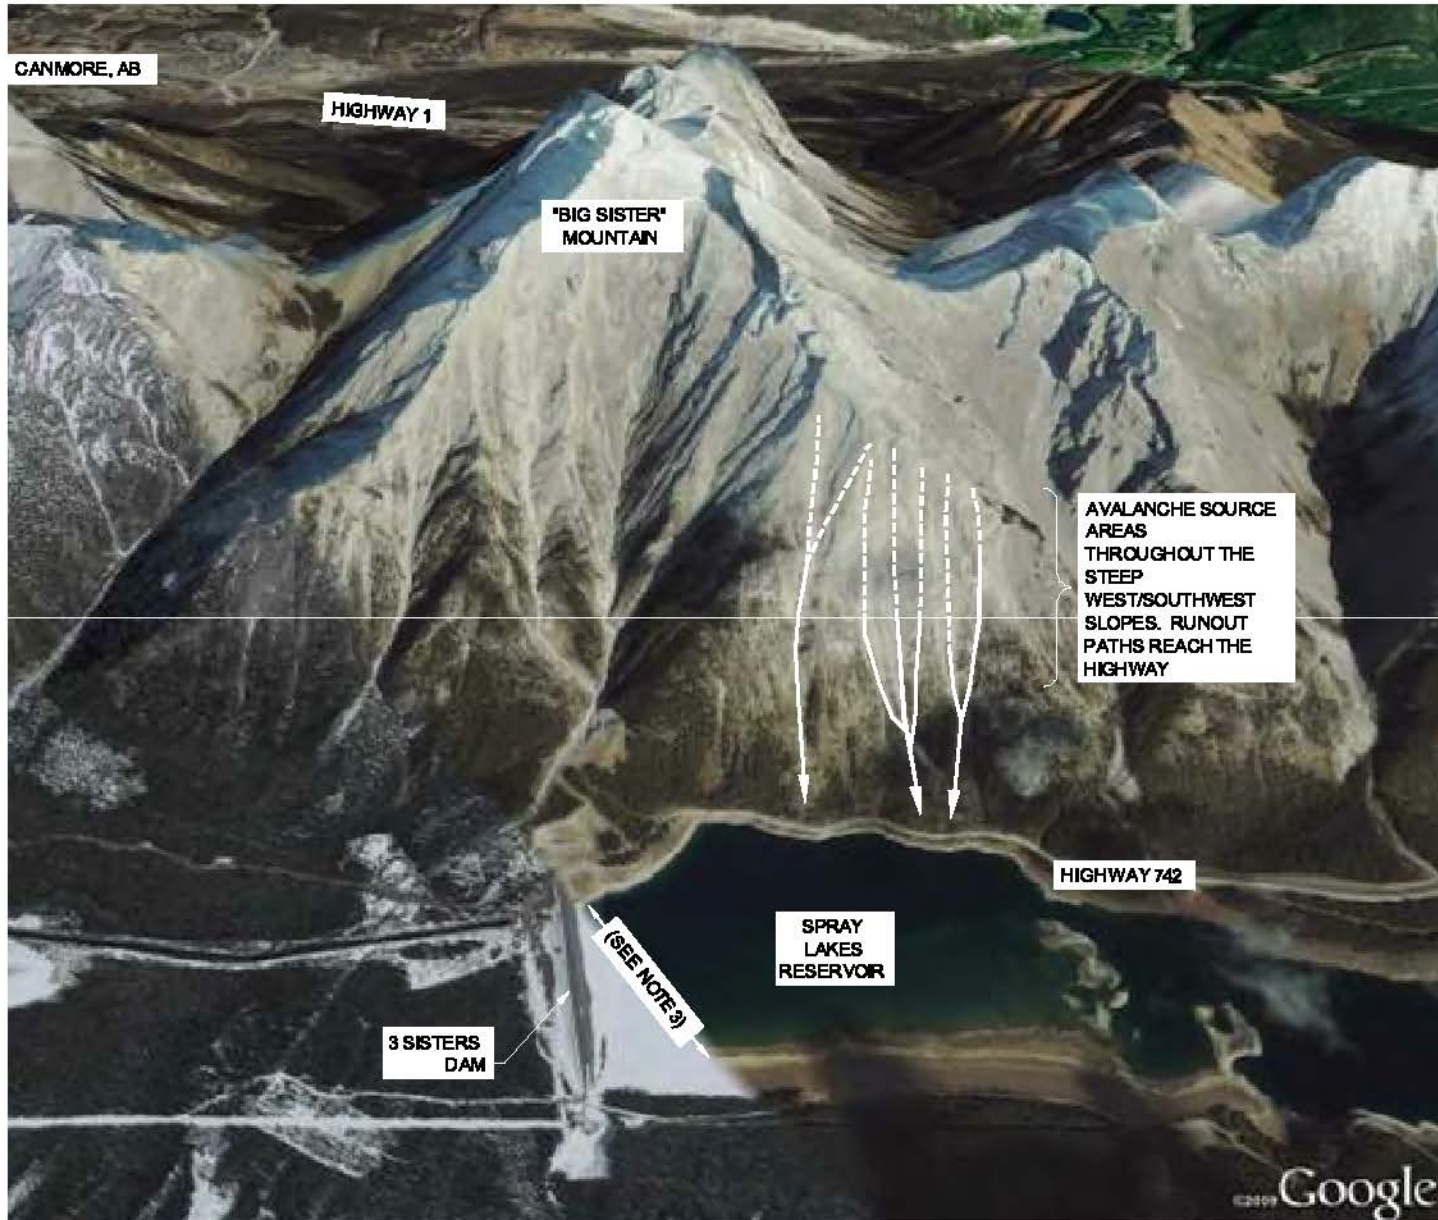
DATE:	JUNE 2009	JOB No.:	CG25309.B	CAD FILE:	25309N15.dwg	FIGURE No.:	FIGURE 3	REV.	A

There is an avalanche hazard along the highway from the steep lower slopes on the west/southwest side of the “Big Sister” mountain, a short distance southbound from the Three Sisters Dam. The approximate location of the avalanche source zones and runout paths above the highway are shown on Figure 3, attached.

It is understood from the Parks Division that the avalanche hazard at this site is relatively low for most of each winter season because there is typically relatively little snow accumulation in the avalanche source zones in the treed area upslope of the highway. However, under certain conditions more significant and unstable snowpacks can develop and the avalanche hazard increases correspondingly. This can occur as a result of moist snowfalls that “stick” to the slope rather than more typical drier winter snow that is prone to being blown off the slope by the prevailing winds in this area. Suitably moist snowfalls with winds favourable for snowpack accumulation in the source zones can occur during upslope storm events and/or in the spring of each year. As a result, the segment of the highway below the avalanche runout zones has been temporarily closed on occasion every few years but typically not every year. The frequency and duration of closures varies depending on weather and snowpack conditions. The avalanche hazard conditions are evaluated daily during each season by the Parks Division personnel.

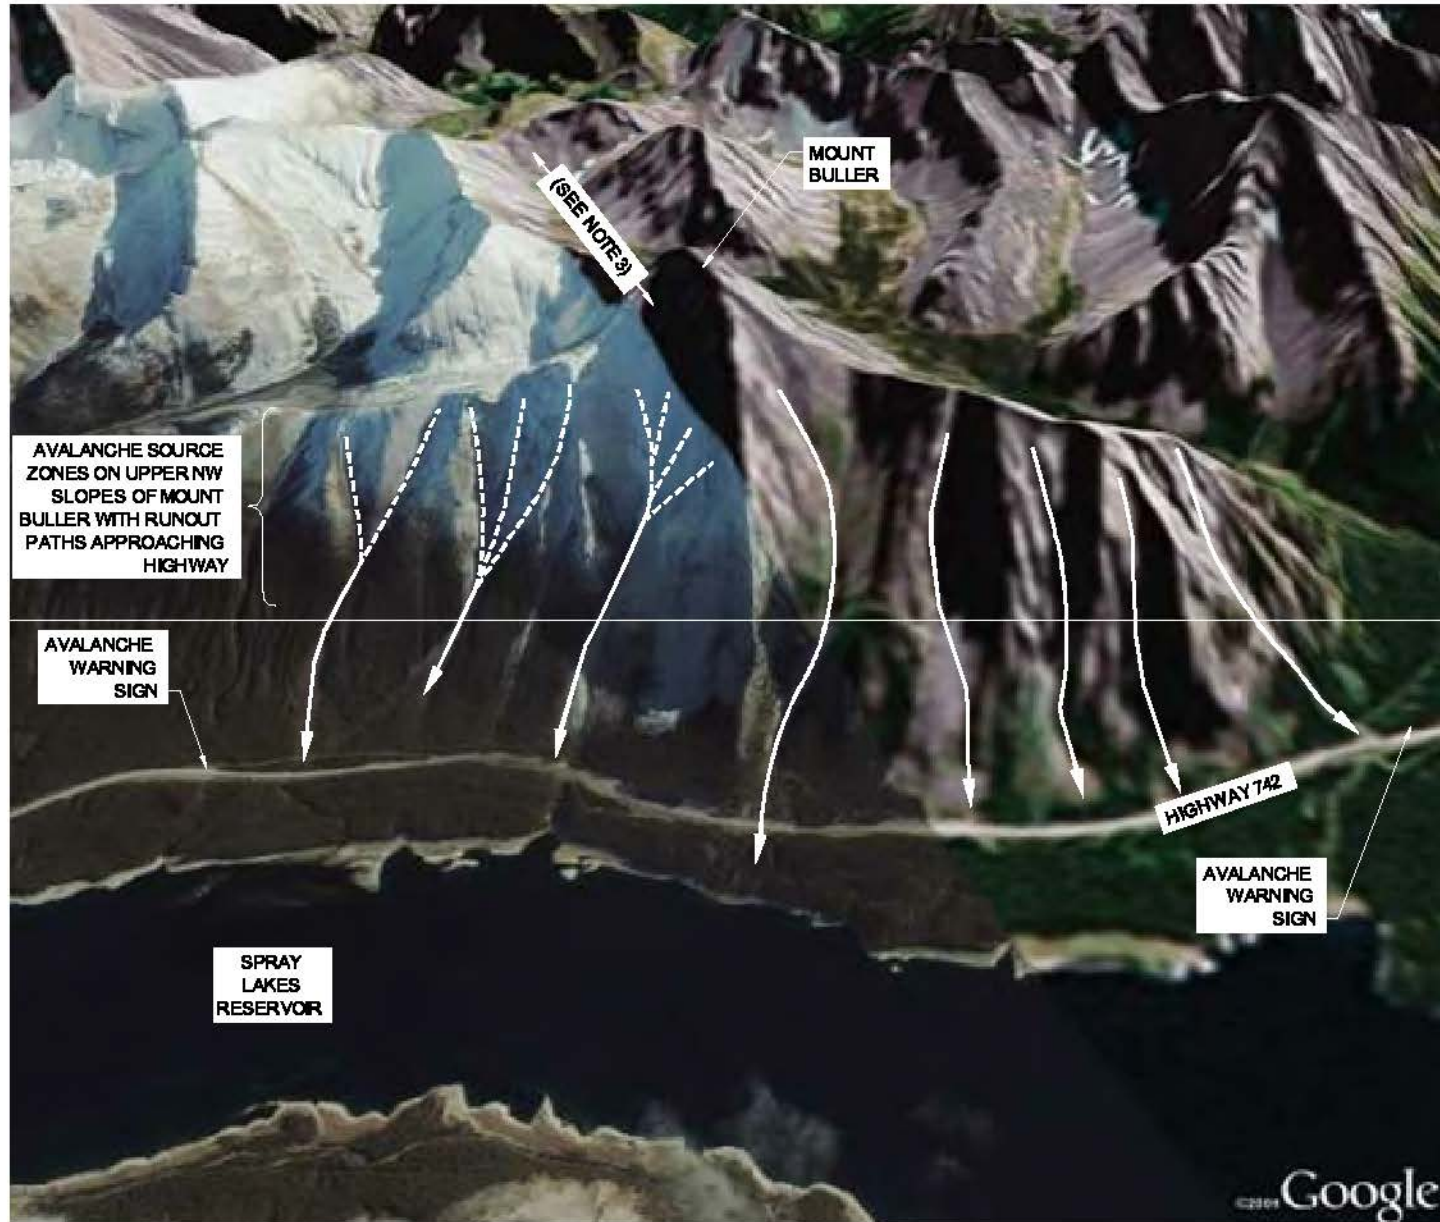
There is an avalanche hazard to the highway from the west/northwest slopes of Mount Buller. The approximate location of the avalanche source zones and runout paths above the highway are shown on Figure 4, attached.

It is understood from the Parks Division that this area typically produces avalanches throughout each winter season, and in the last approximately 20 years avalanche runout has come close to the highway on occasion but has not reached the road surface. However, the potential for future avalanche runout to reach the highway cannot be entirely ruled out. It is also understood that heli-bombing avalanche control measures have been applied at this site on one occasion in the past.

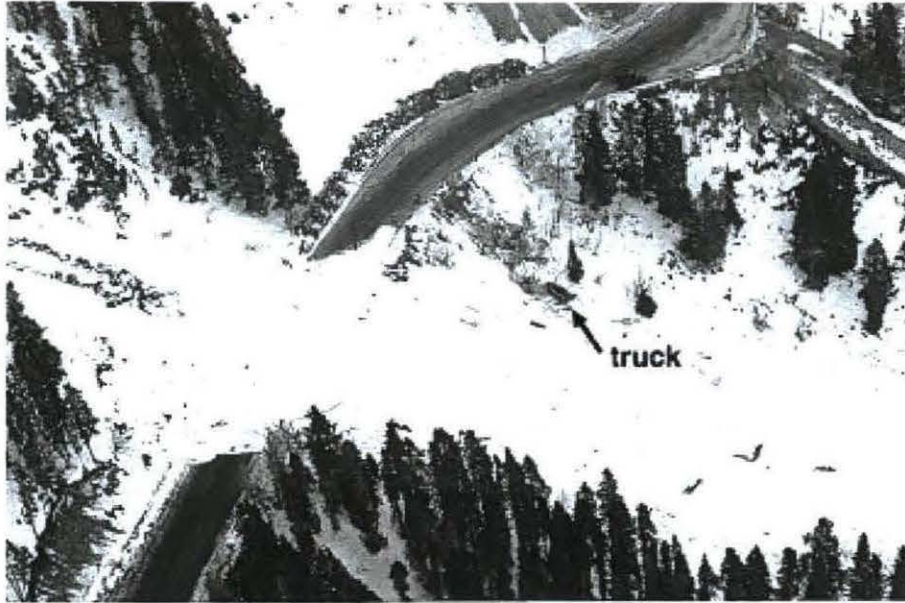
Photo 742-18 (top)
(Figure 7.4 from Jamieson and Geldsetzer (1996))

February 1, 1991 photo of avalanche across Highway 742, apparently a short distance southbound from the warning sign at Km 4.8. The location of the truck that was swept from the highway is shown.

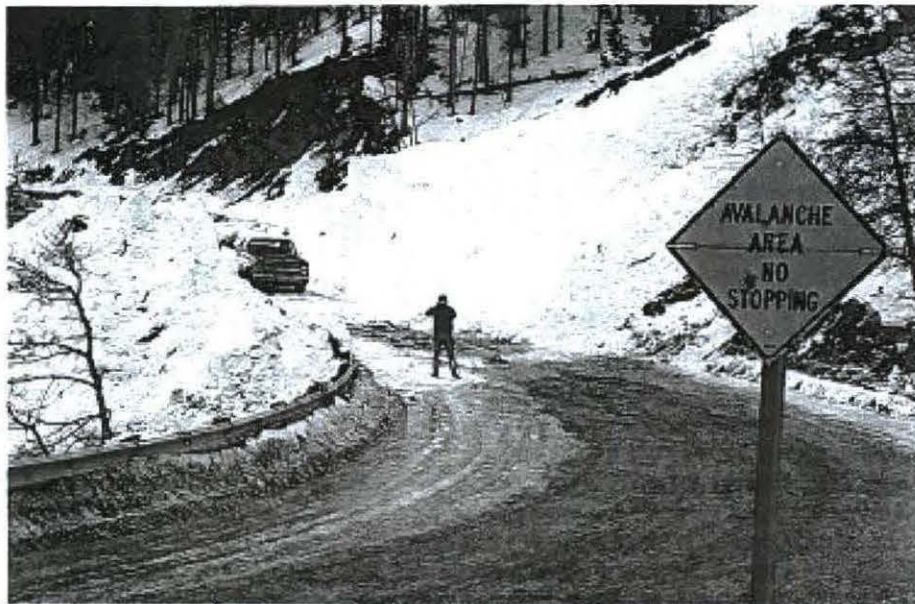
Photo 742-19 (bottom)
(Figure 7.5 from Jamieson and Geldsetzer (1996))

February 1, 1991 photo facing southbound from the warning sign around Km 4.8, with the recently-cleared snow deposit across the highway visible in the background.

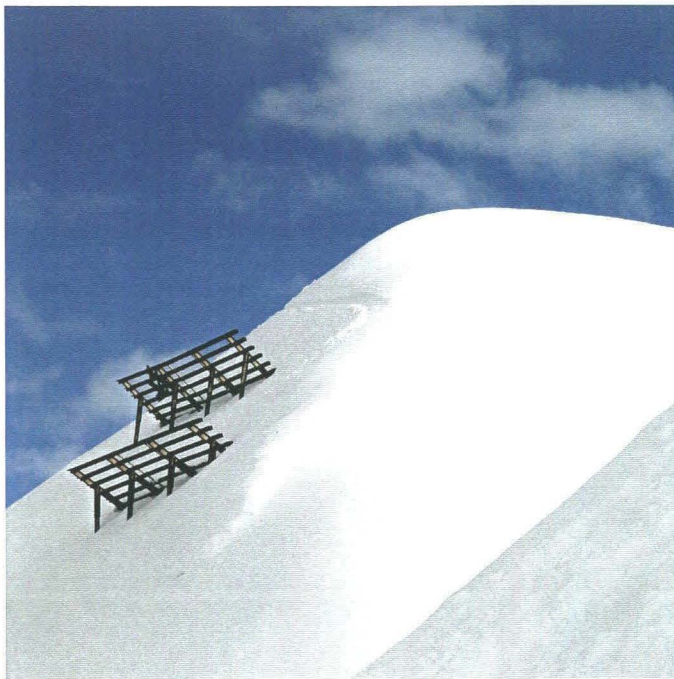
Photo 742-20 – example of a snow redistribution structure installed at a ski resort in Austria to deter the accumulation of an unstable snowpack in an avalanche source area.
