Highway 742 – Grassi Lakes Area, ~Km 3.3 to ~Km 6.1

October 2008 Site Inspections

~Km 3.3 To ~Km 3.6 Cut Slopes

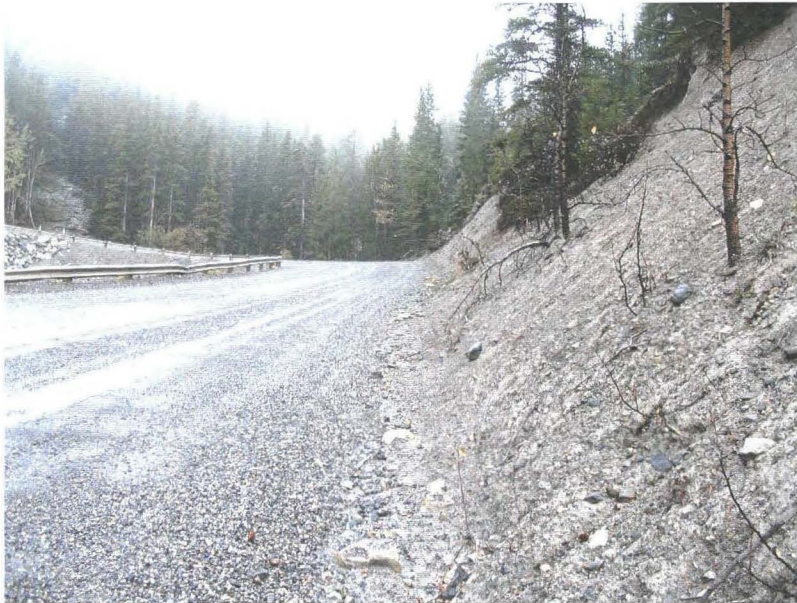
- The cut slope along the upslope side of the road is typically 6 to 7 m high and exposes silt till soil with occasional gravel to cobble sized particles. The cut slope angles are typically around 32 to 34°, however in places they are up to approximately 45°. Photos 742-1 and 742-2 show one of the areas with an approximately 45° cut slope and without a ditch.

- The upslope ditch along this segment of the highway is undersized and in places of negligible size and capacity. The ditch is typically 1 to 1.5 m wide and 0.3 to 0.5 m deep, however there are segments where there is no upslope ditch at all.

The upslope ditch appears to be undersized relative to the size and inclination of the cut slopes along this segment of the highway. In places, there is a negligible to no ditch along the toe of cut slopes up to 45° inclination. There is a risk that cobble-sized, and possibly up to boulder-sized, rocks within the silt till could erode out from the cut slope and then slide or roll downslope onto the road surface without being contained by the ditch. It is also possible that without timely maintenance, eroded material and slope wash from the cut slopes (consisting of fines to gravel and cobble sized rocks) could easily fill the existing ditch to capacity and limit the ability of the ditch to contain surface runoff from the road.

Photo 742-1 (top) – Facing southbound along the road from around Km 3.5. Note the lack of upslope road ditch adjacent to the cut slope exposed rocky silt till soil at up to 45° inclination. Despite the lack of ditch, there was little to no evidence of debris from the cut slope spilling onto the road nor of surface runoff eroding the road surface.

The Risk Level for this site could be reduced by increasing the ditch size along this segment of the highway to provide a greater ditch capacity that would reliably contain eroded material from the cut slope and accommodate surface runoff from the road surface. This would reduce the dependence on timely maintenance to clear any debris from the cut slope that spills onto the road surface.

However, it is not recommended that the ditch be re-sized at this time. The Risk Level is likely 18 or less, as described above, and the effort and follow-up maintenance to increase and maintain the ditch size is judged to outweigh the benefit of the possible reduction in the Risk Level at this site. Furthermore, it is understood that there is a buried telephone cable along the upslope ditch that would likely need to be buried deeper or relocated in order to accommodate a deeper ditch.

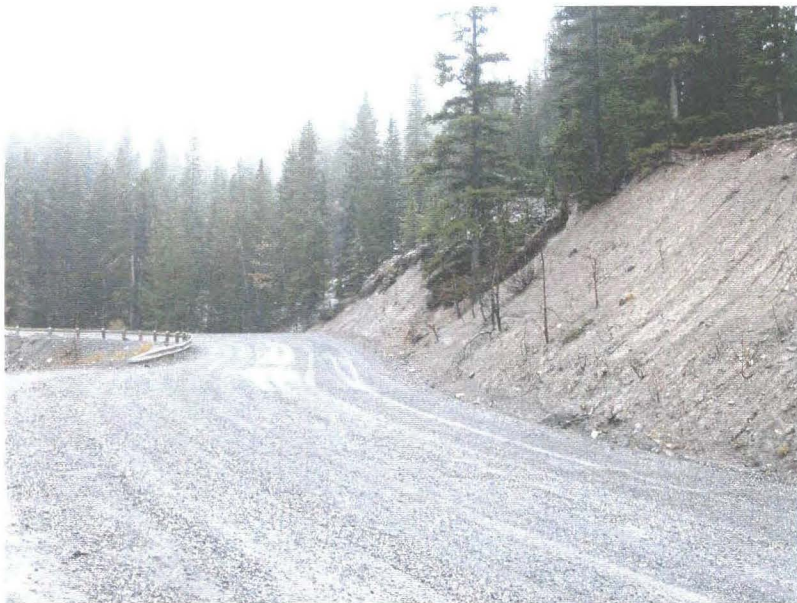
Photo 742-2 (bottom) – Another view facing southbound around Km 3.5.
