~Km 3.7 Fill Embankment

Site Observations

Hwy 742 – ~Km 3.7 Fill Embankment

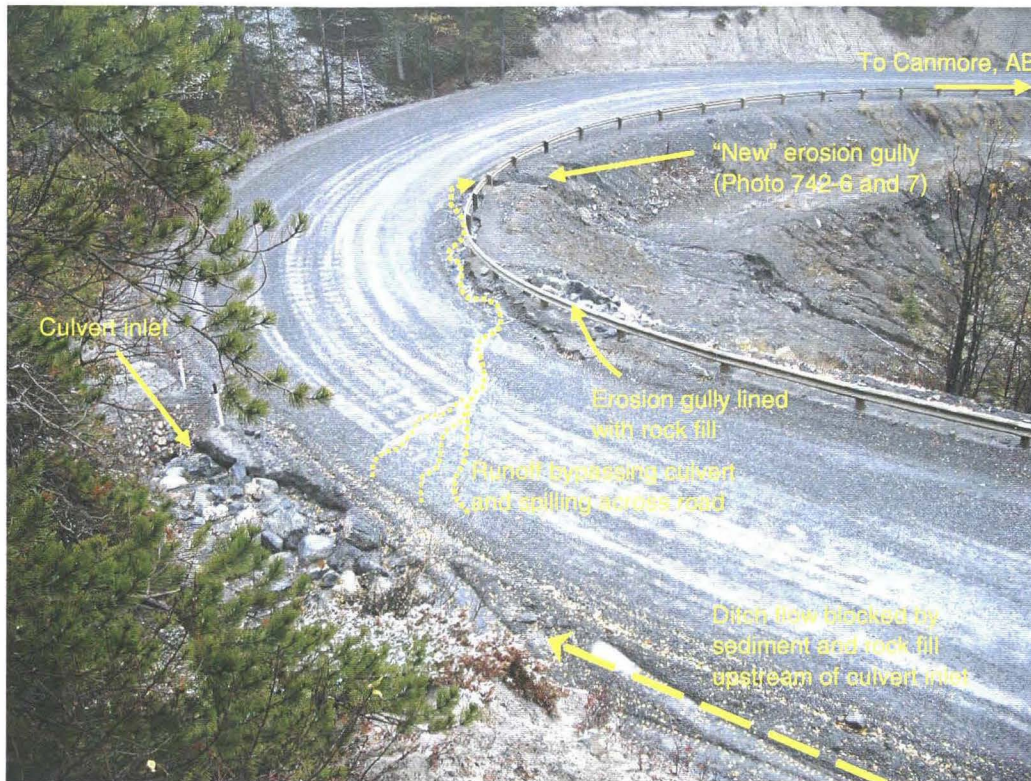
- The infilling of these segments of the ditch has caused the ditch flow to erode slightly into the upslope edge of the traffic surface to get around the boulders blocking the ditch, as shown in Photo 742-4. Ditch flow had also bypassed the culvert altogether by spilling onto the road surface, flowing across the road and onto the downslope embankment face. This had led to erosion in the downstream face of the embankment fill as follows:

Photo 742-3 (top) – Facing northbound along the highway and across the Km 3.7 Fill Embankment site.

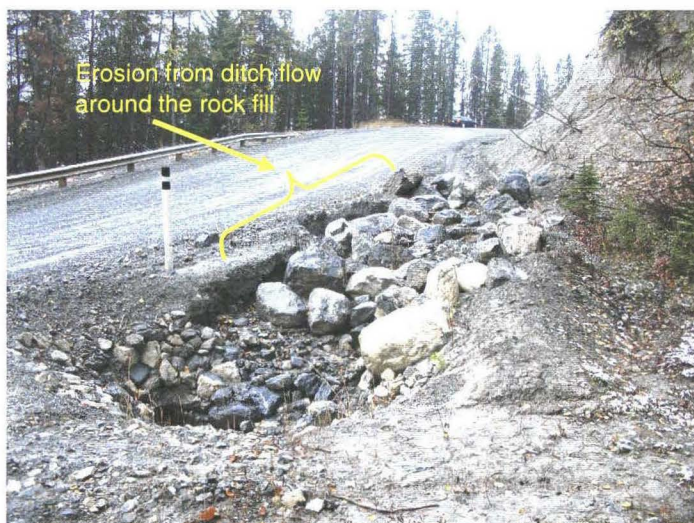
- Boulder-sized rocks for a short distance upstream from the culvert inlet, as shown in Photo 742-4. It appears that these boulders were placed in the ditch, perhaps in an attempt to armor the ditch against excessive downcutting and with the intent that ditch flow could percolate through the large voids between the boulder-sized rocks.

Photo 742-4 (bottom) – Facing southbound across the culvert inlet area. Note the rock fill in the ditch for a short distance upstream of the culvert inlet. Note how the ditch flow has eroded slightly into the road surface adjacent to the rock fill.

- Ditch flow into the culvert should be re-established to prevent water from flowing across the road. This could be done by removing the boulder-sized rocks in the ditch as well as cleaning out the accumulated fine grained to gravel sized soil further upstream along the ditch and also regrading the road to prevent surface runoff from flowing towards the downslope side of the road. This should be treated as an ongoing maintenance task because the upslope road ditch will need to be kept open and clear of debris (the buried telephone cable in the upslope ditch will need to either be buried at a greater depth or otherwise protected in order to accommodate this). It will also be necessary to avoid excessive erosion and downcutting of the ditch upstream of the culvert inlet (which was likely that reason that the rock fill was placed in the ditch in the first

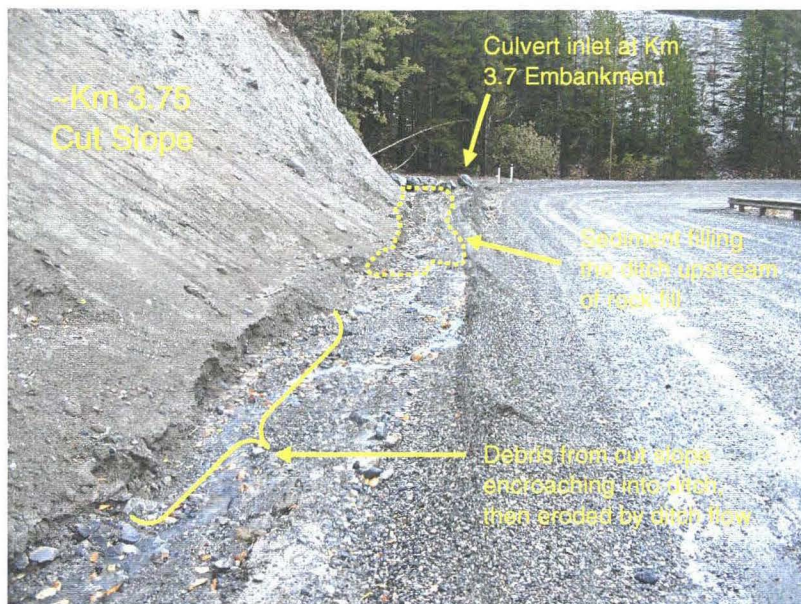
- The segment of the ditch upstream from the boulders is filled with fine grained soil and gravel that has eroded from the cut slopes above the ditch, as shown in Photo 742-5. This material appeared to have been deposited where the ditch flow was slowed by the rock fill upstream of the culvert inlet.

Photo 742-5 (top) – Adjacent to ~Km 3.75 Cut Slope site, facing northbound along the upslope road ditch, towards the culvert inlet at ~Km 3.7. Note the accumulation of sediment in the ditch upstream of the culvert inlet. This had reduced the ditch capacity and led to ditch flow spilling across the road surface as shown in Photo 742-3.

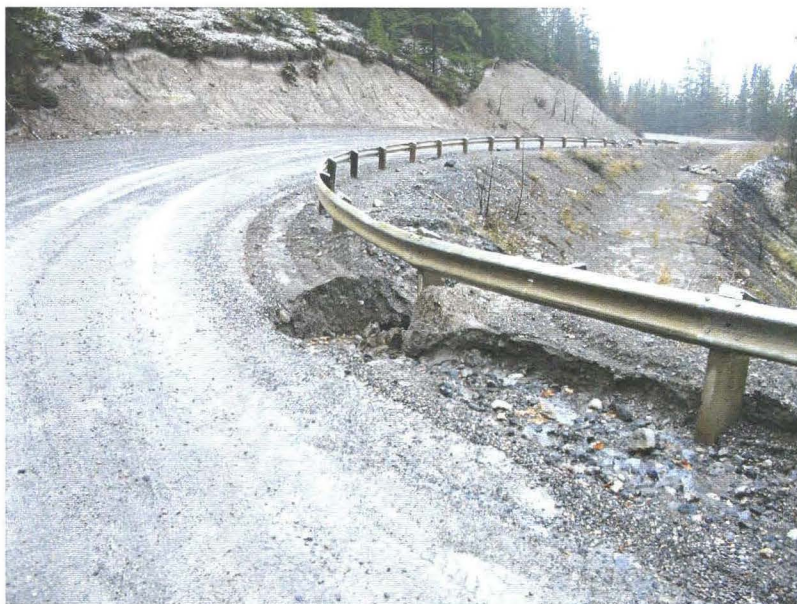
- A newer erosion gully a short distance northbound of the culvert (i.e. to the left, when standing over the culvert alignment and facing downslope). Photos 742-6 and 742-7 show how the head of this gully has eroded

The gully erosion on the downslope embankment face will continue if the ditch flow continues to spill onto the road surface and then drain onto the downslope face of the embankment. Continued erosion and possible lateral expansion of the head of the gully will undermine a longer segment of the guardrail and also lead to a loss of a portion of the traffic surface.

Photo 742-6 (bottom) – Head of “new” erosion gully in the downstream embankment slope, encroaching below the guardrail and into the road surface. See Photo 742-3 for the location of this gully relative to the rest of the site.

- Restore the full trafficable road width and re-support the exposed guardrail post by placing and compacting backfill in the head of the newer erosion gully. Wraps of geosynthetic could be incorporated into the fill in order to reinforce the resulting slope and try to minimize future surface erosion and gullying.
- Attempt to minimize future erosion along the newer erosion gully by placing rock armoring along it. This would be worthwhile as a backup measure, even after the surface flow from the roadway draining into the gully is curtailed by cleaning out the upslope road ditch and re-establishing the ditch flow into the culvert.

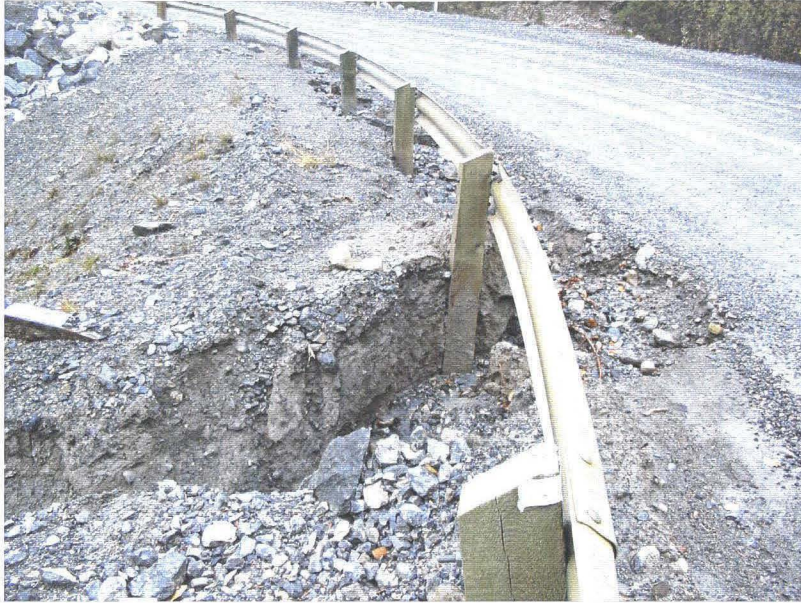
inside of the guardrail and is encroaching into the downslope edge of the road surface. One of the guardrail posts has been undermined and exposed (as shown in Photo 742-7).

Photo 742-7 (top) – Another view of the head of “new” erosion gully in the downstream embankment slope, encroaching below the guardrail and into the road surface. See Photo 742-3 for the location of this gully relative to the rest of the site.

The older erosion gully that had been armored with rock fill above the culvert alignment is visible in the left background of this photo.
