~Km 3.75 Cut Slope

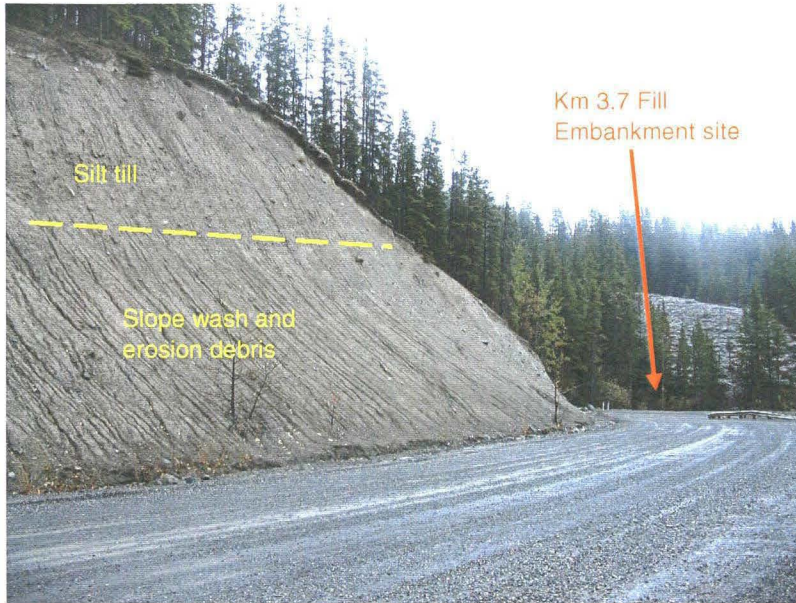
- This cut slope is located immediately southbound of the ~Km 3.7 Fill Embankment site. It is in the order of 100 m long along the road, and extends southbound to approximately Km 3.8. Photo 742-8 shows the cut slope.

- The cut slope is approximately 12 to 14 m high.
 - The upper portion, roughly the upper half, exposes silt till soil at roughly 45° inclination. The exposed soil includes up to cobble-sized rocks. There is widespread shallow gullying and runnelling in the exposed soil. The runnelling suggests that the silt till may be slightly cemented.

- The lower portion, roughly the lower half, of the cut slope is at approximately 36° inclination and consists of eroded material (slope wash) from the upper portion of the slope.

Photo 742-8 – Facing southbound across the ~Km 3.75 Cut Slope site. The upper portion of the cut slope exposes silt till that appears to be slightly cemented. The lower portion of the slope is covered with slope wash/eroded material that encroaches into the ditch along the toe of the slope. Please refer to Photo 742-5 for a closer view of the ditch along the toe of the slope.

No action is recommended beyond the current maintenance as required to clear any rocks from the road surface.
