~Km 4.1 to ~Km 4.5 Cut Slopes, Ditches and Drainage Courses

Site Observations

April 2009

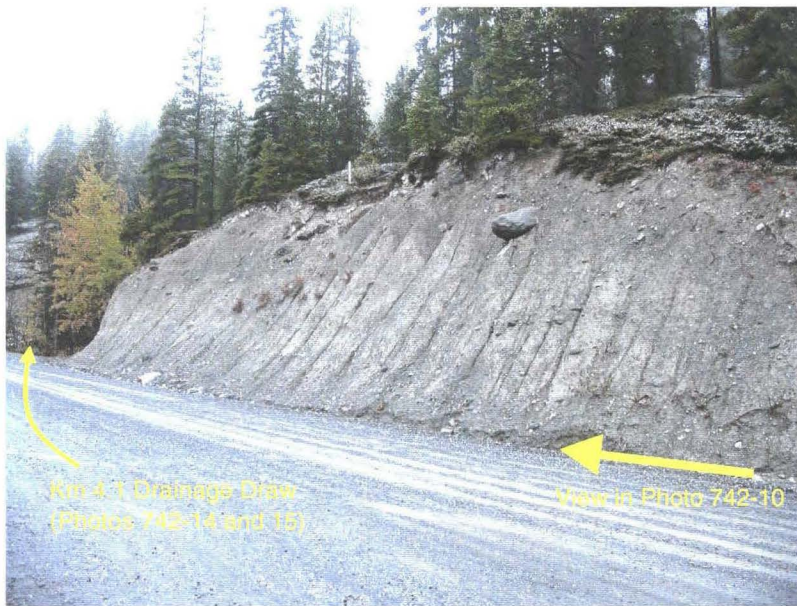
- Roughly 20 m northbound from a pull-out at ~Km 4.1, where two 45° inclination cut slopes on either side of a drainage draw expose rocky silt till that has up to boulder-sized rocks included. Photo 742-9 shows one of these cut slopes. The ditch along the toe of these cut slopes is very small to negligible. As shown in Photo 742-10, eroded material and slope wash from the cut slopes has accumulated along the toe of the slopes and then been washed clean of fine grained soil by surface runoff flowing along the upslope edge of the road.

- The rockfall catch ditch design chart, attached as Figure C1 in Appendix C, suggests ditches in the order of 4 m wide and 1.3 m deep for rock cut slopes in the same range of height and inclination as the soil cut slopes along this segment of the highway. Even if the suggested ditch width and depth are factored down because the cut slopes in this area are in rocky till soil, rather than exposed bedrock, the existing ditches are still judged to be undersized with respect to containing debris from the cut slopes. Therefore, there is a potential for large rocks that erode out from the cut slope to slide and roll down the cut slopes and onto the road. No such rocks were noted on the road at the time of the October 2008 site inspection, but this hazard cannot be ruled out.

Photo 742-9 (top) – Cut slope immediately northbound of the Km 4.1 Drainage Draw.

- The maintenance contractor should clean out the accumulated sediment from the upslope road ditch and regrade the existing ditches to restore their available capacity. In the future, the ditches should continue to be cleaned out as necessary to maintain them as close as practical to maximum capacity. The buried telephone cable along the upslope ditch will need to be buried at a greater depth or otherwise protected in order to accommodate this.
- In addition to the ditch cleaning, the surface runoff flow path around Km 4.2 that takes ditch flow into the head of the erosion gully adjacent to the guardrail should also be graded out. The road surface should be graded as necessary in the future to minimize the chances of the ditch overflowing in the future and eroding drainage channels across the road.

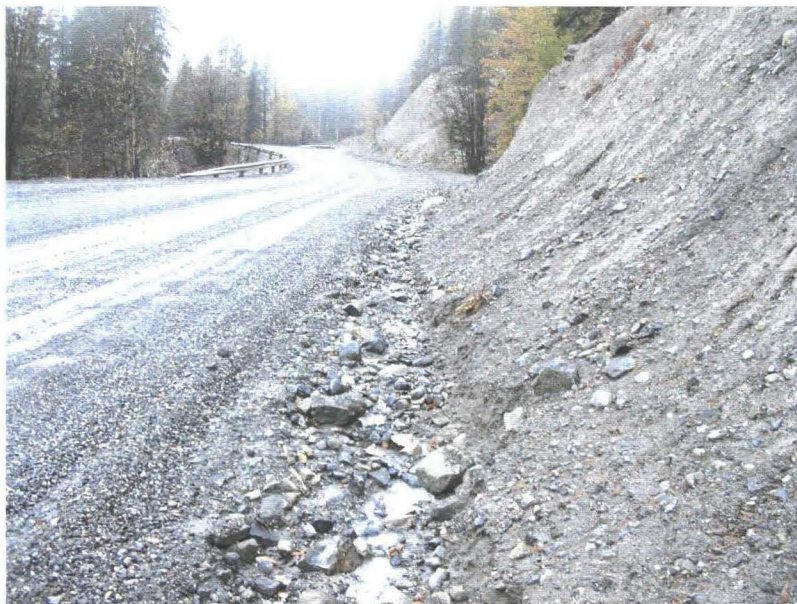
Photo 742-10 (bottom) – Facing southbound/uphill along the ditch immediately northbound of the Km 4.1 Drainage Draw. The slope wash/eroded material along the toe of the cut slope has filled the very small ditch. The ditch flow has washed the fine grained soil from the material and left behind the gravel-sized and larger rocks behind.

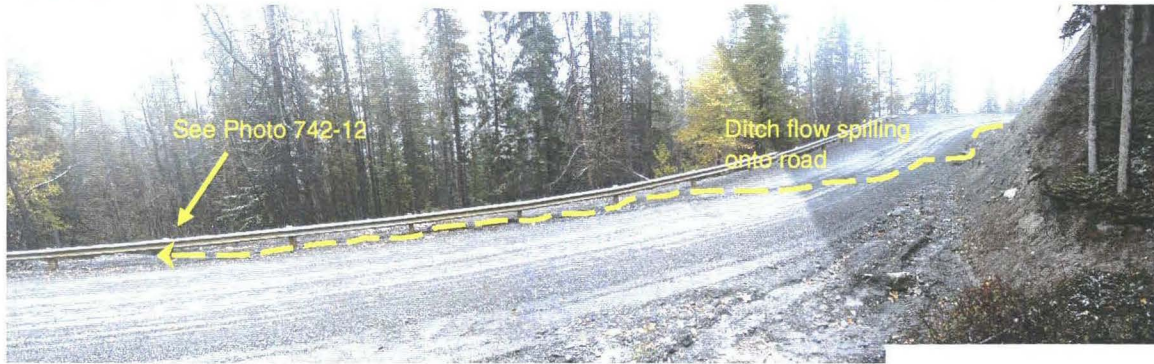
- Around Km 4.2, ditch flow along the very small to negligible upslope road ditch has spilled across the road, as shown on Photos 742-11 and 742-13. This flow has started to erode a gully into the fill slope below the highway, as shown in Photo 742-12. As of October 2008, the guardrail adjacent to the gully was set back roughly 1 m from the head of the gully so there was no imminent hazard to the road.

- The undersized ditches have also caused the ditch flow to spill across the road around Km 4.2, which has led to the erosion of a gully into the fill slope below the road in that area (as shown in Photos 742-11 to 742-13). The risk to the road from this gully erosion is mitigated, for the short term, by the guardrail being inset roughly 1 m from the current position of the head of the gully.

Photo 742-11 (top) – At approximately Km 4.2, showing the ditch flow spilling across the road. Please refer to Photo 742-12 for a view of the head of the erosion gully being formed where this surface runoff flows below the guardrail and onto the fill slope below the road.

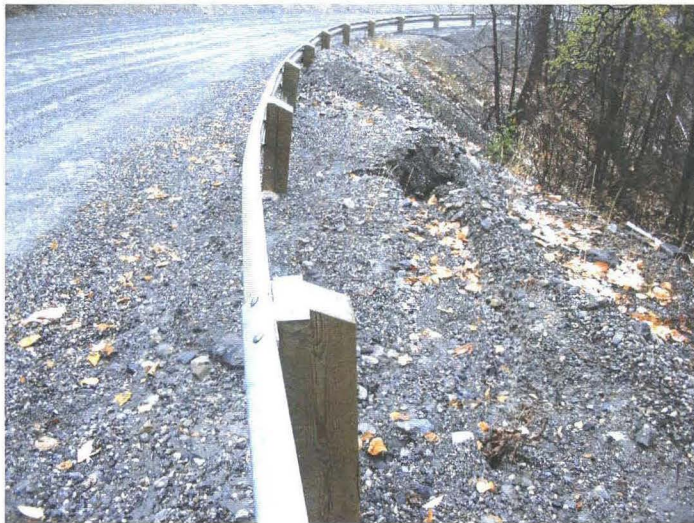
The recommended Risk Level relative to the ditch flow spilling across the road and leading to the erosion of a gully in the fill slope below the road around Km 4.2 like that in Photo 742-12, based on AT's general geohazard risk matrix, is as follows:

- Probability Factor of 9 to reflect how the ditch flow spills across the road under the current conditions at the site.
- Consequence Factor of 2 if the head of the erosion gully shown in Photo 742-12 retrogresses below the guardrail in the next one to two years, i.e. it would affect the use of the roadway but without requiring closure.

Photo 742-12 (middle) – Erosion gully developing in the fill slope below the road around Km 4.2, where the ditch flow coming across the road flows below the guardrail. Note how the guardrail is set back roughly 1 m from the crest of the fill slope, thus mitigating the hazard to the road from the gully erosion in the short term.

- Culverts should be installed at the drainage draws at Km 4.1 and 4.15 in order to drain ditch flow and standing water from the sediment-infilled areas adjacent to the road.
- This site should be added to the Southern Region annual inspection tour in 2009 in order to check the condition of the erosion gully at Km 4.2 and review the site conditions in general. It may be necessary to revise the recommended Risk Levels in the future.

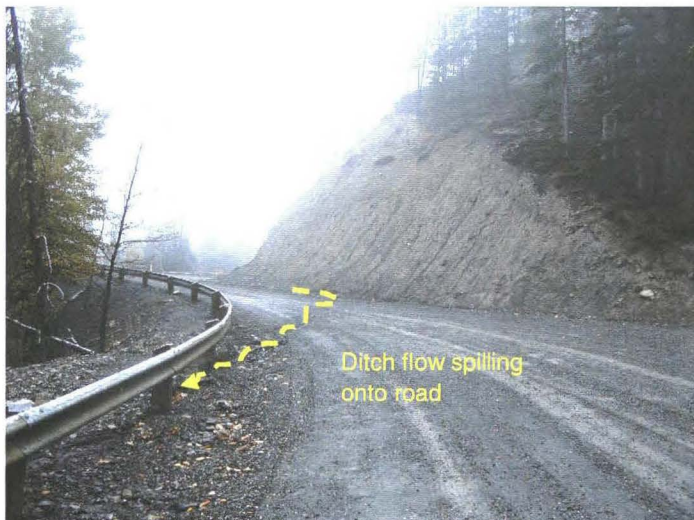
Photo 742-13 (bottom) – Facing southbound from approximately Km 4.2, with the ditch flow coming across the road surface as shown. A typical cut slope in the order of 8 to 9 m high and up to 45° inclination is visible in the background.

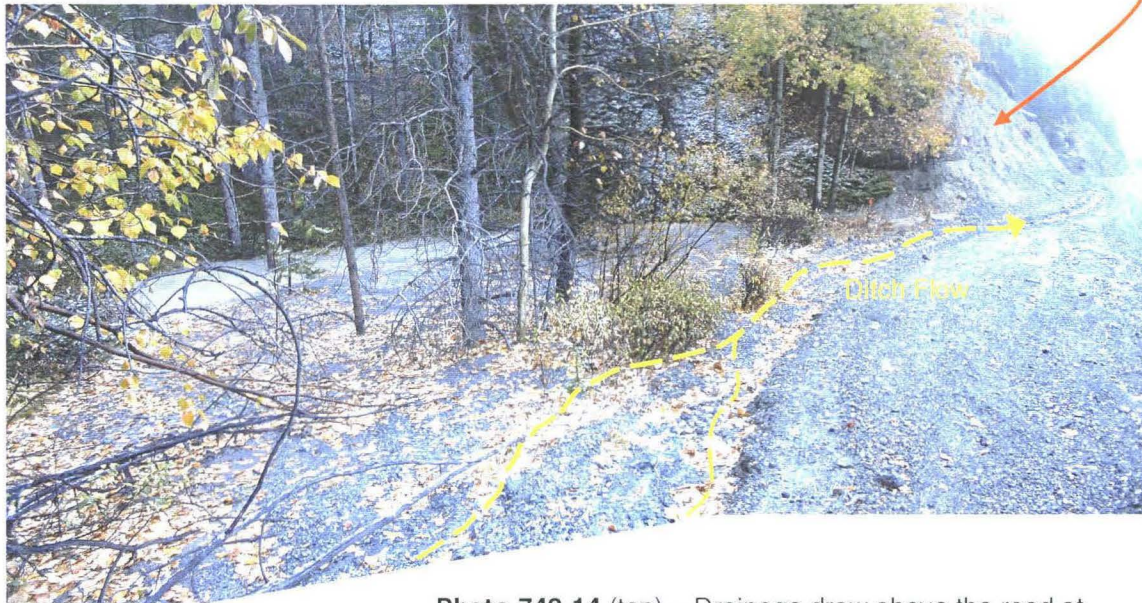
- Immediately southbound of Km 4.1:
 - Water and soil washed along the ditch has infilled a natural drainage draw in the slope above the road. The thickness of the accumulated sediment is not clear, and could be in the order of 1 m. Several of the trees in the infilled area were dead. Photo 742-14 shows the infilled area upslope of the road. There did not appear to be a culvert installed at this location and there are no delineator posts marking a culvert. However, if there is a culvert present the inlet would very likely be buried by the accumulated sediment.

- It did not appear that the sediment accumulation in the drainage draw had been causing ditch flow to overtop the road at this location. As shown in Photo 742-14, the ditch flow appears to continue past the infilled area without problem. It also appeared unlikely that ditch flow could flow across the road in this area because the road surface is very slightly

The infilling of the drainage draws at approximately Km 4.1 and 4.15 with sediment and water from the ditch flow did not appear to be posing a significant risk to the highway at the time of the October 2008 site inspection. The dead trees in the infilled area at Km 4.1 may eventually become a hazard to the road if they start to fall over.

Photo 742-14 (top) – Drainage draw above the road at ~Km 4.1, infilled with sediment and water from the ditch flow. There does not appear to be a culvert installed at this location. The ditch flow appears to continue past this location, as marked. Note the dead tree in the infilled area.

- It is not recommended that the accumulated sediment in the drainage draws at Km 4.1 and 4.15 be removed. This material does not appear to create a significant hazard to the road and if it is removed, the low-lying areas on the slope face will eventually fill with sediment over time again.

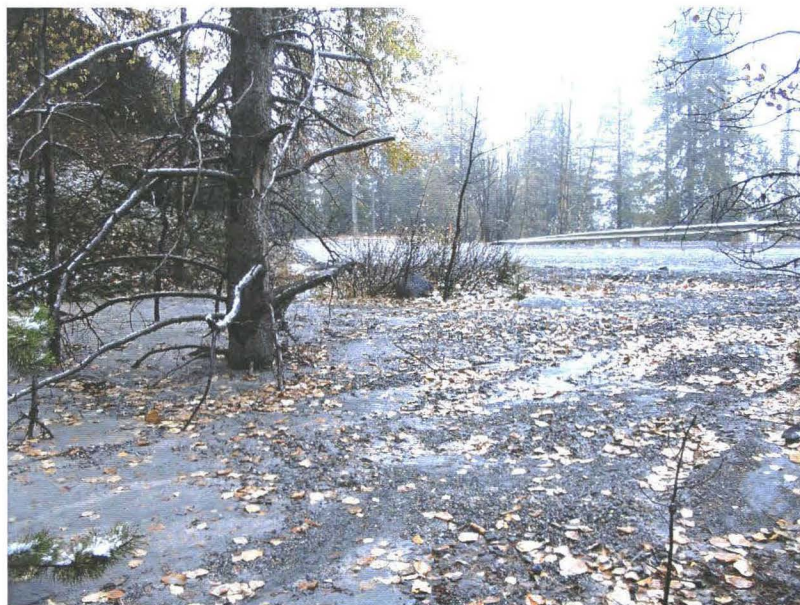
Photo 742-15 (bottom) – Another view of the infilled drainage draw at ~Km 4.1.

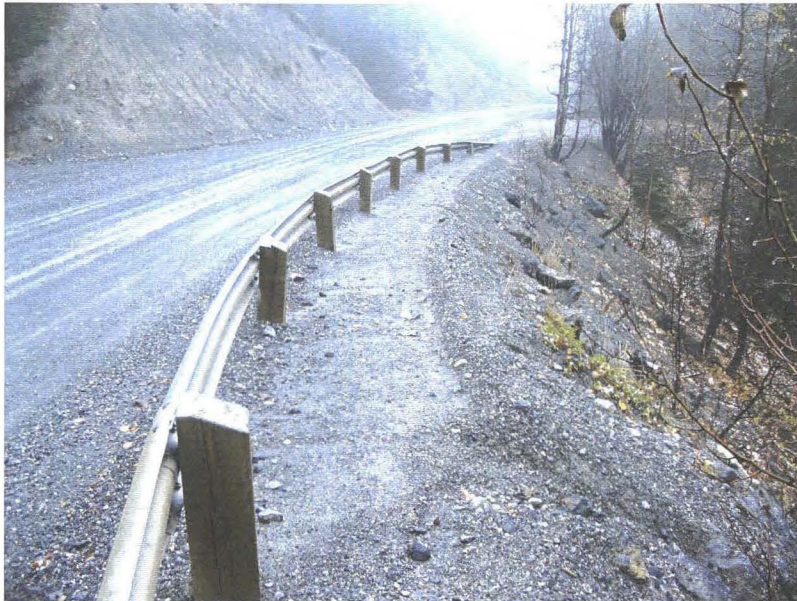
banked inwards to shed runoff towards the upslope side of the road. Furthermore, the risk to the road from gully erosion in the fill slope below the road as a result of concentrations of road surface runoff discharging onto the slope below the road is also mitigated by the guardrail being inset roughly 1 m or more from the crest of the fill slope, as shown in Photo 742-16.

Photo 742-16 (top) – Opposite the drainage draw at Km 4.1, showing the guardrail inset more than 1 m from the crest of the fill slope below the road.

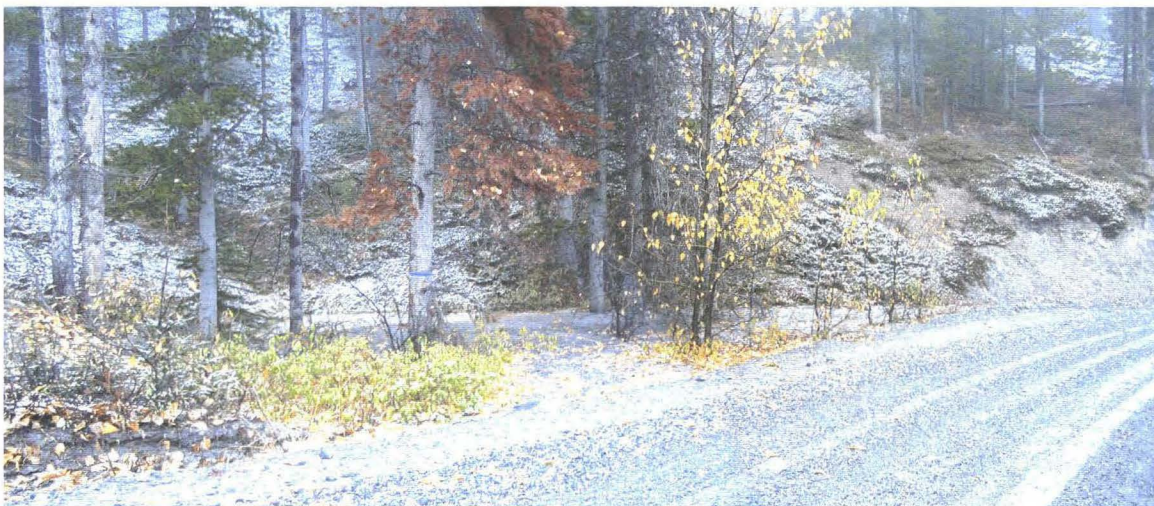
- At approximately Km 4.15:
 - A natural drainage draw at this location has also been infilled by water and soil washed along the ditch, similar to that at Km 4.1. Photo 742-17 shows this area.

Photo 742-17 (bottom) – Drainage draw upslope of the road at approximately Km 4.15, infilled with sediment and water from the ditch flow similar to the draw at ~Km 4.1.
