August 28, 2009

CG25309.B

**Re: Southern Region Geohazard Assessment Program
Highway 742:02 – August 2004 Debris Flow Site
2009 Annual Inspection Report**

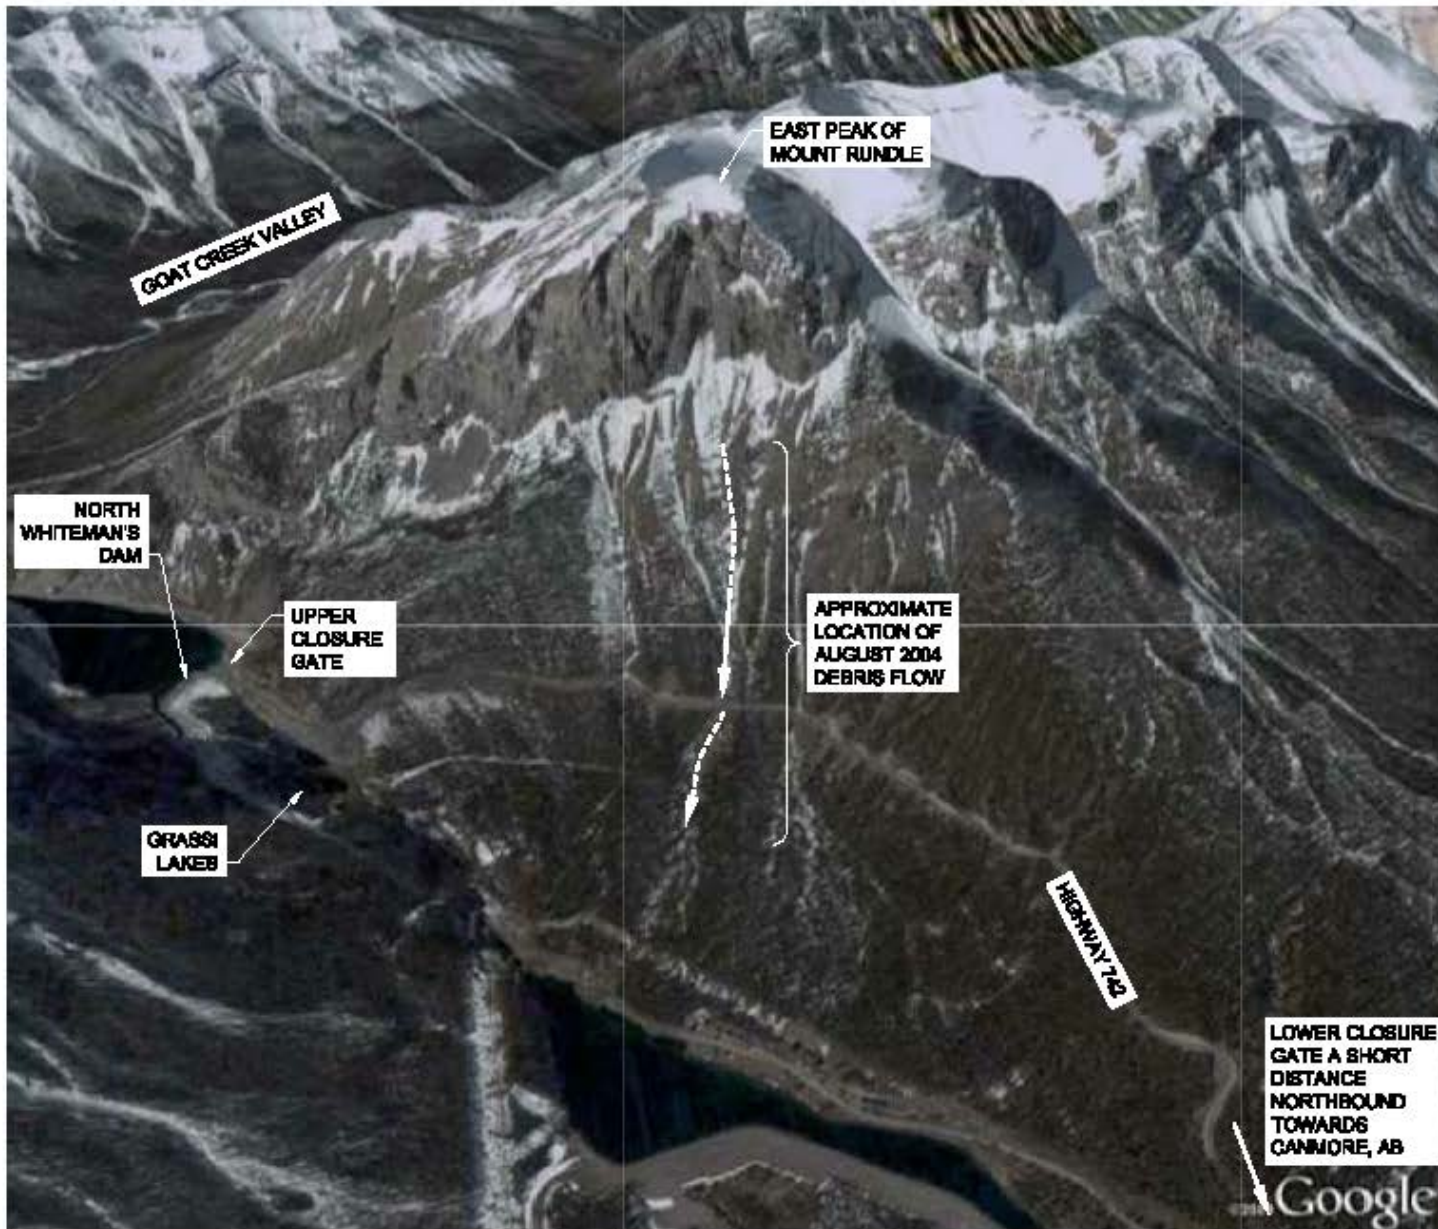
PROJECT: SOUTHERN REGION GEHAZARD ASSESSMENT			
	TITLE: OBLIQUE VIEW OF "EAST END OF RUNDLE" SHOWING AUGUST 2004 DEBRIS FLOW SITE			
CLIENT:	DATE: JUNE 2009	JOB No.: CG25309.B	CAD FILE: 25309N18.dwg	FIGURE No.: FIGURE 1 REV. A

The location of the August 2004 debris flow was confirmed to Alberta Transportation (AT) and AMEC by Mr. George Field, Public Safety Specialist for Kananaskis Country with the Parks Division of Alberta Tourism, Parks and Recreation during a joint AT, AMEC and Parks Division field review of this segment of the highway on June 11, 2009. The August 2004 debris flow crossed the highway at the following location:

- Latitude 51.079710 N, Longitude 115.407780 W.
- UTM coordinates Easting 611531, Northing 5659895 (Zone 11).

This location is illustrated on Figure 1, attached.

This location is approximately 4.9 km southbound along the highway from the junction between Highway 742 and Three Sisters Parkway in Canmore, AB. Therefore, “~Km 5.4(?)” location referenced in the April 2009 report on the Highway 742 corridor geohazards review is revised to “Km 4.9” as listed in this report.

~Km 5.4 (?) Debris Flow

August 2004 Debris Flow
