## ~Km 5.2 To ~Km 6.1 Cut Slopes

### *Site Observations*

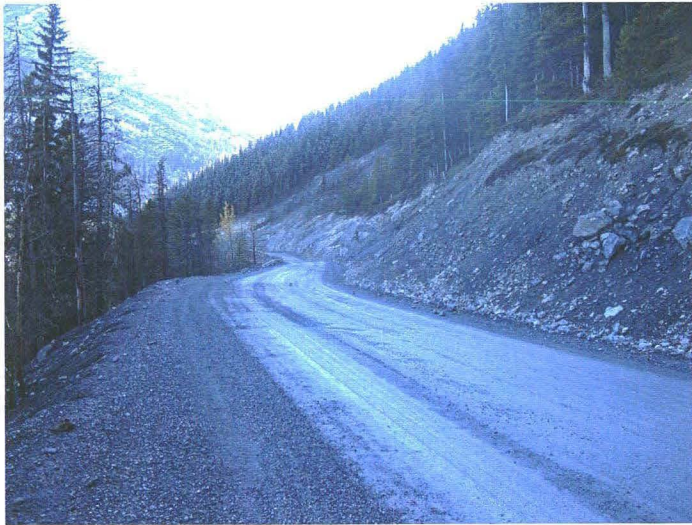
- From ~Km 5.2 to ~Km 5.5:
  - The cut slopes are up to approximately 6 to 8 m high and expose rocky soil and rock talus at up to 45° inclination. Photos 742-21 and 742-22 show typical views of these cut slopes.
  - There is no upslope ditch along this segment.
  - Cobble-sized rocks have rolled across and onto the road, as shown in Photos 742-23 and 742-24.
  - There is no guardrail along this segment of the road. The fill slope below the road is up to 40 to 45° inclination. Photo 742-25 shows a typical view.

**Photo 742-21** (top) – Typical view facing southbound along the segment of the highway between ~Km 5.2 and ~Km 5.5. Note the lack of upslope road ditch along the toe of the approximately 45° cut slope exposing rocky soil. Note also the lack of guardrail along the downslope edge of the narrow road.

- Install rockfall warning signs between ~Km 5.2 and ~Km 5.5 (if not already in place).
- Extend the existing guardrail for a few hundred metres further northbound, between ~Km 5.2 and ~Km 5.5. This would be consistent with the requirements of Figures H3.4 and H3.5 of AT's November 2007 Roadside Design Guide.

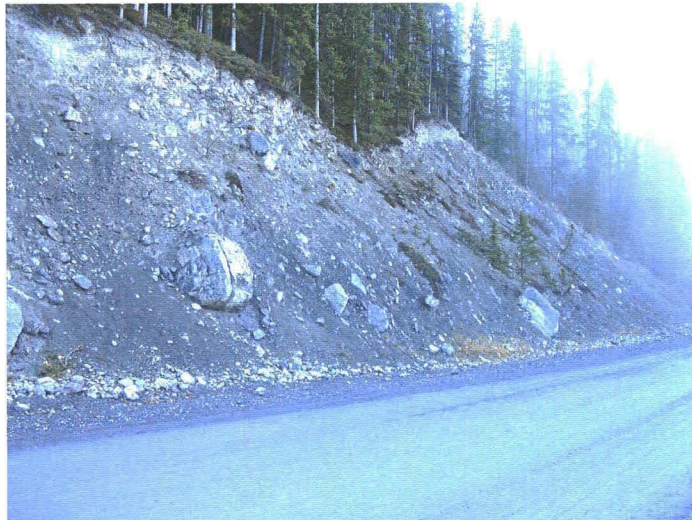
**Photo 742-22** (middle) – Typical cut slope between Km 5.2 and Km 5.5, roughly 6 to 8 m high at up to 45° inclination. There is no ditch along the toe of the slope, and rocks that erode out from the cut slope may roll onto the road surface.

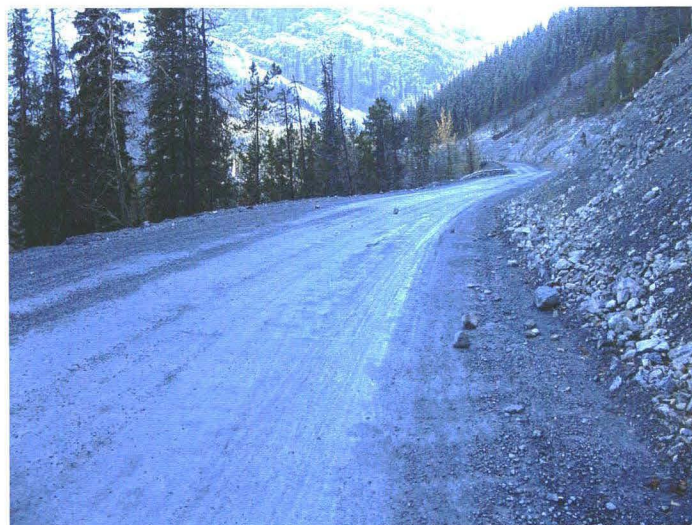
**Photo 742-23** (bottom) – Facing southbound along the highway between Km 5.2 and Km 5.5. Note the cobble-sized rocks that have rolled out from the toe of the cut slope and onto the road surface. It is likely that other rocks have rolled out onto the road at other times and have been cleared to the edge by the maintenance contractor.

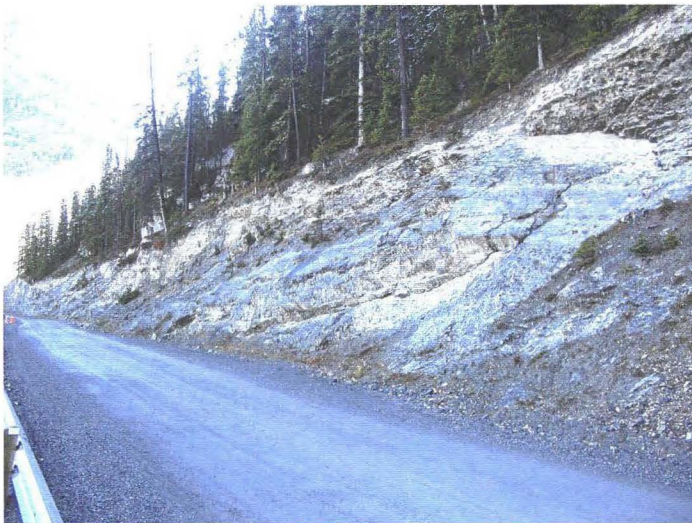
- At approximately Km 5.6, there is an orange paint marker visible roughly mid-way up the cut slope where a large block of rock appears to be close to breaking off from the slope and sliding down a joint plane and onto the road. Photos 742-29 and 742-30 show this location. Photo 742-31 shows another, similar location a short distance southbound of approximately Km 5.6.

- There is also a risk of large blocks of rock breaking free from the cut slope and sliding down along the planes of the sheet joints with the debris spilling onto the road surface. This could occur at the locations shown in Photos 742-29 and 742-31 as the exposed bedrock weathers further and experiences more freeze/thaw periods along with rainfall and snowmelt infiltrating into the open joints and tension cracks around the rock blocks.

**Photo 742-31** (bottom) – An area a short distance southbound from ~Km 5.6 where there appears to be a hazard of some large rocks breaking loose and sliding down the sheet joint plane and onto the road.

- At the two sites around Km 5.6, remove the large blocks of rock that appear to be close to breaking off and sliding down the joint plane slope onto the road. This could be done by a specialist rock slope contractor experienced with scaling and cleaning of highway rock cut slopes in British Columbia.

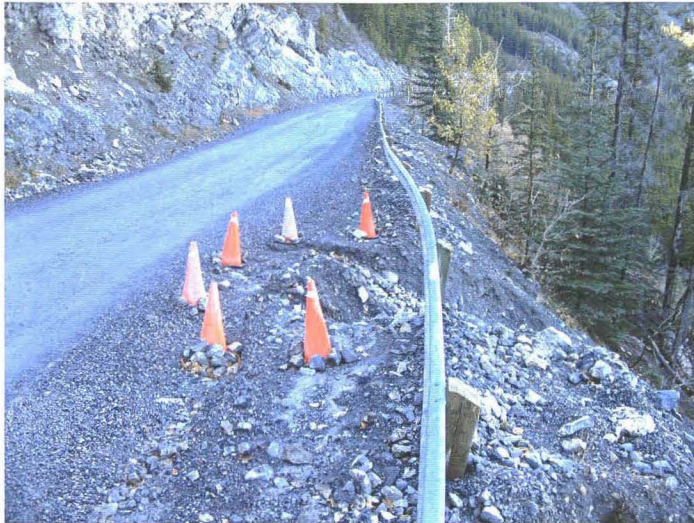
- At approximately Km 5.7:
  - There is a gully eroding below the guardrail, as shown in Photos 742-32 to 742-34. The gully erosion is occurring at a location where soil and gravel that has been graded from the road surface has built up below the guardrail and caused a concentration of surface runoff from the road to

- There is one location at approximately Km 5.7 where a concentration of surface runoff from the road is eroding a gully below the guardrail and into the downslope side of the road surface. The surface runoff along the road appeared to be

channeled and concentrated into the head of the gully by soil and rock debris accumulating along the guardrail line due to repeated grading of the road surface.

**Photo 742-32** (top) – At ~Km 5.7, gully erosion in the fill slope below the road that has encroached below the guardrail and reduced the trafficable width of the road. Debris from plowing and grading the road surface has built up below the guardrail in the segment of the highway upslope /southbound from this location and has caused a concentration of surface runoff to discharge onto the fill slope below the road at this location, which has led to the gully erosion.

In addition to the above, maintenance crews should inspect and maintain the traffic cones marking the gully encroachment below the guardrail at Km 5.7.

- It is judged impractical to establish an upslope road ditch to contain surface runoff from the road due to the limited road width in this area and impracticality of widening the road to accommodate an upslope ditch as noted above.
- Moving forward, the best option to manage the hazard of the gully erosion into the road surface is judged to be:
  - Attempting to backfill the eroded portion of the road surface with granular material.
  - Taking care to avoid accumulations of graded material along the guardrail line that concentrate surface runoff from along the road into the head of the erosion gully – or - establishing culverts or flumes extending down the slope face below the road, into which surface runoff from the road can be directed into in the absence of an upslope ditch and buried culverts below the road surface.

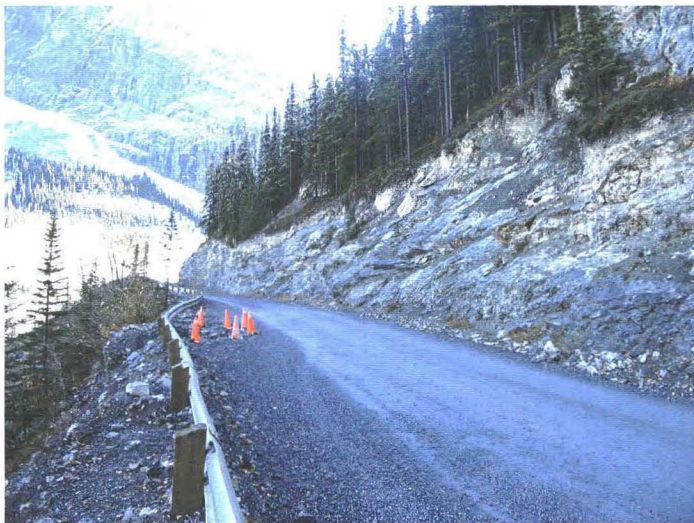
**Photo 742-33** (middle) – Facing southbound towards the gully erosion and illustrating the reduction in road width adjacent to the gully.

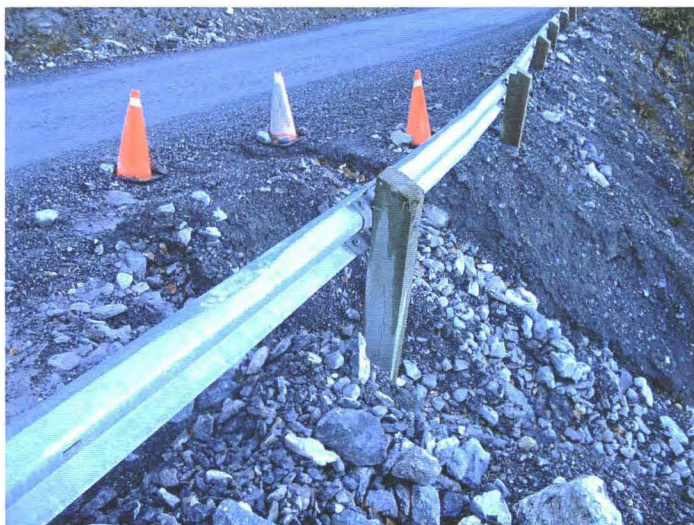
**Photo 742-34** (bottom) – Another view of the head of the gully erosion, showing how the guardrail posts have been undermined.

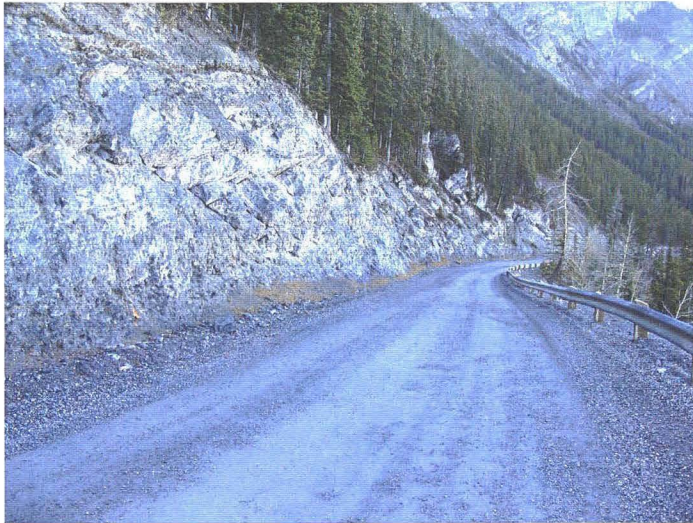
**Photo 742-35** (top) – Typical view of the cut slopes around Km 5.8, a short distance northbound from the curve in the road. Note the accumulation of gravel and cobble-sized rocks along the toe of the cut slope. The cut slopes in this area also appeared to be primarily undergoing solution weathering, with relatively minor volumes of resulting rockfall.

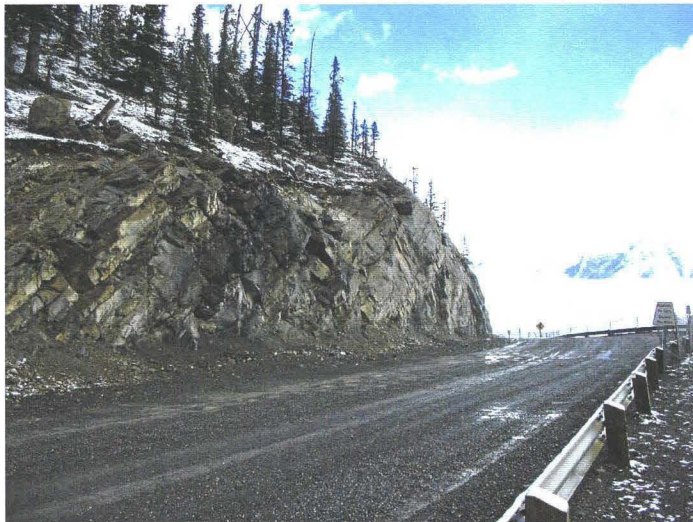
**Photo 742-36** (middle) – Typical view of the cut slopes between ~Km 5.8 and ~Km 6.1. The cut slopes along this segment are typically around 50 to 55° inclination and 5 m or less in height. The cut slopes face southeast, therefore the southwest dip direction of the bedrock exposed in the cut slopes is roughly parallel to the bearing of the highway. This is less favorable with respect to slope stability than along the segment between ~Km 5.5 and ~Km 5.8 where bedrock dip direction is downwards into the cut slopes, however not a significant risk to this segment of the highway.
