~Km 5.2 To ~Km 6.1 Cut Slopes

Site Observations

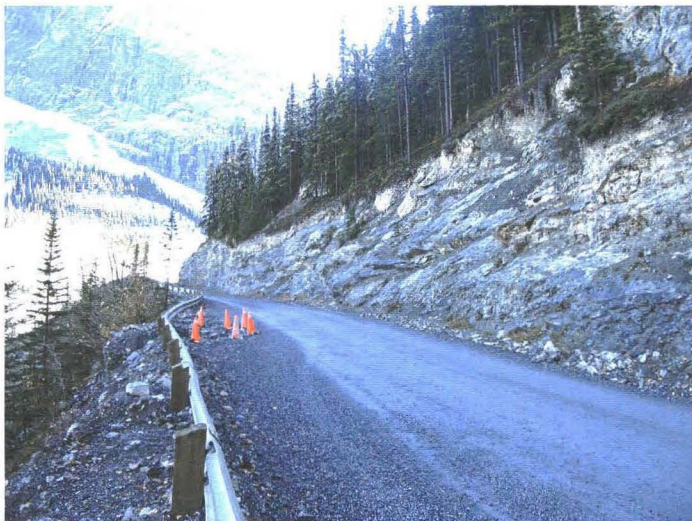
- At approximately Km 5.7:
 - There is a gully eroding below the guardrail, as shown in Photos 742-32 to 742-34. The gully erosion is occurring at a location where soil and gravel that has been graded from the road surface has built up below the guardrail and caused a concentration of surface runoff from the road to

Photo 742-33 (middle) – Facing southbound towards the gully erosion and illustrating the reduction in road width adjacent to the gully.

In addition to the above, maintenance crews should inspect and maintain the traffic cones marking the gully encroachment below the guardrail at Km 5.7.

- It is judged impractical to establish an upslope road ditch to contain surface runoff from the road due to the limited road width in this area and impracticality of widening the road to accommodate an upslope ditch as noted above.
- Moving forward, the best option to manage the hazard of the gully erosion into the road surface is judged to be:
 - Attempting to backfill the eroded portion of the road surface with granular material.
 - Taking care to avoid accumulations of graded material along the guardrail line that concentrate surface runoff from along the road into the head of the erosion gully – or - establishing culverts or flumes extending down the slope face below the road, into which surface runoff from the road can be directed into in the absence of an upslope ditch and buried culverts below the road surface.

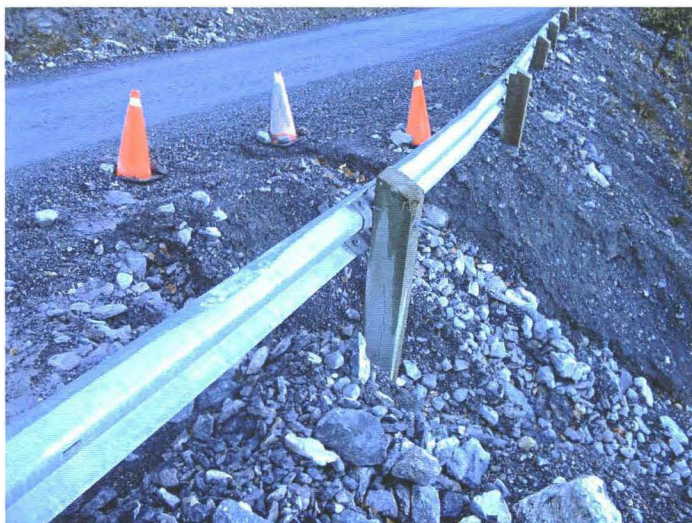
Photo 742-34 (bottom) – Another view of the head of the gully erosion, showing how the guardrail posts have been undermined.
