### ~Km 5.2 To ~Km 6.1 Cut Slopes

#### *Site Observations*

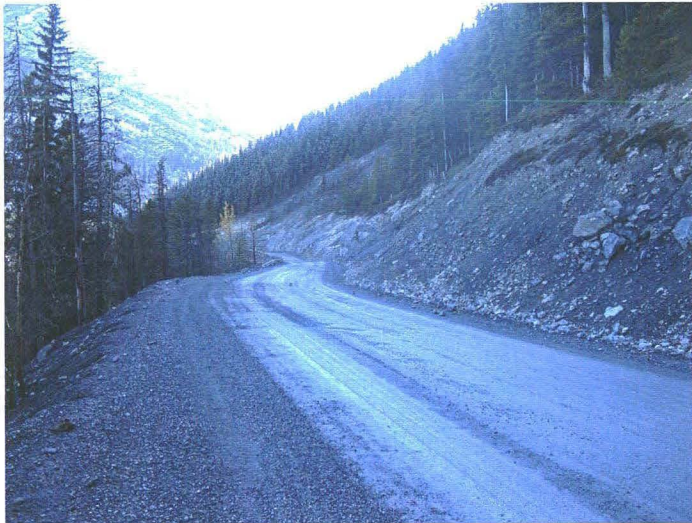
- From ~Km 5.2 to ~Km 5.5:
  - The cut slopes are up to approximately 6 to 8 m high and expose rocky soil and rock talus at up to 45° inclination. Photos 742-21 and 742-22 show typical views of these cut slopes.
  - There is no upslope ditch along this segment.
  - Cobble-sized rocks have rolled across and onto the road, as shown in Photos 742-23 and 742-24.
  - There is no guardrail along this segment of the road. The fill slope below the road is up to 40 to 45° inclination. Photo 742-25 shows a typical view.

**Photo 742-21** (top) – Typical view facing southbound along the segment of the highway between ~Km 5.2 and ~Km 5.5. Note the lack of upslope road ditch along the toe of the approximately 45° cut slope exposing rocky soil. Note also the lack of guardrail along the downslope edge of the narrow road.

- Install rockfall warning signs between ~Km 5.2 and ~Km 5.5 (if not already in place).
- Extend the existing guardrail for a few hundred metres further northbound, between ~Km 5.2 and ~Km 5.5. This would be consistent with the requirements of Figures H3.4 and H3.5 of AT's November 2007 Roadside Design Guide.

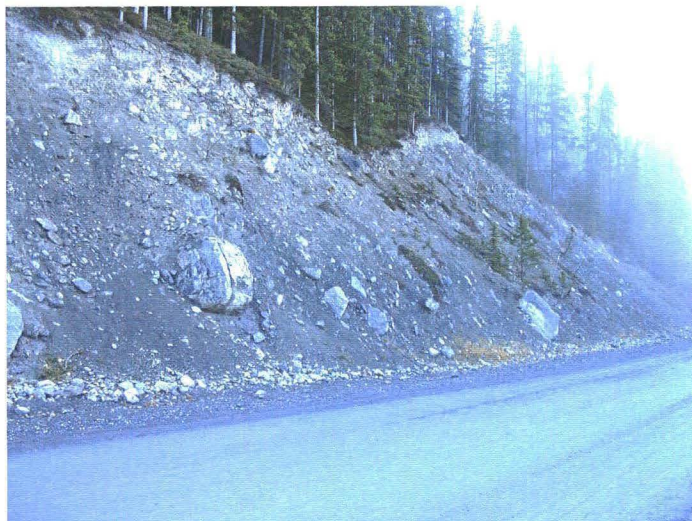
**Photo 742-22** (middle) – Typical cut slope between Km 5.2 and Km 5.5, roughly 6 to 8 m high at up to 45° inclination. There is no ditch along the toe of the slope, and rocks that erode out from the cut slope may roll onto the road surface.

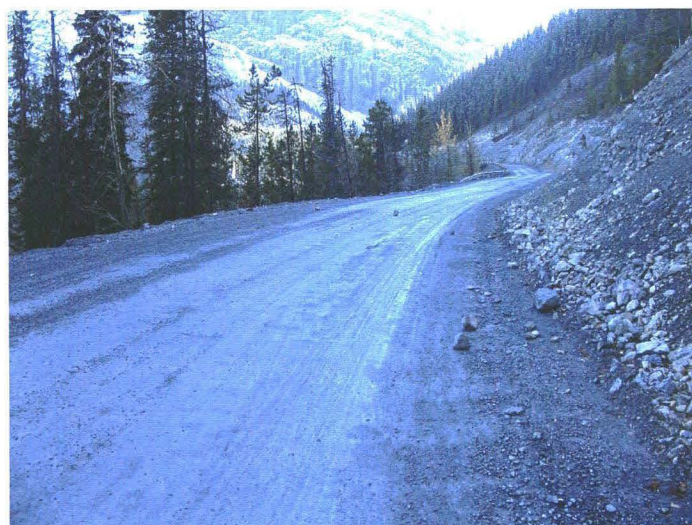
**Photo 742-23** (bottom) – Facing southbound along the highway between Km 5.2 and Km 5.5. Note the cobble-sized rocks that have rolled out from the toe of the cut slope and onto the road surface. It is likely that other rocks have rolled out onto the road at other times and have been cleared to the edge by the maintenance contractor.

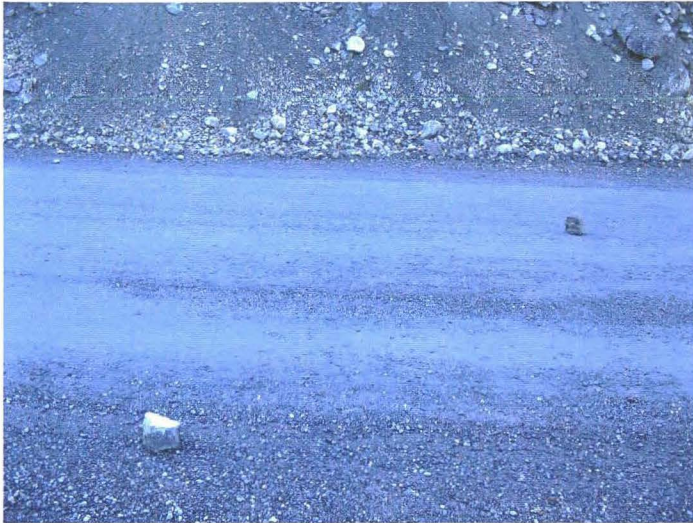
**Photo 742-24** (top) – Another view of cobbles eroded out from the cut slope that have rolled out onto the road between ~Km 5.2 and ~Km 5.5.

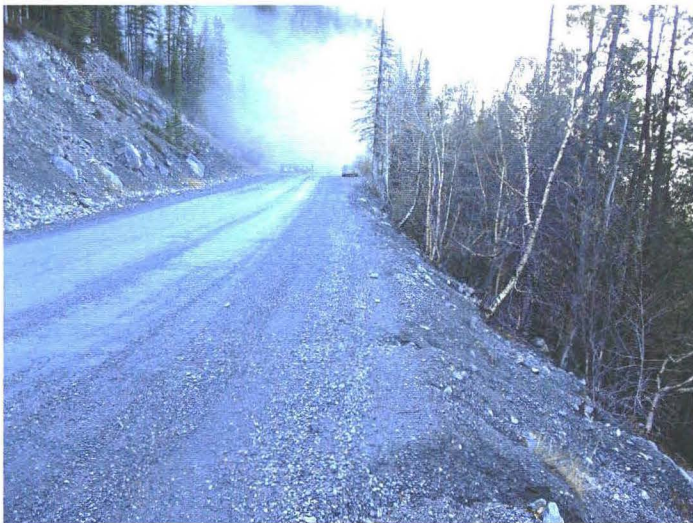
**Photo 742-25** (middle) – Facing northbound along the segment of the highway between ~Km 5.2 and ~Km 5.5. Note the narrow road width and lack of guardrail along the downslope side.

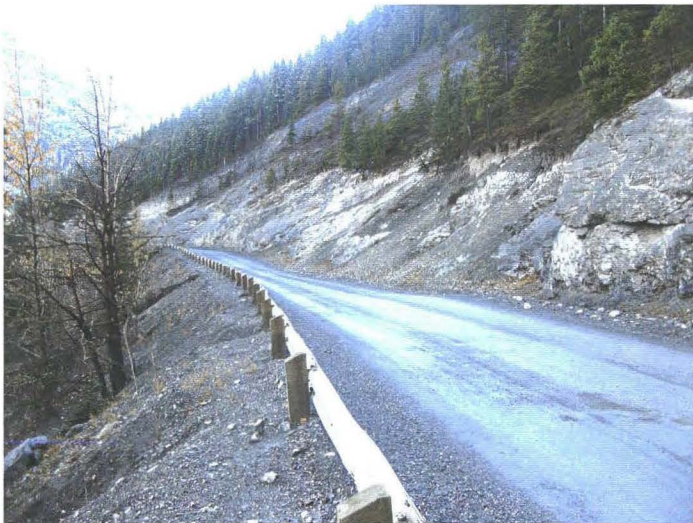
**Photo 742-26** (bottom) – Facing southbound from around Km 5.5. The cut slopes expose bedrock from around this point southwards. There is also a guardrail along this segment of the highway.

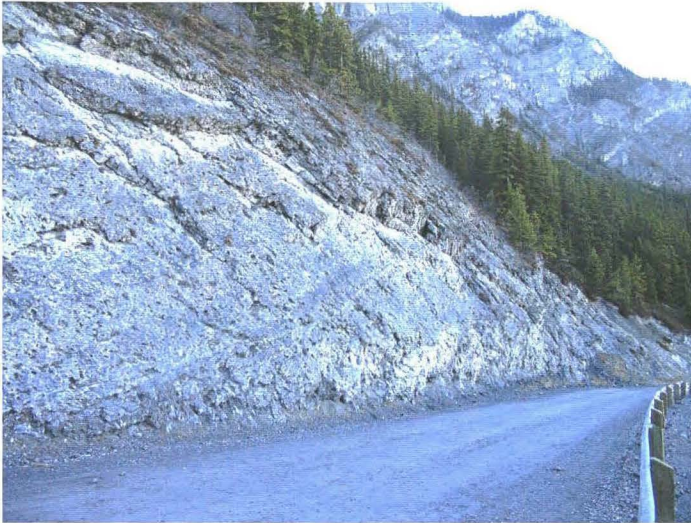
- There is a set of sheet joints visible in the exposed bedrock. The sheet joints are perpendicular to the bedding planes and dip down towards the road at approximately 40 to 45° down from horizontal. The orientation of the sheet joints is shown on Photos 742-27 and 742-28. The sheet jointing effectively creates an overdip slope<sup>3</sup> in the cut slope along this segment of the road, with the potential for large blocks of rock to break off along the sheet joint planes and fall towards the road.

**Photo 742-27** (top) – Typical cut slope between Km 5.5 and Km 5.8. The cut slopes are typically steeper than  $60^\circ$  and expose limestone with bedding that dips into the slope, which is favorable with respect to slope stability. However, there is a set of sheet joints perpendicular to the bedding that dips down towards the road at around  $40^\circ$ , effectively creating an overdip slope along this segment of the highway. Also note the narrow road and lack of a ditch along the toe of the cut slope.

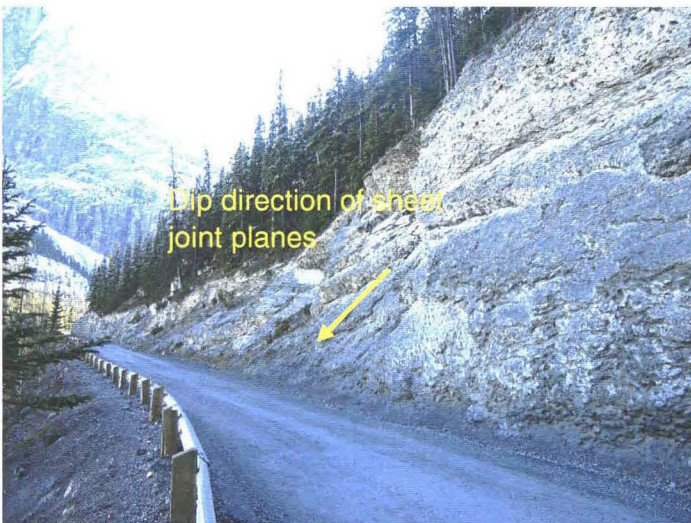
**Photo 742-28** (middle) – Another view of a typical cut slope around Km 5.55. This cut slope is around 10 to 12 m high without a ditch along the toe. The adjacent road surface is approximately 6 m wide. There appeared to be relatively little rockfall in this area, with gravel and occasional cobbles along the toe of the cut slope. It appeared that the cut slopes in this area appear to be undergoing solution weathering with the exposed limestone slowly dissolving over time when wet from rain or snowmelt.

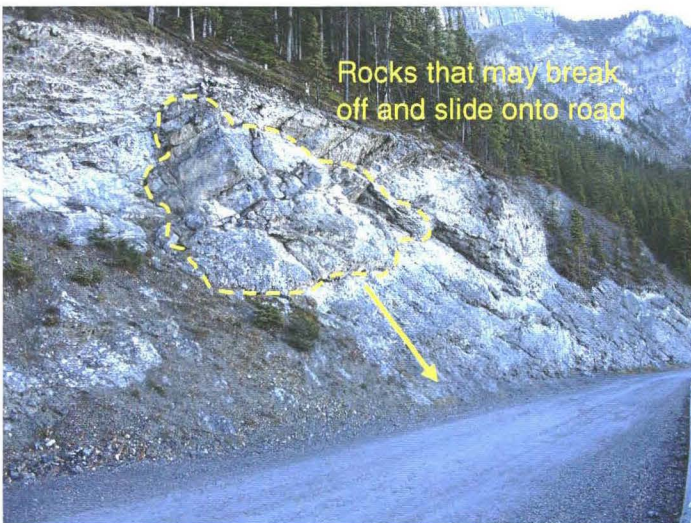
- At approximately Km 5.6, there is an orange paint marker visible roughly mid-way up the cut slope where a large block of rock appears to be close to breaking off from the slope and sliding down a joint plane and onto the road. Photos 742-29 and 742-30 show this location. Photo 742-31 shows another, similar location a short distance southbound of approximately Km 5.6.

- There is also a risk of large blocks of rock breaking free from the cut slope and sliding down along the planes of the sheet joints with the debris spilling onto the road surface. This could occur at the locations shown in Photos 742-29 and 742-31 as the exposed bedrock weathers further and experiences more freeze/thaw periods along with rainfall and snowmelt infiltrating into the open joints and tension cracks around the rock blocks.

- Probability Factor of 4 to reflect the current inactivity of this type of rockfall but with a fall occurrence considered to be “improbable” or a “remote” probability.
- Consequence Factor of 6 because if one of the large blocks of rock were to slide onto the road, it could severely damage a vehicle and injure the occupants or require complete closure of the road for at least a period of hours before the debris could be cleared by a loader.

**Photo 742-29** (bottom) – Rockfall/rockslide hazard at ~Km 5.6 from a number of boulder-sized rocks that appear to be close to breaking off the cut slope face and sliding down the sheet joint plane and onto the road surface. This location had been previously marked by others with orange paint near the middle of the slope.

- At the two sites around Km 5.6, remove the large blocks of rock that appear to be close to breaking off and sliding down the joint plane slope onto the road. This could be done by a specialist rock slope contractor experienced with scaling and cleaning of highway rock cut slopes in British Columbia.

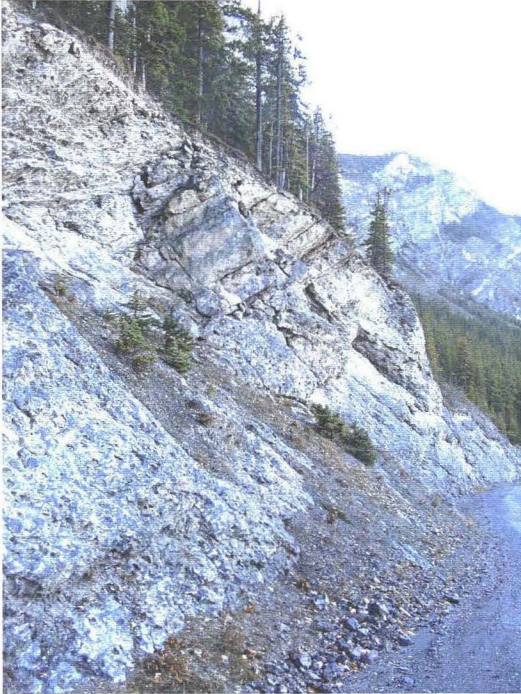
**Photo 742-30** (top) – Another view of the location at ~Km 5.6 where a number of boulder-sized rocks appear to be close to breaking loose and sliding down onto the road.

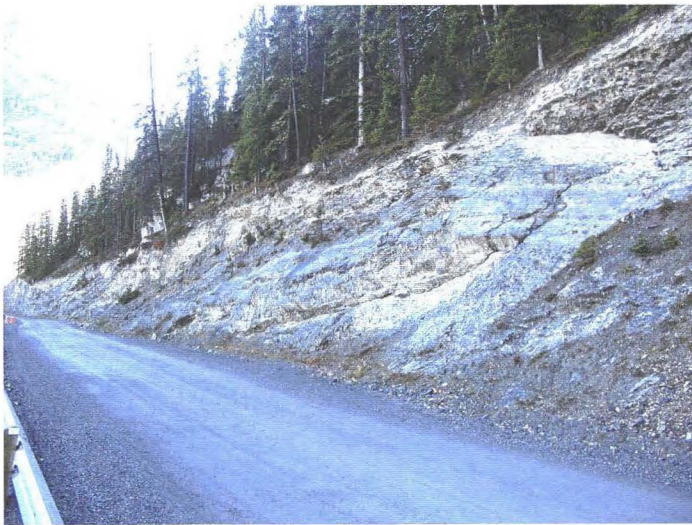
**Photo 742-31** (bottom) – An area a short distance southbound from ~Km 5.6 where there appears to be a hazard of some large rocks breaking loose and sliding down the sheet joint plane and onto the road.

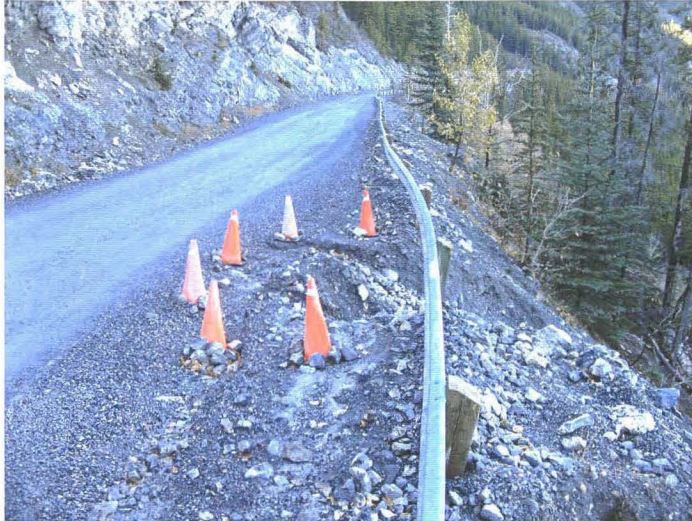
- At approximately Km 5.7:
  - There is a gully eroding below the guardrail, as shown in Photos 742-32 to 742-34. The gully erosion is occurring at a location where soil and gravel that has been graded from the road surface has built up below the guardrail and caused a concentration of surface runoff from the road to

- There is one location at approximately Km 5.7 where a concentration of surface runoff from the road is eroding a gully below the guardrail and into the downslope side of the road surface. The surface runoff along the road appeared to be

**Photo 742-32** (top) – At ~Km 5.7, gully erosion in the fill slope below the road that has encroached below the guardrail and reduced the trafficable width of the road. Debris from plowing and grading the road surface has built up below the guardrail in the segment of the highway upslope /southbound from this location and has caused a concentration of surface runoff to discharge onto the fill slope below the road at this location, which has led to the gully erosion.

In addition to the above, maintenance crews should inspect and maintain the traffic cones marking the gully encroachment below the guardrail at Km 5.7.

- It is judged impractical to establish an upslope road ditch to contain surface runoff from the road due to the limited road width in this area and impracticality of widening the road to accommodate an upslope ditch as noted above.
- Moving forward, the best option to manage the hazard of the gully erosion into the road surface is judged to be:
  - Attempting to backfill the eroded portion of the road surface with granular material.
  - Taking care to avoid accumulations of graded material along the guardrail line that concentrate surface runoff from along the road into the head of the erosion gully – or - establishing culverts or flumes extending down the slope face below the road, into which surface runoff from the road can be directed into in the absence of an upslope ditch and buried culverts below the road surface.

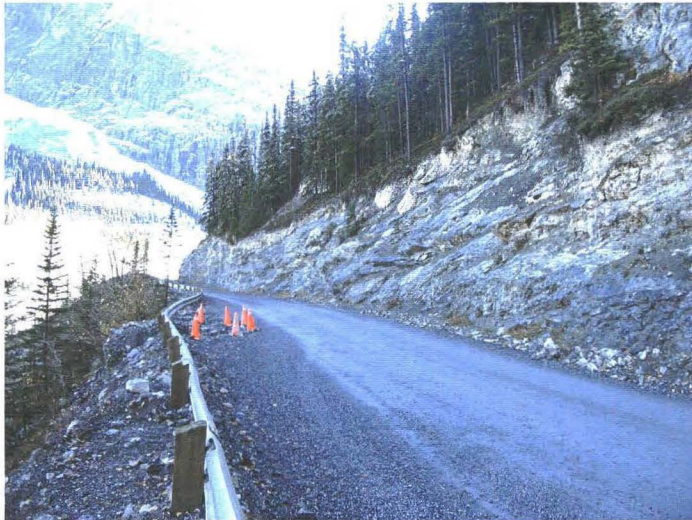
**Photo 742-33** (middle) – Facing southbound towards the gully erosion and illustrating the reduction in road width adjacent to the gully.

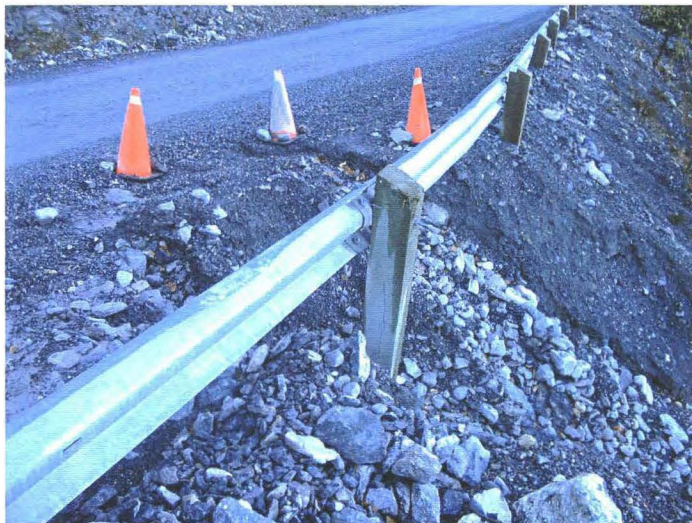
**Photo 742-34** (bottom) – Another view of the head of the gully erosion, showing how the guardrail posts have been undermined.

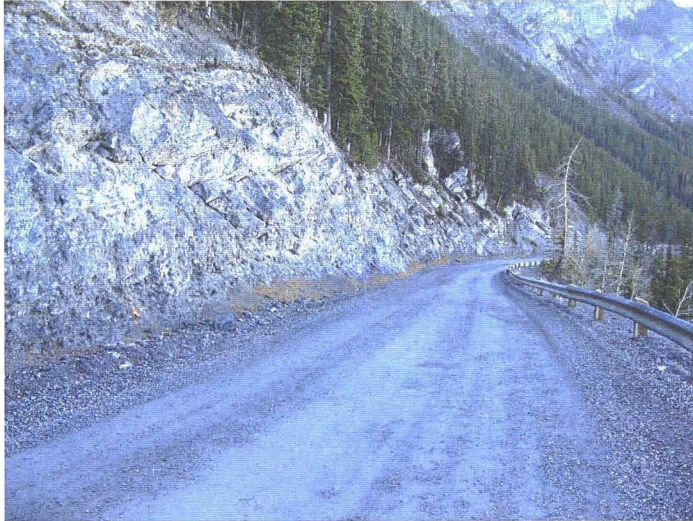
**Photo 742-35** (top) – Typical view of the cut slopes around Km 5.8, a short distance northbound from the curve in the road. Note the accumulation of gravel and cobble-sized rocks along the toe of the cut slope. The cut slopes in this area also appeared to be primarily undergoing solution weathering, with relatively minor volumes of resulting rockfall.

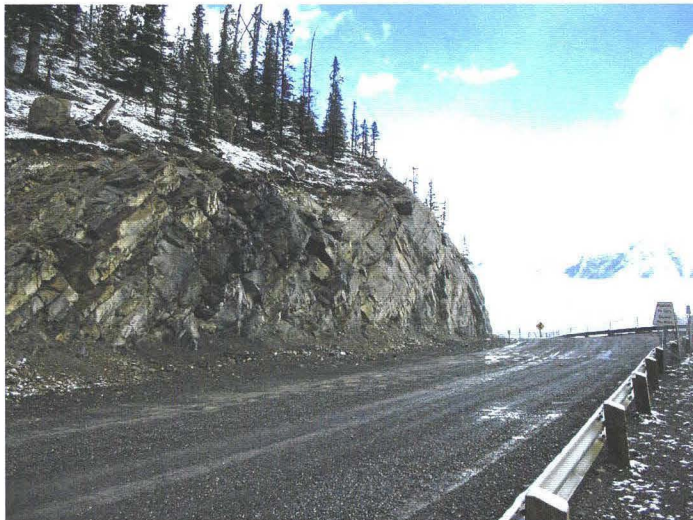
**Photo 742-36** (middle) – Typical view of the cut slopes between ~Km 5.8 and ~Km 6.1. The cut slopes along this segment are typically around 50 to 55° inclination and 5 m or less in height. The cut slopes face southeast, therefore the southwest dip direction of the bedrock exposed in the cut slopes is roughly parallel to the bearing of the highway. This is less favorable with respect to slope stability than along the segment between ~Km 5.5 and ~Km 5.8 where bedrock dip direction is downwards into the cut slopes, however not a significant risk to this segment of the highway.

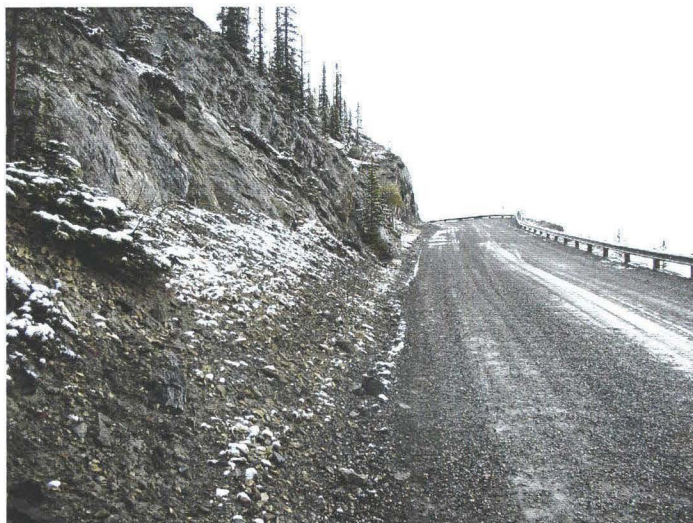
**Photo 742-37** (bottom) – Typical view facing northbound towards the sharp bend in the highway around Km 5.8. Note the accumulation of gravel-sized debris along the lower part of the cut slope in some areas. Erosion and minor rockfall appear to be ongoing along this segment of the highway, but not a significant risk.
