~Km 5.2 To ~Km 6.1 Cut Slopes

Site Observations

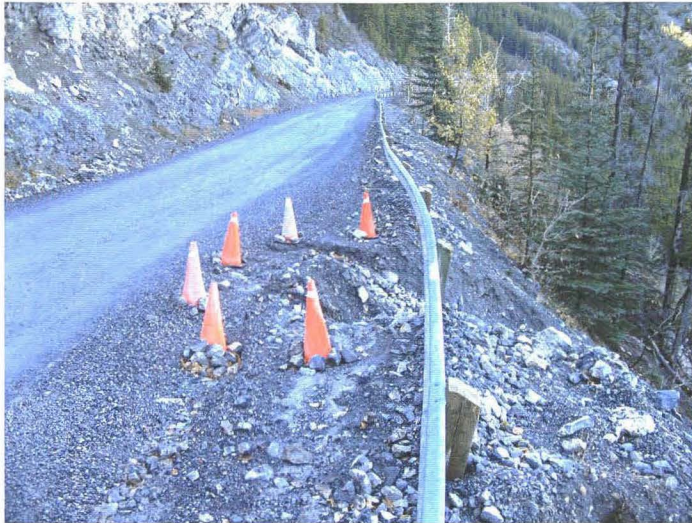
- At approximately Km 5.7:
 - There is a gully eroding below the guardrail, as shown in Photos 742-32 to 742-34. The gully erosion is occurring at a location where soil and gravel that has been graded from the road surface has built up below the guardrail and caused a concentration of surface runoff from the road to

- There is one location at approximately Km 5.7 where a concentration of surface runoff from the road is eroding a gully below the guardrail and into the downslope side of the road surface. The surface runoff along the road appeared to be

Photo 742-32 (top) – At ~Km 5.7, gully erosion in the fill slope below the road that has encroached below the guardrail and reduced the trafficable width of the road. Debris from plowing and grading the road surface has built up below the guardrail in the segment of the highway upslope /southbound from this location and has caused a concentration of surface runoff to discharge onto the fill slope below the road at this location, which has led to the gully erosion.

In addition to the above, maintenance crews should inspect and maintain the traffic cones marking the gully encroachment below the guardrail at Km 5.7.

- It is judged impractical to establish an upslope road ditch to contain surface runoff from the road due to the limited road width in this area and impracticality of widening the road to accommodate an upslope ditch as noted above.
- Moving forward, the best option to manage the hazard of the gully erosion into the road surface is judged to be:
 - Attempting to backfill the eroded portion of the road surface with granular material.
 - Taking care to avoid accumulations of graded material along the guardrail line that concentrate surface runoff from along the road into the head of the erosion gully – or - establishing culverts or flumes extending down the slope face below the road, into which surface runoff from the road can be directed into in the absence of an upslope ditch and buried culverts below the road surface.

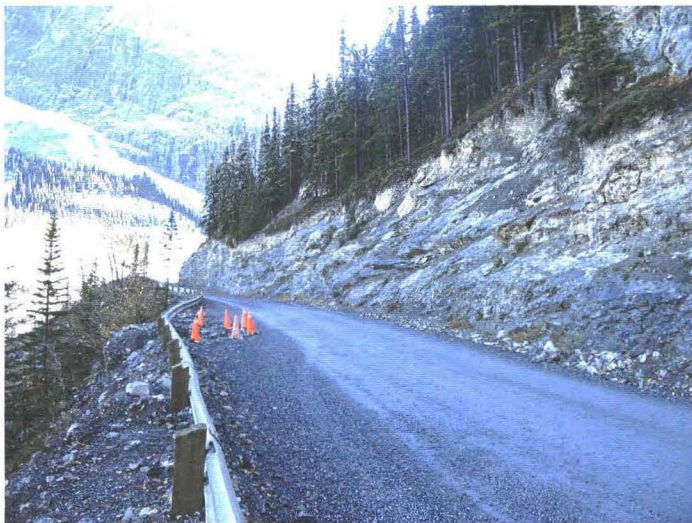
Photo 742-33 (middle) – Facing southbound towards the gully erosion and illustrating the reduction in road width adjacent to the gully.

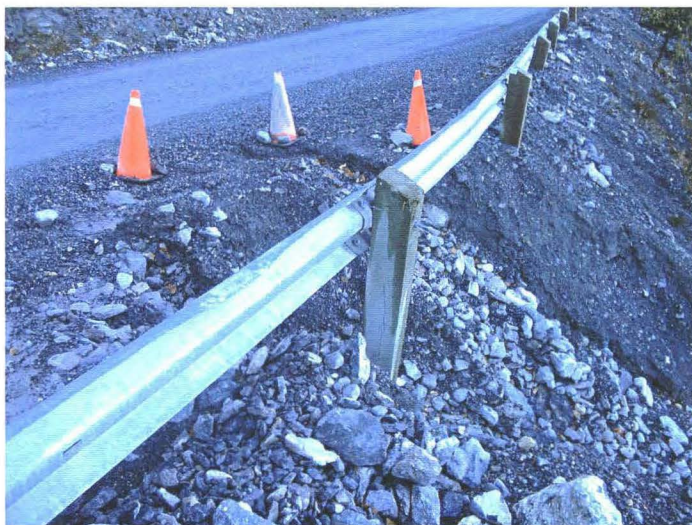
Photo 742-34 (bottom) – Another view of the head of the gully erosion, showing how the guardrail posts have been undermined.

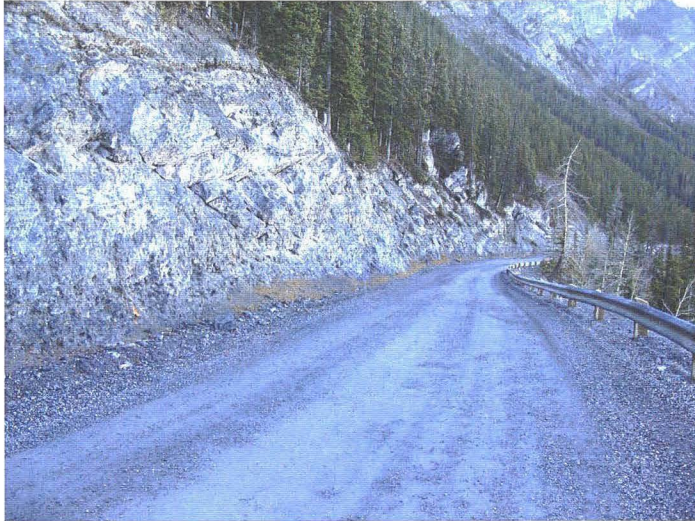
Photo 742-35 (top) – Typical view of the cut slopes around Km 5.8, a short distance northbound from the curve in the road. Note the accumulation of gravel and cobble-sized rocks along the toe of the cut slope. The cut slopes in this area also appeared to be primarily undergoing solution weathering, with relatively minor volumes of resulting rockfall.

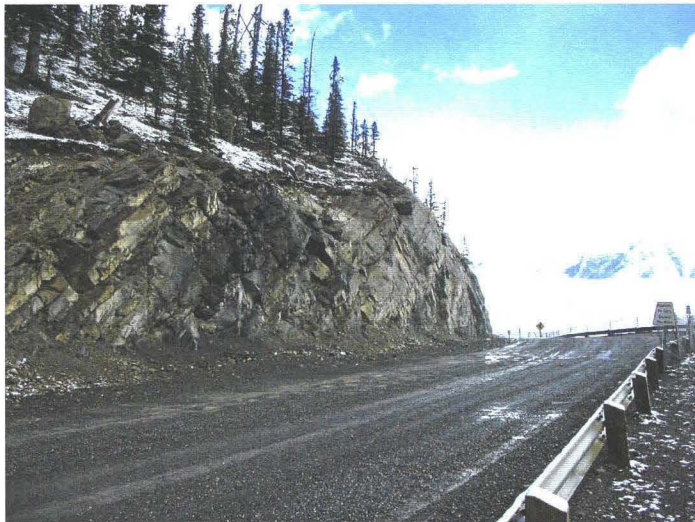
Photo 742-36 (middle) – Typical view of the cut slopes between ~Km 5.8 and ~Km 6.1. The cut slopes along this segment are typically around 50 to 55° inclination and 5 m or less in height. The cut slopes face southeast, therefore the southwest dip direction of the bedrock exposed in the cut slopes is roughly parallel to the bearing of the highway. This is less favorable with respect to slope stability than along the segment between ~Km 5.5 and ~Km 5.8 where bedrock dip direction is downwards into the cut slopes, however not a significant risk to this segment of the highway.

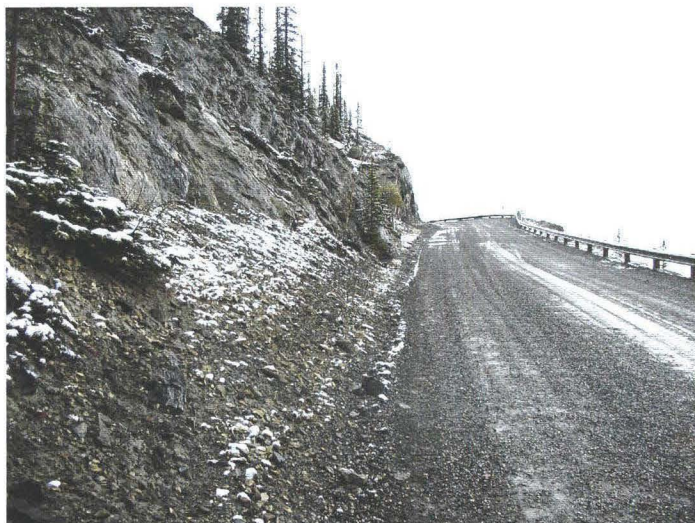
Photo 742-37 (bottom) – Typical view facing northbound towards the sharp bend in the highway around Km 5.8. Note the accumulation of gravel-sized debris along the lower part of the cut slope in some areas. Erosion and minor rockfall appear to be ongoing along this segment of the highway, but not a significant risk.
