SOUTHERN REGION GEOHAZARD RISK ASSESMENT SITE INSPECTION FORM

SITE NUMBER AND NAME	HIGHWAY & KM:	PREVIOUS INSPECTION DATE		
S010A Archery Range	762:02, 10.026	INSPECTION DATE: April 30, 2018		
		June 14, 2016		
LEGAL DESCRIPTION	NAD 83 COORDINATES:	RISK ASSESMENT		
NE 33-21-4-W5	UTM Northing Easting	PF: 1		
	11 5633710 676840			
AVERAGE ANNUAL DAILY TR	RAFFIC:	Contractor Maintenance Area:		
800 (north), (Ref No. 65170)		27

PRIMARY SITE ISSUE: Monitoring landslide repairs affecting the highway embankment and underlying natural slope.

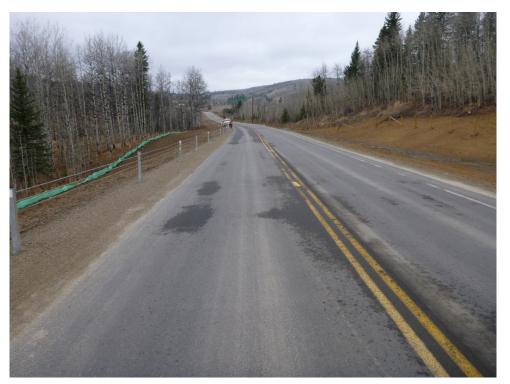
Photo 1 Highway repair completed in 2017. HTCB installed on southbound lane shoulder. Photo taken facing northeast on April 30, 2018.

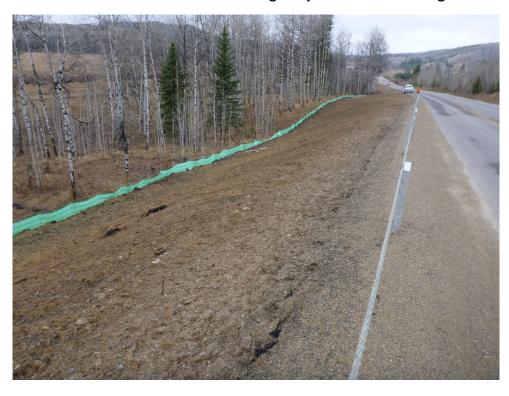
Photo 2 West embankment of highway. Photo taken facing northeast on April 30, 2018.

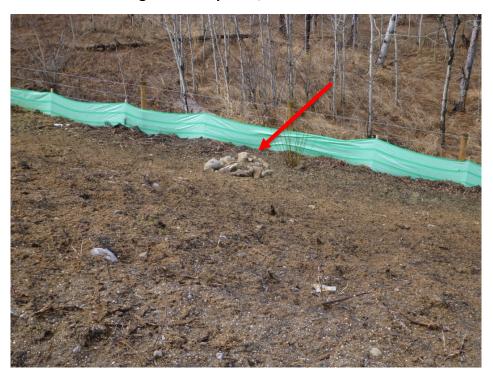
Photo 3 Drainage installed beneath highway. Rock placed at outlet of drain. Photo taken facing west on April 30, 2018.

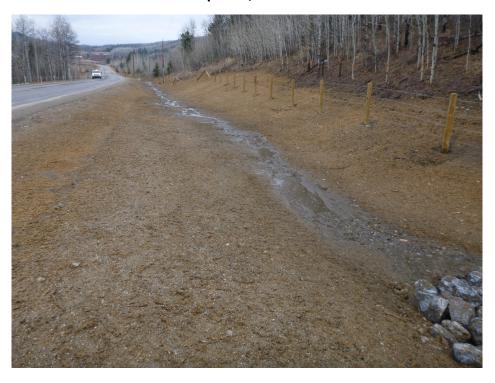
The ditches were mulched but rolled erosion control product was not used. Ditch may erode with spring and early summer runoff when vegetation is not well established.

Photo 4 East side of highway ditch. Some erosion noted. Rolled erosion control product not used on ditch bottom. Vegetation not established on slopes. Photo taken facing northeast on April 30, 2018.
